Identification of Risks of Failure of Pneumatic Tyres of Passenger Vehicles in Ghana

Gabriel S. K. Akakpo¹, Eyram Kwame¹, P. S. A. Gladstone-Bright²,
Christabel S. Ewedji³

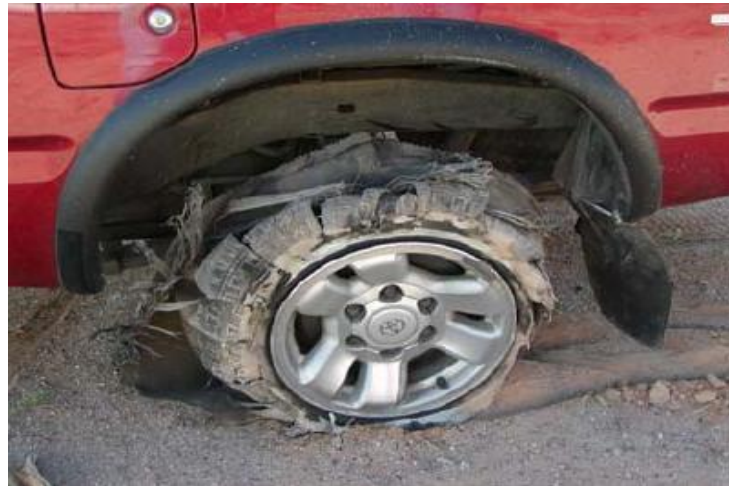
Figure 1: A failed pneumatic tyre

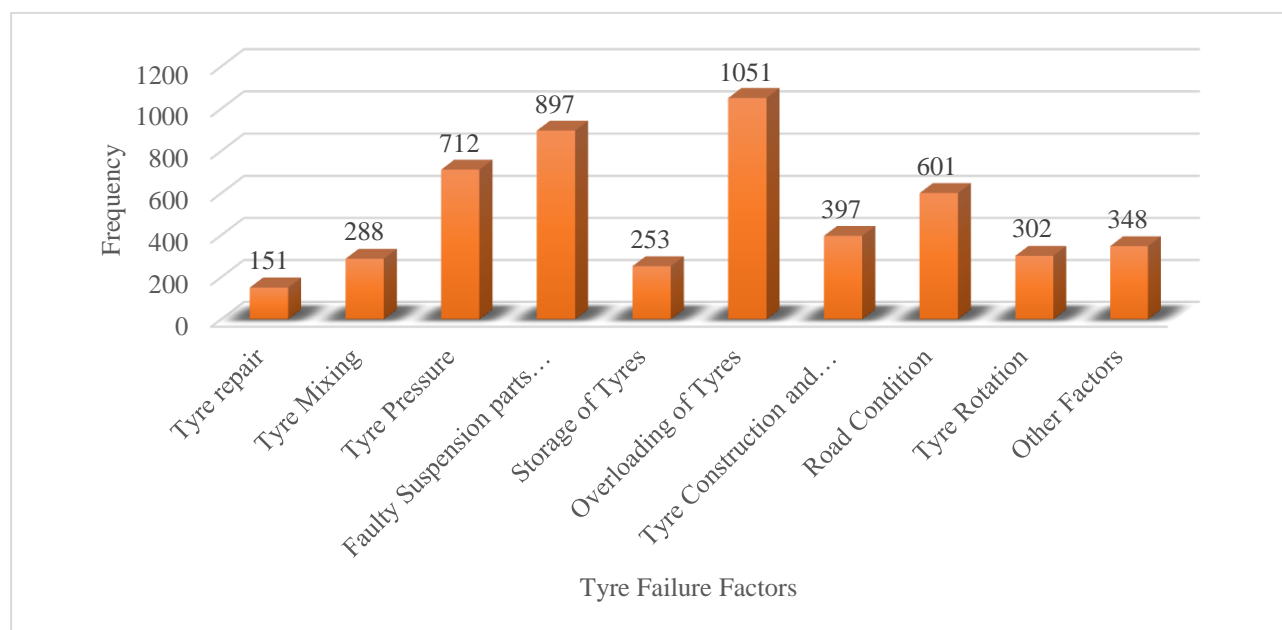
Figure 3: Causes of tyre failure of passenger buses

Considering the different causes of tyre failures among Passenger Buses the study revealed that overloading contributes to failures of about 1051 out of 5000 tyres representing 21% of tyres sampled.

From Figure 3, 151 out of 5000 samples of tyres failed due to wrong repair of tyre. It can be inferred that 3% of the total sample failed because of wrong repair. The first step in repairing tubeless tyres is to locate the piercing object. The object is removed and the area is roughened. Adhesive glue is applied to both the roughened area and the cold patch, then left for about five to six minutes to dry. The cold patch is then firmly pressed on the roughened area. After about ten to twenty minutes, the tyre is fitted to the wheel. After about twenty minutes, the tube is fitted to the tyre, inflated and fitted to the wheel. When tubeless tyres are badly damaged by a piercing object, the vulcanizers fit an inner tube into the damaged tubeless tyre, hence, using it as tubed tyre. In the repair of tubeless tyres of Passenger Buses, only cold patch fittings were used instead of the recommended plug and patch fittings for tubeless tyres. The recommended second coating adhesive glue used to the patch and roughened tyre area were not applied to these Passenger Buses. Therefore, it was observed that the tyre repair procedure is flawed hence tyre repair is one factor of tyre failure of the sampled Passenger Buses.

Figure 3 shows that 288 out of the 5000 damaged tyres that were sampled failed due to tyre mixing representing 5.8%. From careful observations, radial tyres are the predominantly used tyres by Passenger Buses. It was observed that tyres of different sizes and types are used on all wheel positions, which were not specified by the vehicle manufacturer in the placard. In fact, tyre mixing poses hazard to the tyres because each brand of tyre has different resistances to heat, wear and different traction qualities even if they have the same ratings. This is why tyre mixing should not be encouraged in order to avoid using tyres of different constructions, sizes, speed, load and pressure ratings. It was also observed that tyres of smaller radii were wearing at a faster rate as compared to those of bigger radii, as the vehicle tends to lean in the direction of the smaller tyre. Furthermore, when tyres of different pressure ratings are used, it causes a problem of either under-inflation or over-inflation on one tyre and abnormal tyre wear leads to damages.

From Figure 3, it can be seen that 712 out of 5000 samples of damaged tyres failed because of improper tyre pressure, depicting 14.2% of the sample. No routine checks on tyre pressure is done on these Passenger Buses and the issue of tyre inflation and pressure only come up after repairs or when it is observed that a tyre has lost a noticeable amount of pressure. This is usually after the tyre goes down noticeably or the effects of under-inflation are noticed while driving. Most of these vehicles do not have a function Tyre Pressure Monitoring Systems (TPMS), which could be useful in determining loss of tyre pressure.

According to Figure 3, 897 out of 5000 sampled tyres have visible signs of high probability of failure due to faulty suspension parts and wheel alignment, corresponding to 17.9% of the total sample. Faulty suspension parts are clearly evident among Passenger Buses because of the number of tyres that show wear patterns consistent with those caused by faulty suspension parts. Wheel alignment is done when signs of faulty suspension parts become evident in vehicle handling and in some cases when fitting new tyres. However, not all reports of faulty suspension parts are attended to immediately or as soon as they ought to be. Hence, faulty suspension part is an element of risks of Passenger Buses pneumatic tyre failure.

As shown on the graph (Figure 3), 1051 out of 5000 sample tyres failed due to overloading of tyres. This could be inferred that 21% of the sampled damaged tyres are due to overloading. An Iveco Bus, which transports commuters from Tema Station in Accra to Aflao was examined. The gross vehicle weight rating of the Iveco bus as stated on the bus placard is 22680kg at 105 *psi*. The tyre specification as recommended from the placard is 11R22.5 and 105 *psi*. The gross axle weight ratings as stated on the placard are 5,442kg (front) and 17,326kg (rear). What is the evidence of overload?

Figure 3 shows that 397 out of 5000 sampled tyres failed and it can be interpreted as 7.9% of the total damaged tyres failed because of tyre construction and brands at Passenger Buses. Radial tyres are predominantly used by Passenger Buses with different brand names. Some are tubed tyres while others are tubeless. The table below shows, in percentages, the different types of damaged tyres, indicating their brands.
