Emission Testing of 1974 Pontiac V-8 with  
Defective Thermal Vacuum Valves

June 1976

Technology Assessment and Evaluation Branch  
Emission Control Technology Division  
Office of Mobile Source Air Pollution Control  
Environmental Protection Agency

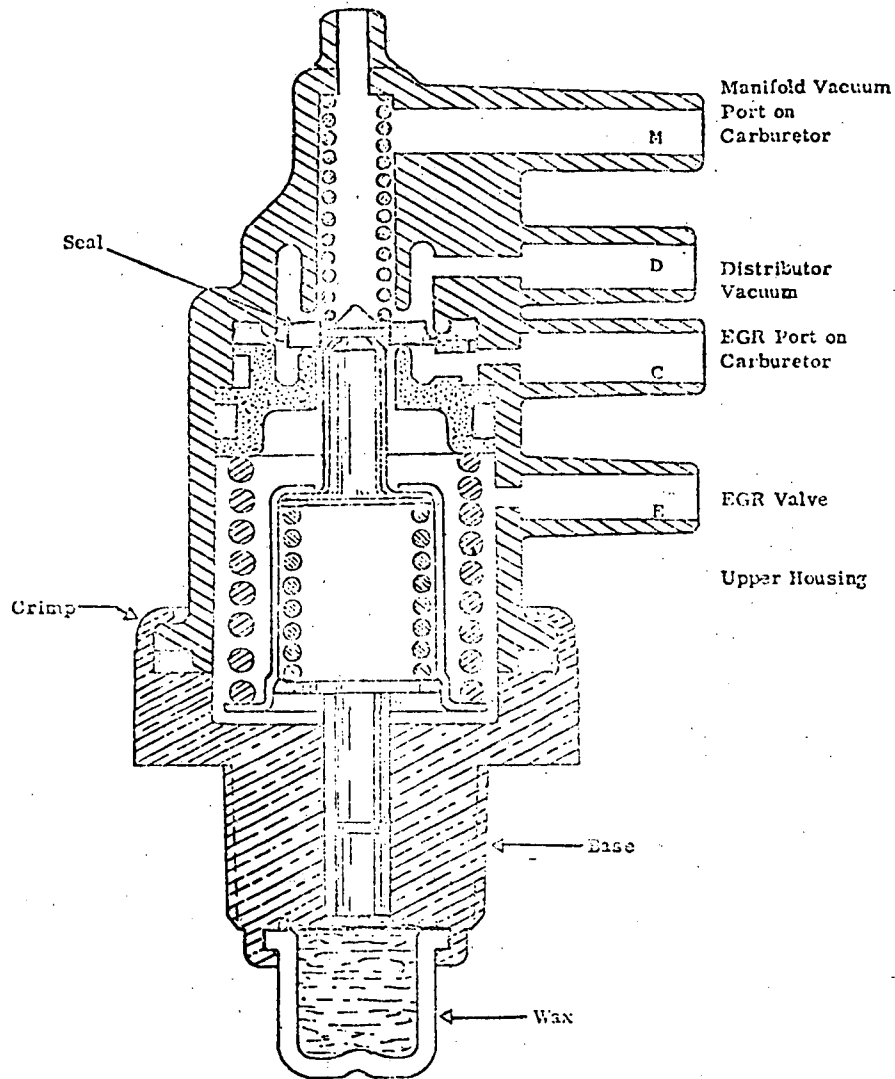
Figure 1 1974 Pontiac V-8 Thermal Vacuum Valve (Dole)

The valve, Figure 1, is a dual function thermal switch. It is activated by intake manifold air temperature. The valve allows a vacuum

signal to be sent to the EGR valve at temperatures above 62<sup>o</sup>F. It simultaneously shuts off the direct vacuum signal to the distributor. The typical installation schematic is shown in Figure 2.

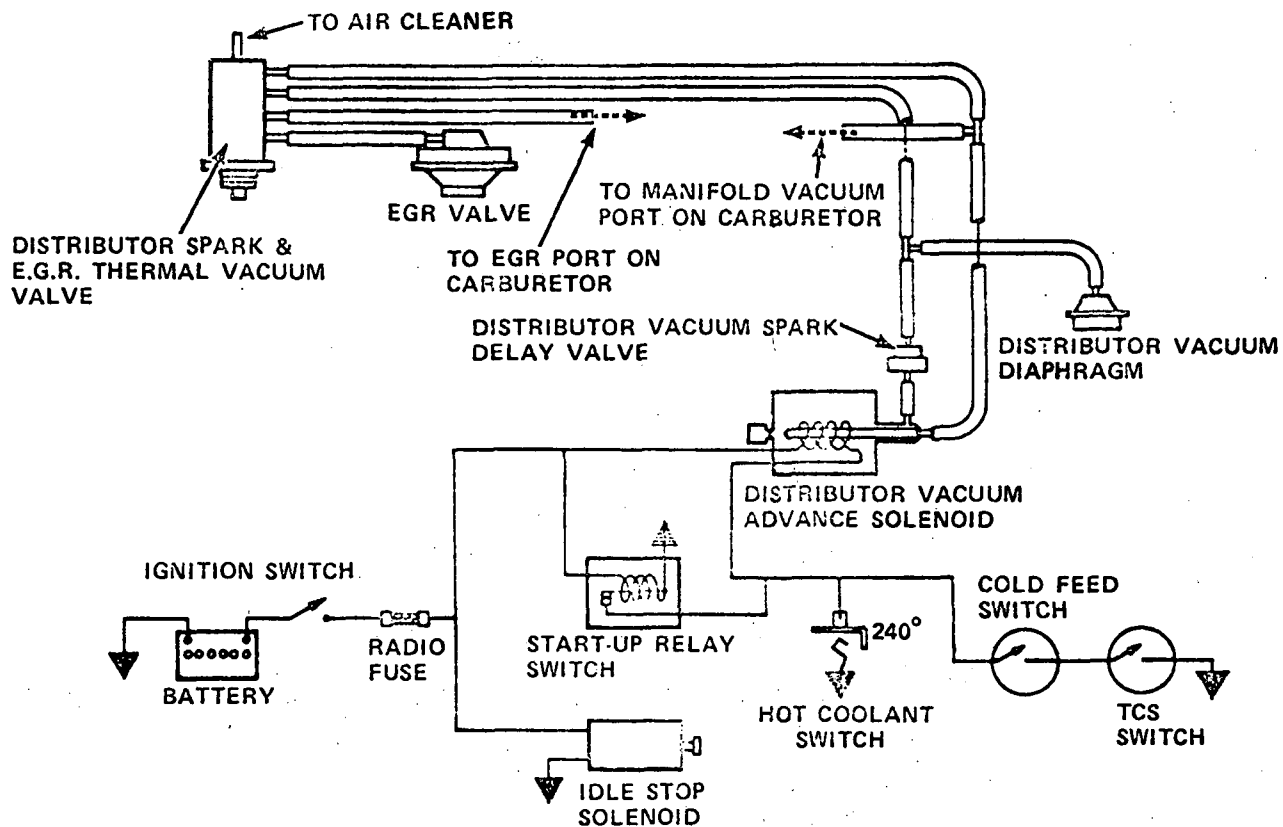
Figure 2 Typical Emission Control System for 1974 Pontiac V-8

The 1974 Pontiac V-8 uses an emission control system that employs a transmission controlled spark (TCS) to control distributor advance and exhaust gas recirculation (EGR). Engine vacuum signals supplied at the carburetor are used to control the EGR valve and distributor advance. The sending of these signals is controlled in part by the TVV.

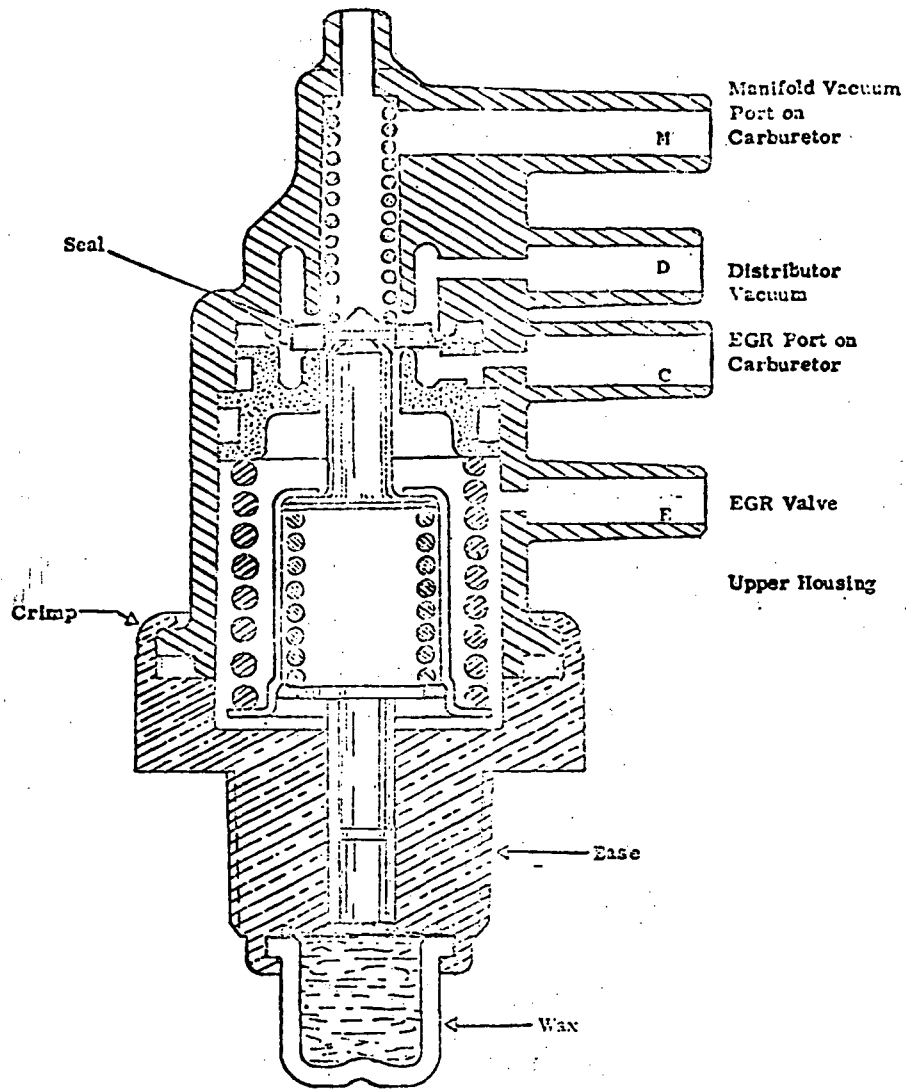
Figure A-1 1974 Pontiac V-8 Thermal Vacuum Valve (Dole)

The tests consisted of applying a controlled vacuum to the valve at the proper port, while raising the actuation temperature in a stepwise fashion and observing when the valve actuated by measuring the vacuum at another port. For instance, referring to Figure A-1: vacuum applied to port 'M' was observed with a vacuum gage at port 'D'. Likewise, a vacuum applied at port 'C' was observed at port 'E'. The valves were also checked for leaks.

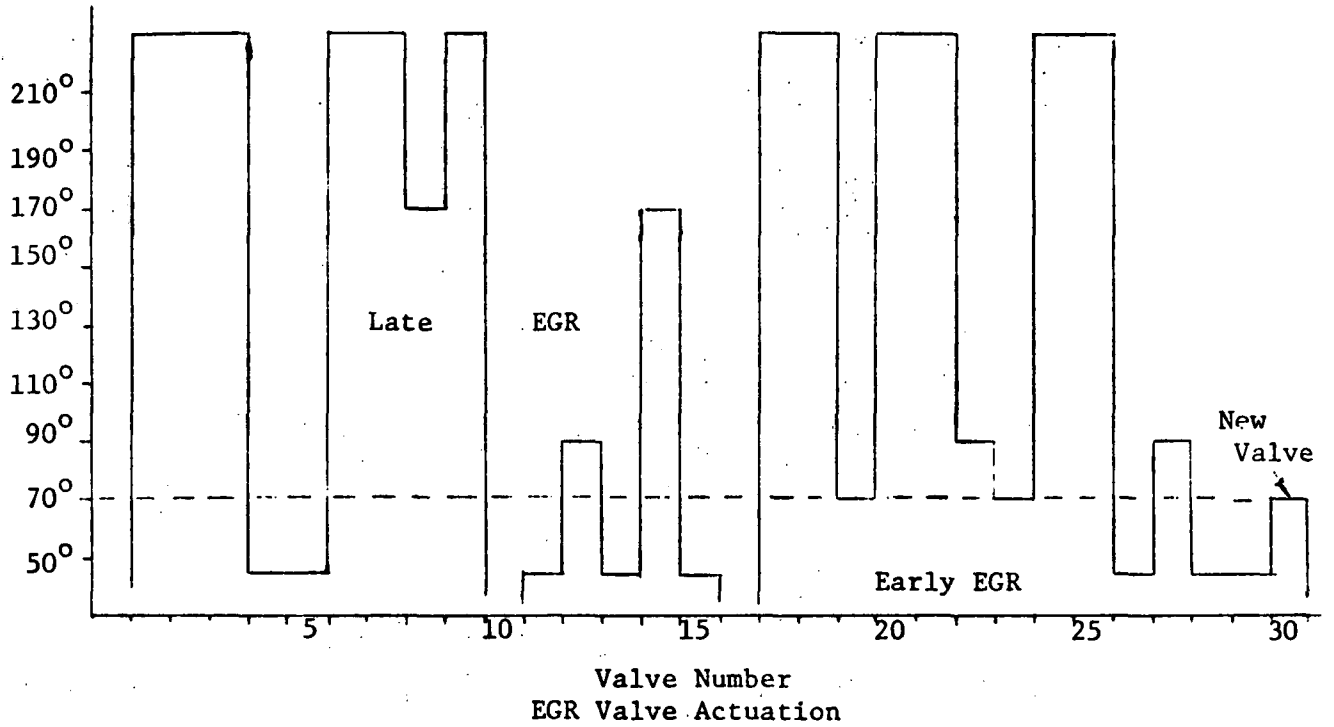
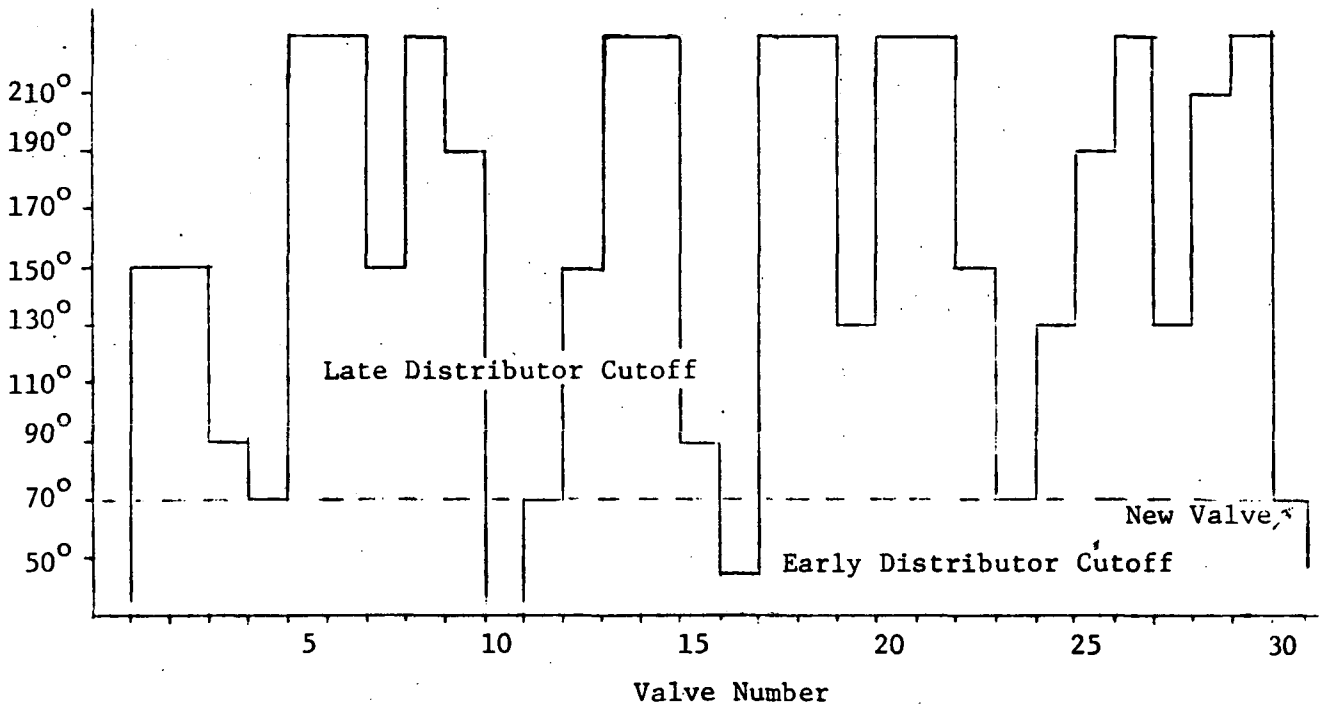
Direct Distributor Vacuum Advance  
Figure A-2 Summary of Functional Test Results

Vacuum test results are depicted in Figure A-2 in which valve actuation temperature for each function is shown for each valve. Of the twenty-eight valves tested (number 10 was broken and not tested), twenty-five did not provide the required vacuum signal at the design temperature. Principal faults were late cutoff of distributor manifold vacuum, late EGR actuation and early EGR actuation.
