Second Amendment Campaign of certain Model 20-EDL Tie Rod End
Sockets Manufactured by TRW and Incorporated into ArvinMeritor Axles
NHTSA File No.: 02E-017.002

NOTICE: Second Amendment Campaign of certain Model 20-EDL Tie Rod End
Sockets Manufactured by TRW and Incorporated into ArvinMeritor Axles

Replacing TRW 20-EDL (20-Size) Tie Rod Assembly Socket Ends on Meritor Axles

Re: Second Amendment to September 2000, Defect Information Report, as amended on June 27, 2001, filed in accordance with 49 CFR §573.5, regarding certain Model 20-EDL Ball Sockets Manufactured by TRW and Sold to ArvinMeritor.

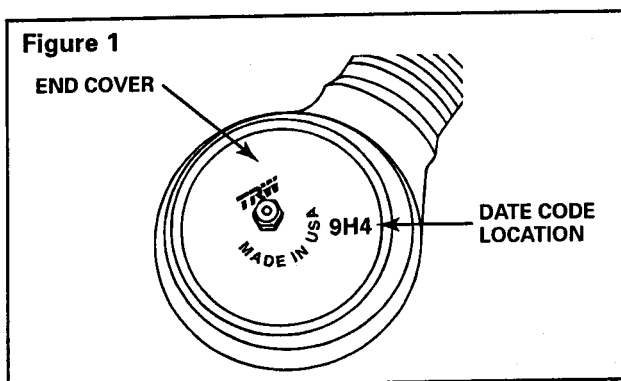
1. Check the date code on the socket end.
Figure 1. A truck chassis number will be identified on the original equipment (OE) manufacturer's list, along with the tie rod end date codes that are affected by this campaign. **A chassis number and date code combination that is not on the list is not part of this campaign.**

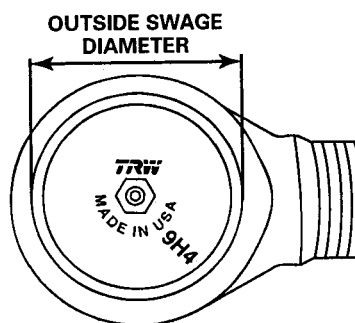
Figure 2

2. The sockets are 20-size sockets. To identify the size, measure the outside swage diameter. **Figure 2.** The outside swage diameter of a 20-EDL (20-size) socket measures approximately 1-7/8-inch. **A socket that measures 2-1/8-inch is a "24-size" socket and is not part of this campaign.**

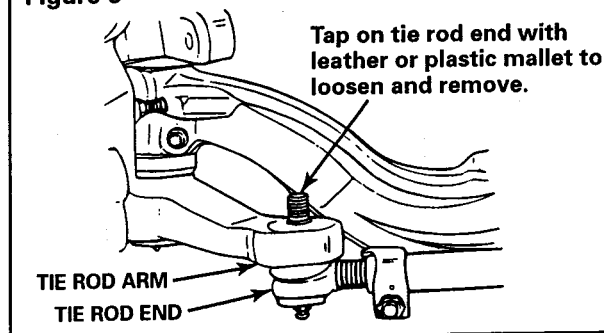
Figure 3

3. Use a tie rod puller or a ball-joint separator to disconnect the cross tube assembly from the tie rod arms. Do not heat the arm to remove the tie rod assembly. If necessary, tap the tie rod end with a leather or plastic mallet to loosen the tie rod end. Do not use a steel hammer. **Figure 3.**

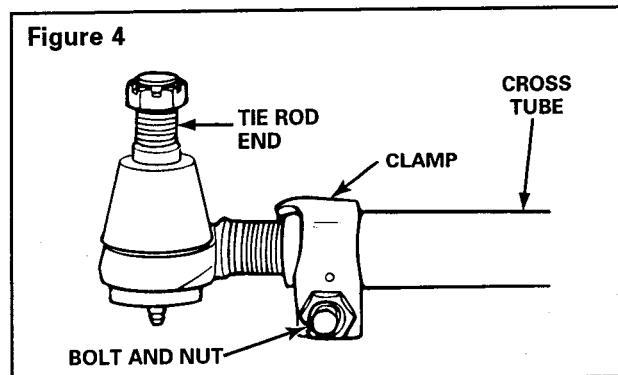
Figure 4

1. Note the position of the bolt and nut in the clamp, and the position of the clamp relative to the ground. **Figure 4.**

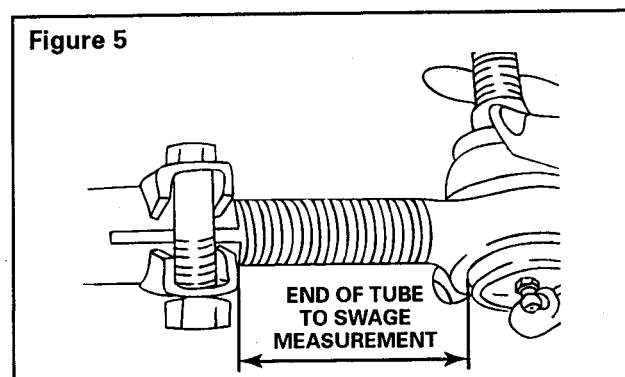
Figure 5

2. On one end, measure from the end of the cross tube to the nearest outside swage diameter. **Figure 5.** Record the measurement.

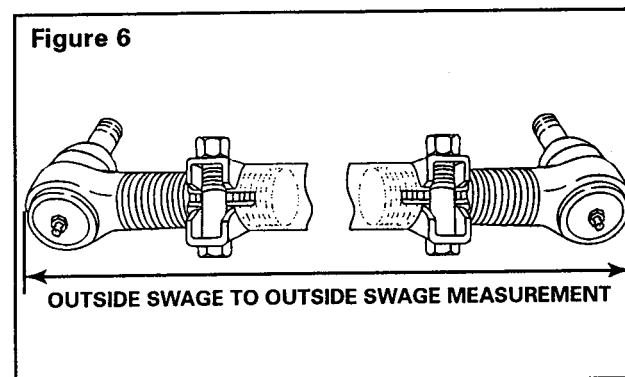
Figure 6

3. Measure the length of the tie rod from the outside of the swage diameter on one socket end to the outside of the swage diameter on the outer socket end. **Figure 6.** Record the measurement.

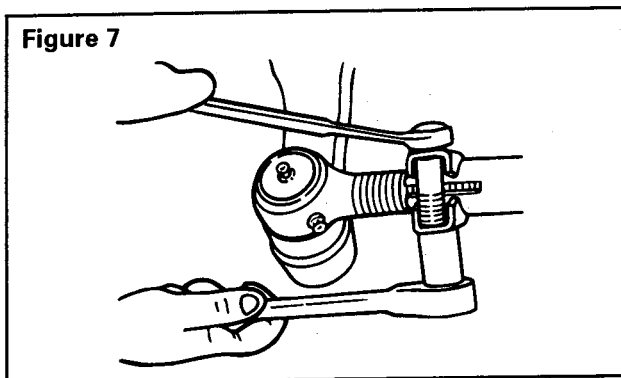
Figure 7

- Loosen the clamp on the cross tube. Figure 7. Remove one threaded tie rod end from the tube.

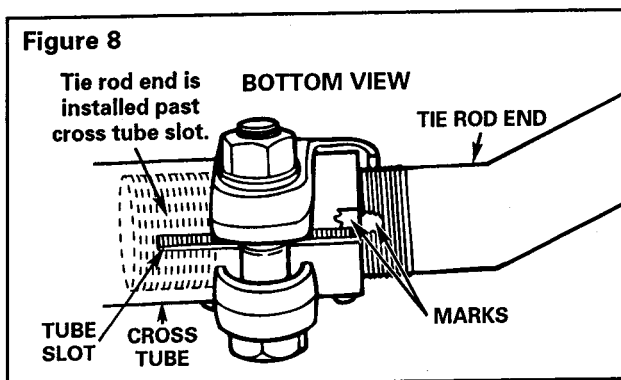
Figure 8

- Thread the new socket end into the cross tube until the measurement from the end of the tube to the nearest outside swage diameter is the same as Step 2. Repeat Steps 4 and 5 for the other socket end.
- Verify that both socket ends are threaded into the cross tube deeper than the cross tube slot. Figure 8.
