**Subject:** Customer Notification Letter and Technical Bulletin

**NOTICE:** Second Amendment Campaign of certain Model 20-EDL Tie Rod End  
Sockets Manufactured by TRW and Incorporated into ArvinMeritor Axles

ArvinMeritor File: C2AE

NHTSA File: 02E-017.002

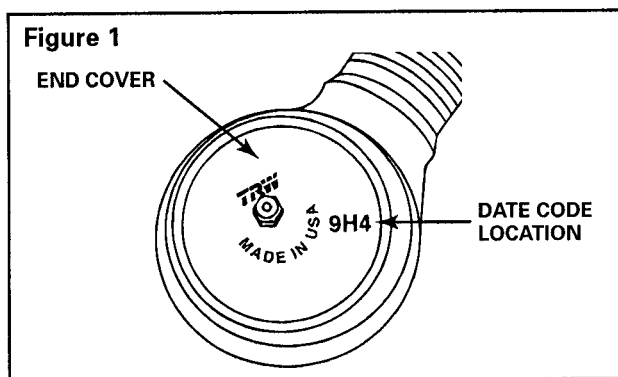
1. Check the date code on the socket end.  
**Figure 1.** A truck chassis number will be identified on the original equipment (OE) manufacturer's list, along with the tie rod end date codes that are affected by this campaign. **A chassis number and date code combination that is not on the list is not part of this campaign.**

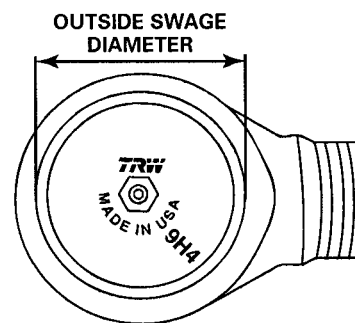
Figure 2

2. The sockets are 20-size sockets. To identify the size, measure the outside swage diameter. **Figure 2.** The outside swage diameter of a 20-EDL (20-size) socket measures approximately 1-7/8-inch. **A socket that measures 2-1/8-inch is a "24-size" socket and is not part of this campaign.**

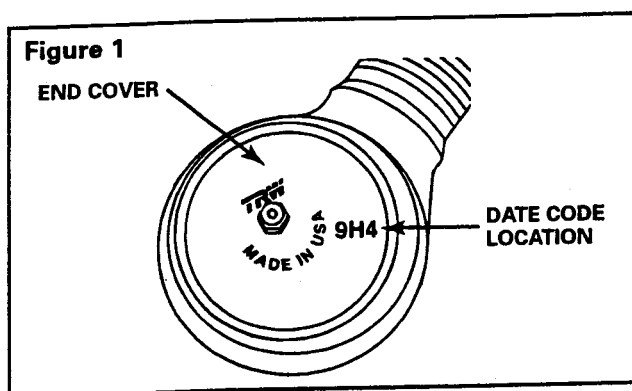
1. Check the date code on the socket end.  
**Figure 1.** A truck chassis number will be identified on the original equipment (OE) manufacturer's list, along with the tie rod end date codes that are affected by this campaign. A chassis number and date code combination that is not on the list is not part of this campaign.

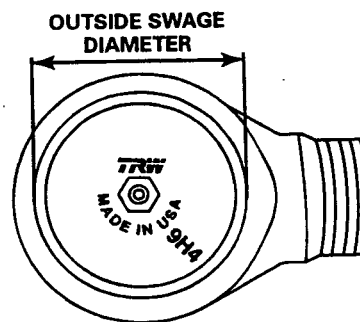
**Figure 2**

2. The sockets are 20-size sockets. To identify the size, measure the outside swage diameter. **Figure 2.** The outside swage diameter of a 20-EDL (20-size) socket measures approximately 1-7/8-inch. A socket that measures 2-1/8-inch is a "24-size" socket and is not part of this campaign.

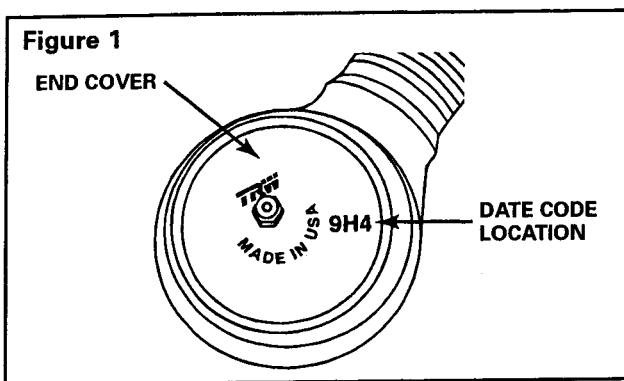
1. Check the date code on the socket end.  
**Figure 1.** A truck chassis number will be identified on the original equipment (OE) manufacturer's list, along with the tie rod end date codes that are affected by this campaign. **A chassis number and date code combination that is not on the list is not part of this campaign.**

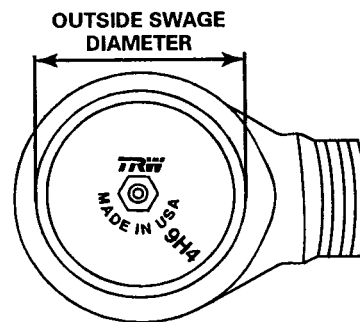
Figure 2

2. The sockets are 20-size sockets. To identify the size, measure the outside swage diameter. **Figure 2.** The outside swage diameter of a 20-EDL (20-size) socket measures approximately 1-7/8-inch. **A socket that measures 2-1/8-inch is a "24-size" socket and is not part of this campaign.**
