This Service Information bulletin supersedes SI B34 04 10 dated November 2010.

Recall Campaign 10V- 446: Inspect Brake Booster Vacuum Supply Line

E60 (5 Series) with N62 or N62TU engines produced from August 8th, 2003 to November 30th, 2009

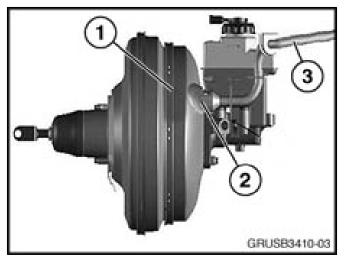
1. Remove the brake booster vacuum supply line (3) together with the non-return valve (2) from the brake booster (1).

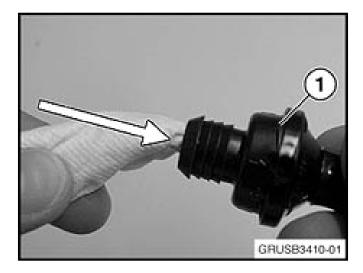
2. Check the brake booster vacuum supply line at the non-return valve upstream from the brake booster for contamination of oil. Insert a tightly rolled up corner of a non-reusable lint free white shop towel (see arrow) into the non-return valve (2). If the towel does not indicate any engine oil residue, proceed to step 4.

3. If the line exhibits contamination with engine oil, proceed to step 5.
