**Re: Defect Information Report – Supplemental Report No. 3
11V-160, FL-592, Business Class M2 Headlight Height
Dealer Notification**

Subject: Business Class M2 Headlight Height

Models Affected: Specific Freightliner Business Class M2 vehicles manufactured July 19, 2010, through January 14, 2011.

FL592A

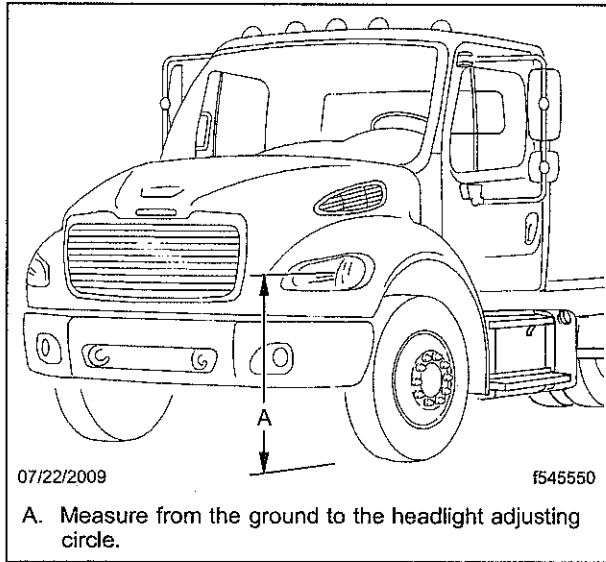
Fig. 1, Headlight Measurement

- 3.2 Measure from the ground to the center of the highest headlight lens. See **Fig. 1** and **Fig. 2**. If this height is 54 inches (137 cm) or less, nothing more needs to be done. Clean a spot on the base label (Form WAR259) and attach a completion sticker for FL592 (Form WAR260) to the base label.

A. Measure from the ground to the headlight adjusting circle.

16. Install the mounting capscrews.
17. Install the headlight cover.
18. Close the hood.
19. Connect the batteries.
20. Check the height of the headlights. Measure from the ground to the center of the highest headlight lens. See **Fig. 1** and **Fig. 2**. The height should be 54 inches (137 cm) or less.
