TECHNICAL SERVICE BULLETIN

Victory Motorcycle

Bulletin Number: V-11-01
V-11-01A
Model Years: 2011

SUBJECT: 2011 Cross Country Handlebar Riser Assembly Inspection / Replacement

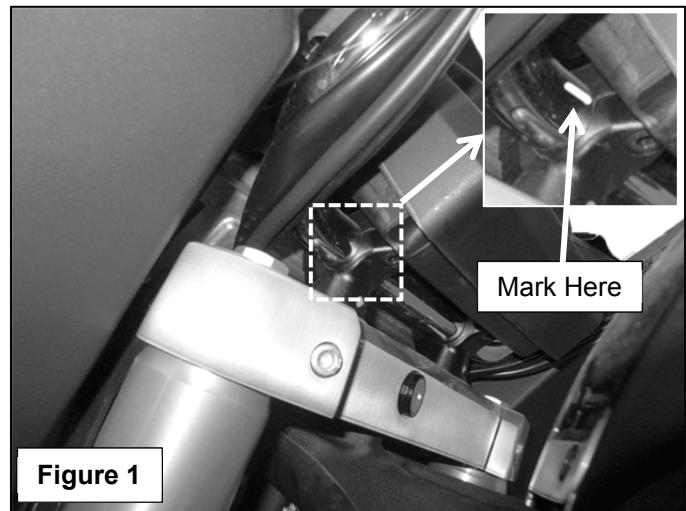
1. Support motorcycle securely in an upright position with the front wheel clamped in a wheel vise.
2. Using a grease pen, mark the handlebar at the parting line between the riser and riser clamp (see Figure 1). The mark will be used to determine if any handlebar rotation has occurred following the inspection.
3. Securely attach tie straps around center of left and right handgrips (see Figure 2).
4. Attach the spring scales to the tie straps (see Figure 2).

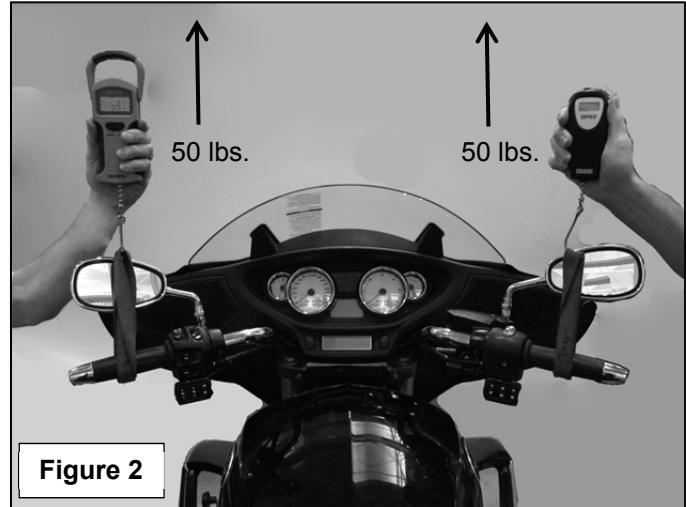
5. With one person on each side of the motorcycle, slowly apply an upward (vertical lifting) force until each scale individually reads 50 lbs. (Force totaling 100 lbs. on the handlebar assembly).

THE HANDLEBAR ASSEMBLY SHOULD NOT ROTATE WITHIN THE RISERS. IF ANY MOVEMENT IS DETECTED THE RISER / CLAMP ASSEMBLIES MUST BE REPLACED (PROCEED TO REPLACEMENT PROCEDURE).

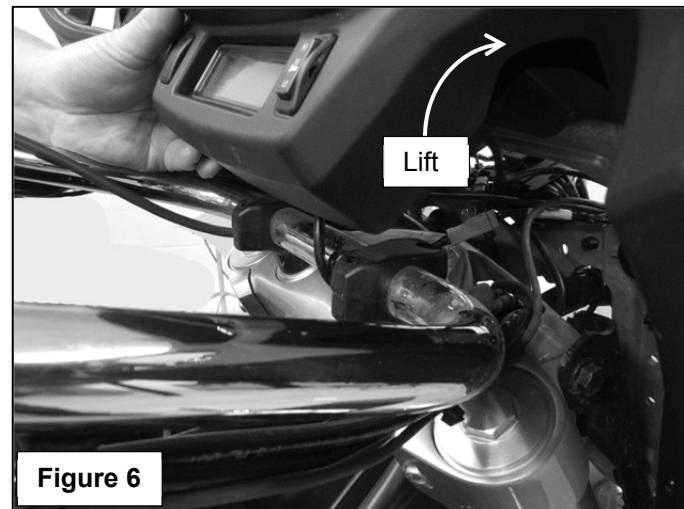
IMPORTANT: If the handlebar assembly is not properly supported, the handlebar may drop down onto the fuel tank when the clamp bolts are loosened. If the fuel tank is not sufficiently protected, damage may occur.

7. Place a protective cover over the fuel tank. While supporting the handlebar assembly, remove the handlebar clamp bolts (see Figure 7).
