**Re: Defect Information Report – Supplemental Report No. 2
11V-330, FL-609, Interim Recall Notice Starter Cable Isolator Bolts**

**August 2011
FL609
Interim Recall Notice
NHTSA # 11V-330**

Subject: Starter Cable Isolator Bolts

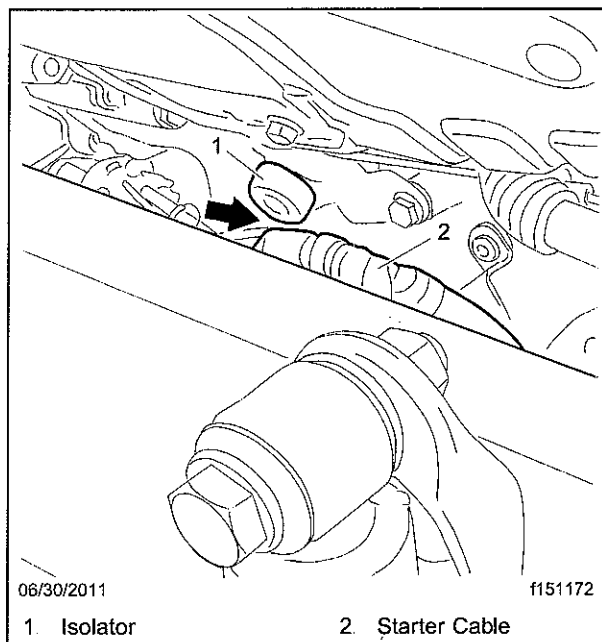
If the bolt is present and there is a minimum of 1/2-inch of clearance between the isolator and the starter cable, no further action is necessary at this time. See **Fig. 1**

Fig. 1, Correct Isolator Installation

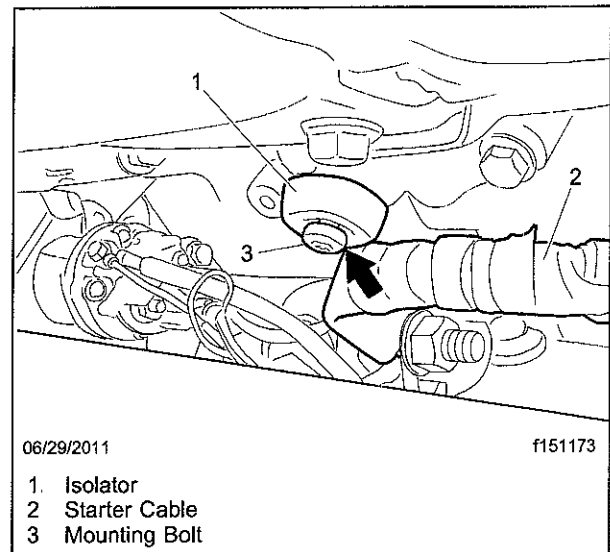
On some vehicles equipped with a Detroit Diesel DD15 or DD16 engine, the bolt attaching a rubber isolator to a support bracket may become loose and back out, potentially contacting an un-fused starter cable and creating a short circuit. A short circuit between an un-fused starter cable and chassis ground could result in a vehicle fire.

If the bolt has backed out of the isolator and is protruding past the front surface of the isolator or if the starter cable is within 1/2-in of the isolator, take the vehicle to an authorized Daimler Trucks North America dealer for repair. See **Fig. 2**

Fig. 2, Bolt Backed Out
