PRODUCT SAFETY RECALL

SUBJECT: Intermediate Steering Shaft Separation

MODELS: 2011 Cadillac Escalade, Escalade ESV
2011 Chevrolet Silverado, Suburban, Tahoe
2011 GMC Sierra, Yukon, Yukon XL

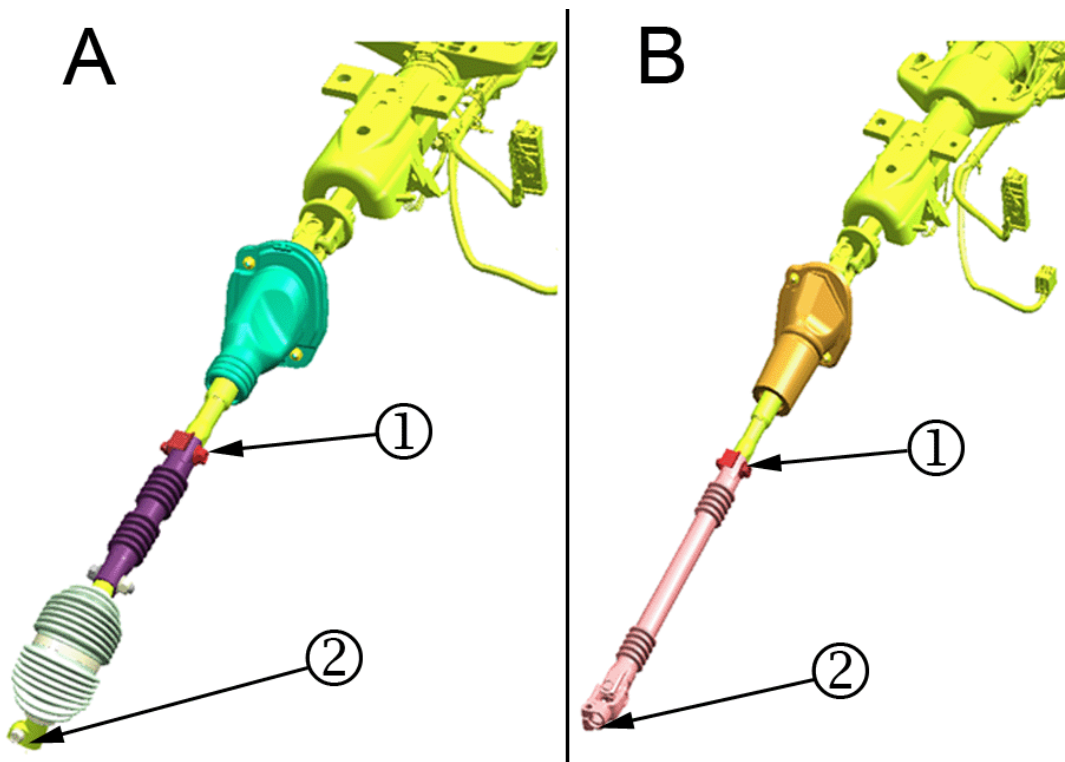
2677257

The “A” portion of the illustration provides an example of an intermediate shaft on a 1500 series vehicle. (1) Mid Joint Bolt (2) Pinion Bolt. The “B” portion of the illustration provides an example of an intermediate shaft on a 2500 or 3500 series vehicle. (1) Mid Joint Bolt (2) Pinion Bolt. Hybrid vehicle intermediate shafts are similar to the intermediate shafts in 1500 series vehicles.

1. Open the hood and locate the intermediate steering shaft mid joint bolt (1). Refer to illustration.
2. Inspect the intermediate steering shaft mid joint bolt (1).
 - If the intermediate steering shaft mid joint bolt is tightened to minimum of 20 N·m (15 lb-ft), proceed to Step 3.
 - If the intermediate steering shaft mid joint bolt is NOT tightened to a minimum of 20 N·m (15 lb-ft), tighten it to 50 N·m (37 lb-ft). Proceed to Step 3.
3. Close the hood and raise and support the vehicle. Refer to *Lifting and Jacking the Vehicle* in SI.

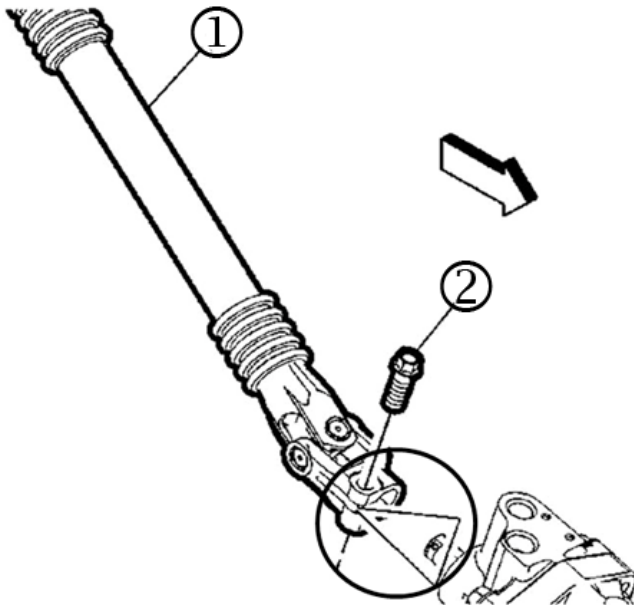
2677256

2500-3500 series vehicle intermediate shaft shown, 1500 series vehicle intermediate shaft similar.

5. Inspect the intermediate steering shaft pinion bolt (2).
 - If the intermediate steering shaft pinion bolt (2) is tightened to minimum of 20 N·m (15 lb-ft), proceed to Step 6.
 - If the intermediate steering shaft pinion bolt (2) is NOT tightened to minimum of 20 N·m (15 lb-ft), tighten it to 47 N·m (35 lb-ft). Proceed to Step 6.
