File In Section: Product Recalls
Bulletin No.: 11191A
Date: July 2011

PRODUCT SAFETY RECALL

SUBJECT: Intermediate Steering Shaft Separation

MODELS: 2011 Cadillac Escalade, Escalade ESV
2011 Chevrolet Silverado, Suburban, Tahoe
2011 GMC Sierra, Yukon, Yukon XL

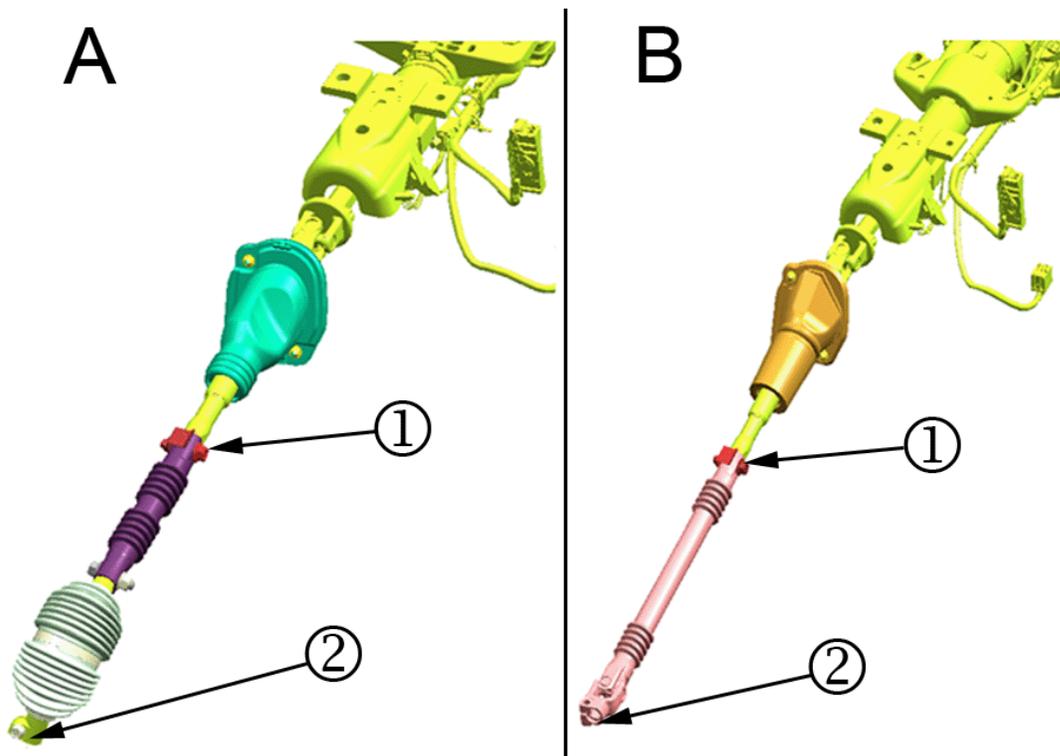
2677257

The "A" portion of the illustration provides an example of an intermediate shaft on a 1500 series vehicle. (1) Mid Joint Bolt (2) Pinion Bolt. The "B" portion of the illustration provides an example of an intermediate shaft on a 2500 or 3500 series vehicle. (1) Mid Joint Bolt (2) Pinion Bolt. Hybrid vehicle intermediate shafts are similar to the intermediate shafts in 1500 series vehicles.

1. Open the hood and locate the intermediate steering shaft mid joint bolt (1). Refer to illustration.
2. Inspect the intermediate steering shaft mid joint bolt (1).
 - If the intermediate steering shaft mid joint bolt is tightened to minimum of 20 N·m (15 lb-ft), proceed to Step 3.
 - If the intermediate steering shaft mid joint bolt is NOT tightened to a minimum of 20 N·m (15 lb-ft), tighten it to 50 N·m (37 lb-ft). Proceed to Step 3.
3. Close the hood and raise and support the vehicle. Refer to *Lifting and Jacking the Vehicle* in SI.

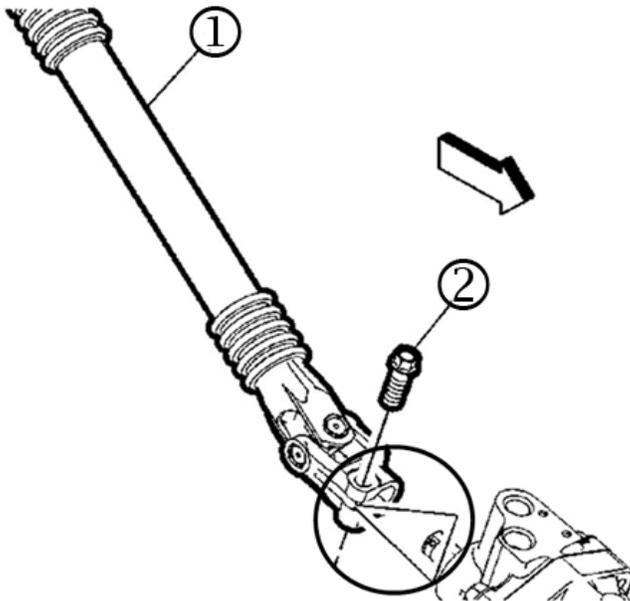
2677256

2500-3500 series vehicle intermediate shaft shown, 1500 series vehicle intermediate shaft similar.

5. Inspect the intermediate steering shaft pinion bolt (2).
 - If the intermediate steering shaft pinion bolt (2) is tightened to minimum of 20 N·m (15 lb-ft), proceed to Step 6.
 - If the intermediate steering shaft pinion bolt (2) is NOT tightened to minimum of 20 N·m (15 lb-ft), tighten it to 47 N·m (35 lb-ft). Proceed to Step 6.
