SAFETY RECALL NOTICE

Recall Campaign: 12V-457

Subject: 2012-2013 Victory Motorcycles – Throttle Cable Retention Nut Torque Inspection

2012-2013 Victory Motorcycles – ALL MODELS

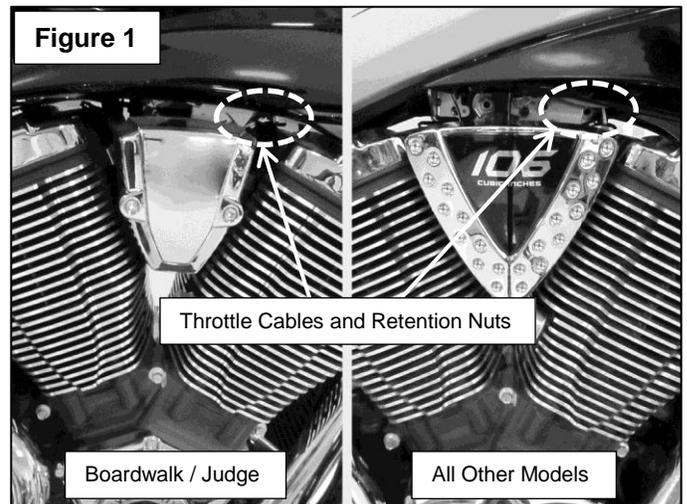
1. Sit on the motorcycle in a normal riding position and rotate the throttle control grip. It should rotate smoothly from the rest position to the completely open position. It should return to the rest position quickly when released.
2. Place the motorcycle securely on its sidestand on a level surface.
3. Working from the right-hand side of the motorcycle, locate the throttle cables and retention nuts above the engine trim cover (see Figure 1).

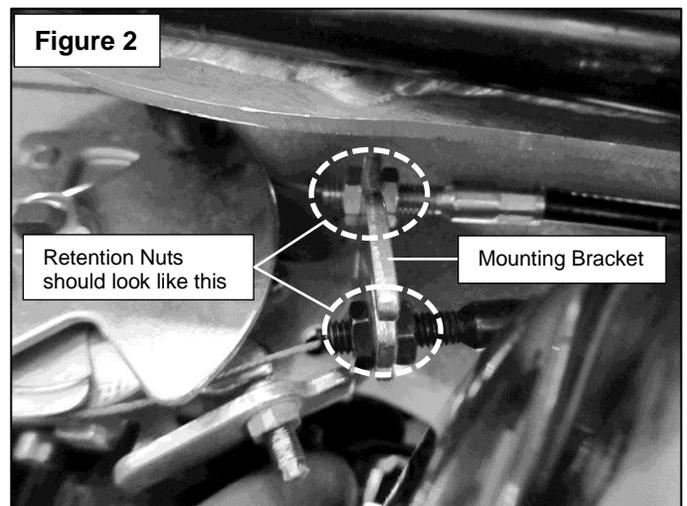
4. Visually inspect the throttle cables to ensure they are securely held in place by the retention nuts. *Each throttle cable should have 1 nut on each side of the mounting bracket. 4 nuts total* (see Figure 2).

CAUTION: If throttle control grip does not operate smoothly and return to the rest position **AND/OR** the throttle cable / retention nut assembly does not resemble Figure 2, **DO NOT** ride your motorcycle.
