TECHNICAL SERVICE BULLETIN

Bulletin Number: V-12-01

SUBJECT: 2012-2013 Victory Motorcycles – Throttle Cable Retention Nut Torque Inspection

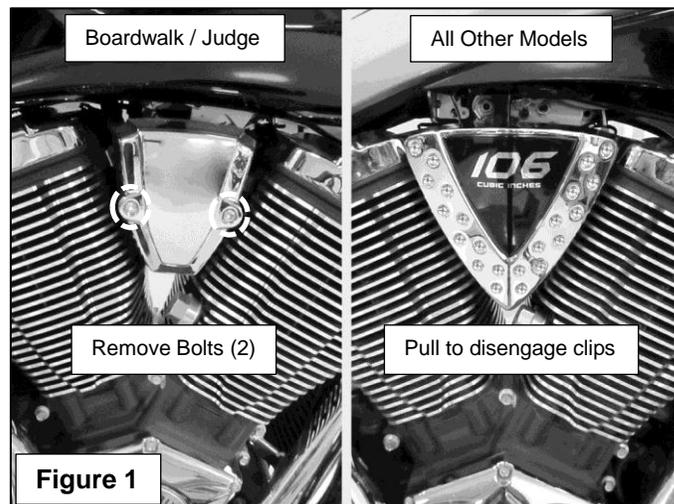
1. Support the motorcycle securely in an upright position with the front wheel clamped in a wheel vise.
2. Working from the right-hand side of the motorcycle, remove the IAC cover (see Figure 1).

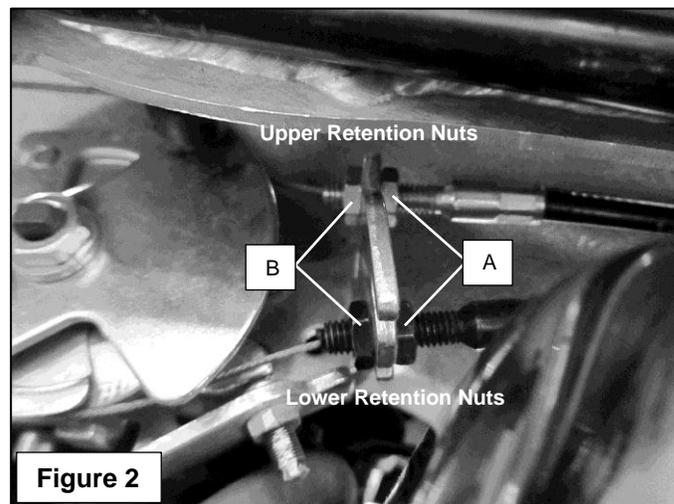
Victory has determined that some motorcycles manufactured on or between 1/03/2012 and 8/16/2012 may have been assembled with incorrect torque applied to the throttle cable retention nuts. If not tightened to specification, the retention nuts can become loose and interfere with proper throttle operation. This could increase the risk of an operator losing control which could result in a vehicle crash.

3. Locate the throttle cable retention nuts (4) above the IAC on the throttle body (see Figure 2).
4. Starting with the upper cable, secure the inboard retention nut (A) with the 10mm open-ended wrench.
5. Position the Torque Wrench / Adapter assembly on outboard retention nut (B) and torque to **48 in-lbs (5.4 Nm)**.
6. Repeat steps 4 and 5 for lower throttle cable retention nuts.
7. Verify proper throttle operation.
8. Reinstall IAC cover.
*Boardwalk & Judge ONLY: Torque IAC cover bolts to **84 in-lbs (9.5 Nm)**.*

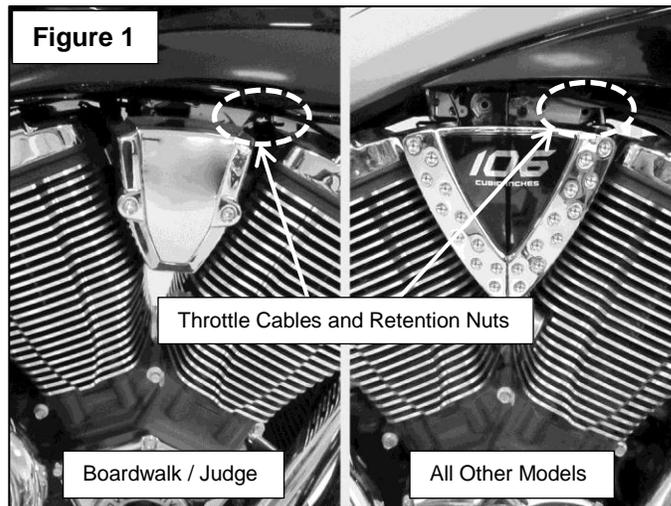
1. Sit on the motorcycle in a normal riding position and rotate the throttle control grip. It should rotate smoothly from the rest position to the completely open position. It should return to the rest position quickly when released.
2. Place the motorcycle securely on its sidestand on a level surface.
3. Working from the right-hand side of the motorcycle, locate the throttle cables and retention nuts above the engine trim cover (see Figure 1).

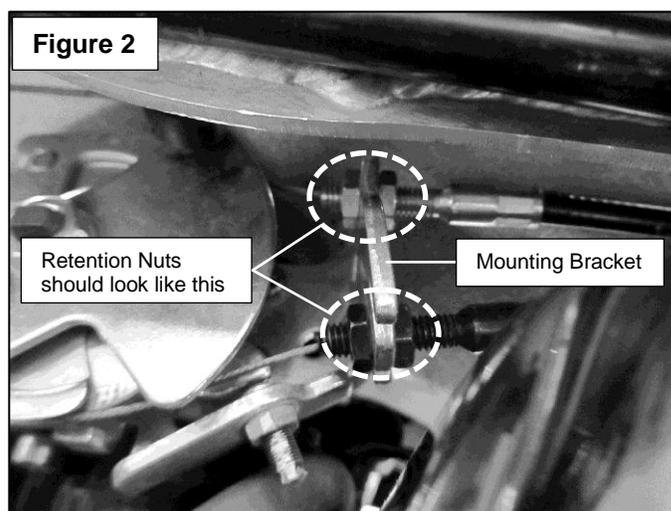
4. Visually inspect the throttle cables to ensure they are securely held in place by the retention nuts. *Each throttle cable should have 1 nut on each side of the mounting bracket. 4 nuts total* (see Figure 2).

CAUTION: If throttle control grip does not operate smoothly and return to the rest position AND/OR the throttle cable / retention nut assembly does not resemble Figure 2, DO NOT ride your motorcycle.
