# Recall Bulletin

**SUBJECT:** Rear Seat Head Restraint May Not Lock in Upright Position

**MODELS:** 2013 Cadillac XTS

GM Recall #12258

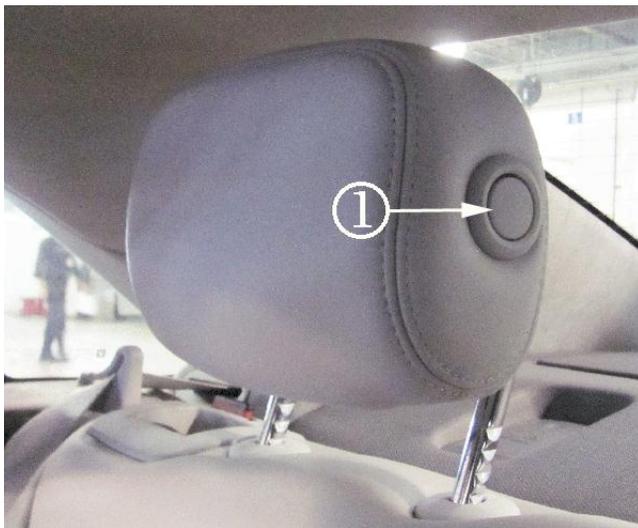
2964026

1. Verify that the rear seat head restraint is in the upright seating position.

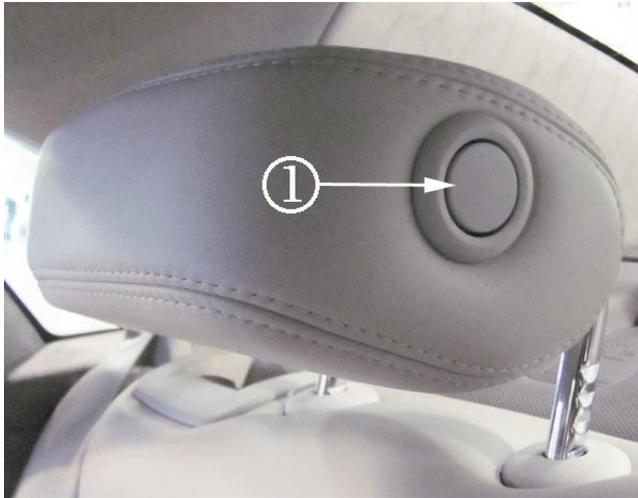
2964027

2. Push rear seat head restraint release button (1). Depressing the rear seat head restraint release button allows the rear seat head restraint to be folded.
3. Ensure the rear seat head restraint folds down after depressing the rear seat head restraint release button (1).
4. Verify that the rear seat head restraint release button returns fully from the depressed position.
  - If the rear seat head restraint release button returns fully from the depressed position, proceed to Step 5.
  - If the release button does NOT return from the fully depressed position, the rear seat head restraint will remain unlocked and will NOT stay in the upright seating position. Replace the rear seat head restraint if it will NOT remain in the upright seating position. Refer to *Rear Seat Head Restraint Replacement* in SI. Begin this inspection again on the second head restraint.

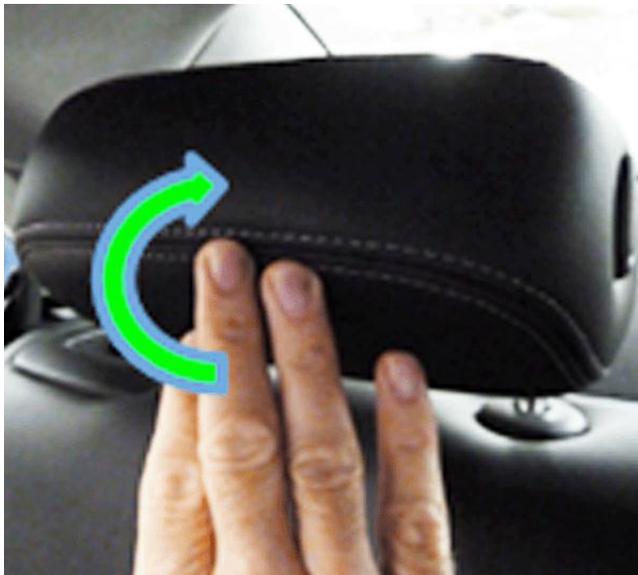
2964030

5. Cycle rear seat head restraint into the upright seating position.

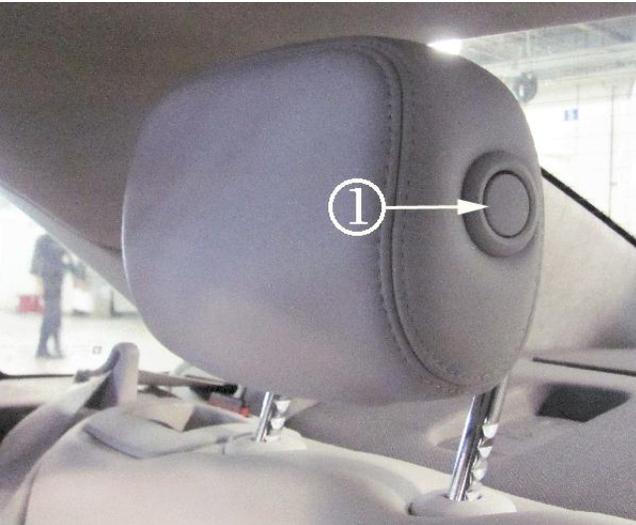
2964026

6. Verify that the rear seat head restraint release button returns fully from the depressed position.
  - If the release button returns fully from the depressed position, proceed to Step 7.
  - If the release button does NOT return fully from the depressed position, the head restraint will remain unlocked and will NOT stay in the upright position. Replace the rear seat head restraint if it will NOT remain in the upright seating position. Refer to *Rear Seat Head Restraint Replacement* in SI. Begin this inspection again on the second head restraint.

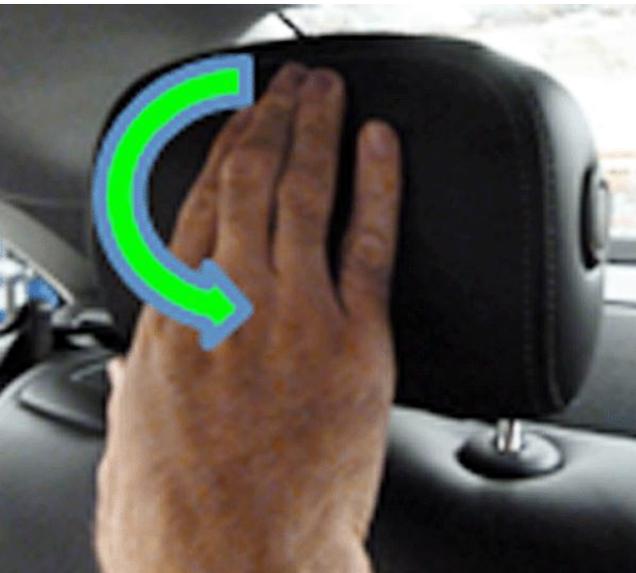
2964032

7. Verify that the rear seat head restraint is locked into the upright position with a push/pull from the top of the rear seat head restraint.
  - If the rear seat head restraint locks and remains in the upright position, proceed to Step 1 and perform the inspection for a total of 5 times on each rear seat head restraint.
  - If the rear seat head restraint does NOT lock and remain in the upright seating position, replace it. Refer to *Rear Seat Head Restraint Replacement* in SI. Begin this inspection again on the second head restraint.
