## ON-SITE AIR BAG INVESTIGATION

CASE NUMBER - NASS-2000-49-068A

VEHICLE - 1997 PLYMOUTH GRAND VOYAGER SE

CRASH DATE - April, 2000

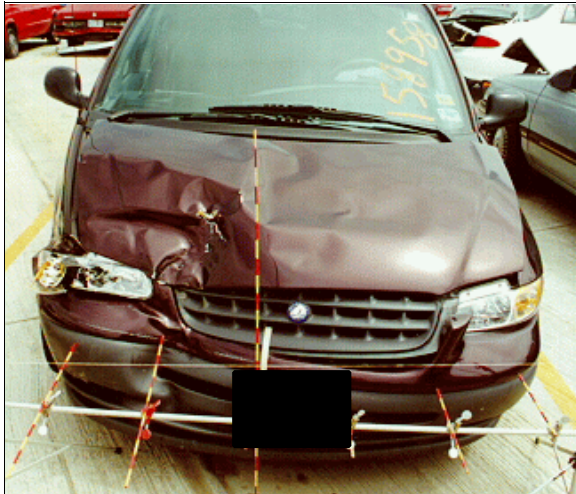
**Figure 4:** Standing view of case vehicle's damaged front right half; Note: direct damage extends from front right bumper corner to white tape

The front right half of the case vehicle (**Figures 4 and 5**) impacted the left front of the Dodge Dakota at the left front tire (**Figure 6**), causing the case vehicle's driver and front right passenger supplemental restraints (air bags) to deploy. The case vehicle rotated approximately 10 degrees counterclockwise while the Dodge Dakota rotated approximately 75 degrees clockwise and side slapped each other with the case vehicle's right back (**Figures 7 and 8**) impacting the Dodge Dakota's left back (**Figure 9** below). The case vehicle continued in a east-

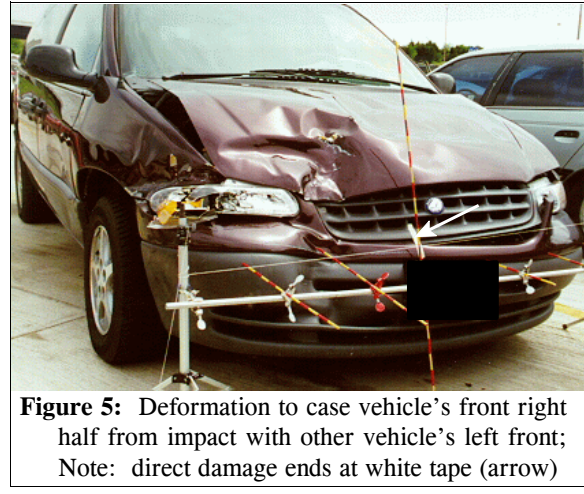
**Figure 5:** Deformation to case vehicle's front right half from impact with other vehicle's left front; Note: direct damage ends at white tape (arrow)

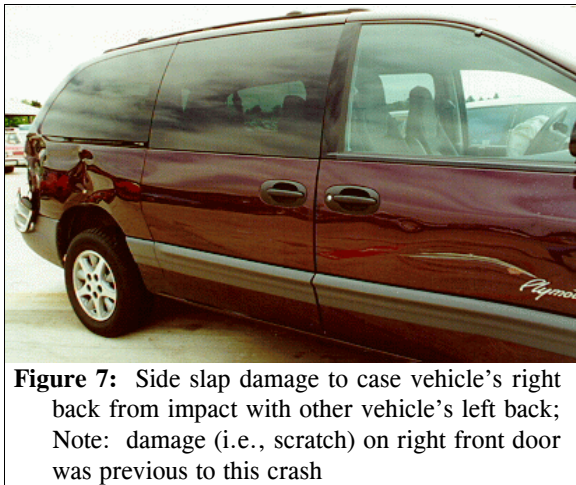
**Figure 7:** Side slap damage to case vehicle's right back from impact with other vehicle's left back; Note: damage (i.e., scratch) on right front door was previous to this crash

located along the right side starting with light scratching to the sliding door then significant deformation again to the right quarter panel (Figures 7 and 8 above). The direct damage started 148 centimeters (58.3 inches) rearward of the right front axle and extended down the right side a measured distance of 244 centimeters (96.1 inches). The direct damage width to the right quarter panel was 67 centimeters (26.4 inches). The case vehicle's third impact—{See End Note A. (3)}, was to the left front tire which was aired out and split from impacting the raised median curb (Figure 11 above). The fourth and final impact was along the vehicle's left side from sideswiping the pole used to support the traffic signal and overhead streetlights [i.e., contact to the rearview mirror (Figure 12 above) with minor scratches down the left side to just before the left rear taillight]. The direct damage (excluding the rearview mirror) for the left sideswipe involved only surface scratches and was measured at 342 centimeters (134.6 inches) in length. There was a 32 centimeter (12.6 inch) separation from the mirror to the start of the scratch to the left side.

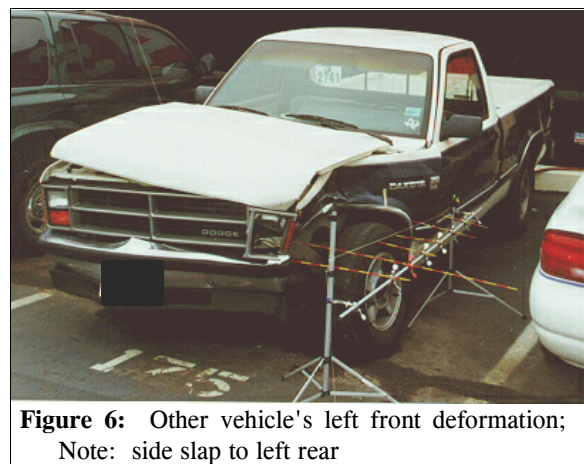
**Figure 6:** Other vehicle's left front deformation; Note: side slap to left rear

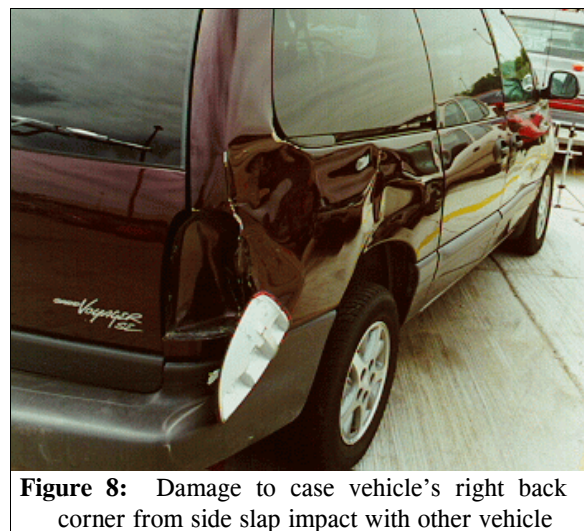
**Figure 8:** Damage to case vehicle's right back corner from side slap impact with other vehicle

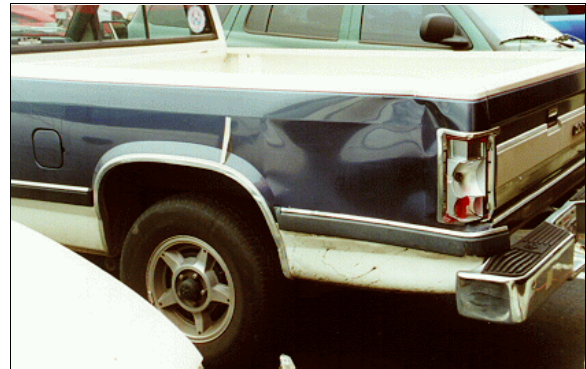
Figure 9: Damage to other vehicle's left back from side slap impact (i.e., 2<sup>nd</sup> event) with case vehicle; Note: direct damage begins at white tape

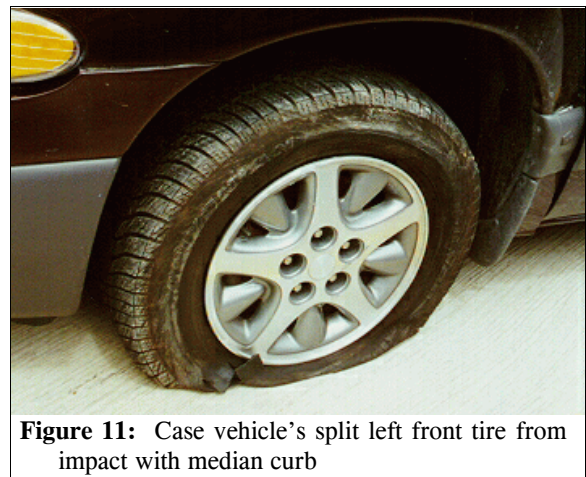
Figure 11: Case vehicle's split left front tire from impact with median curb

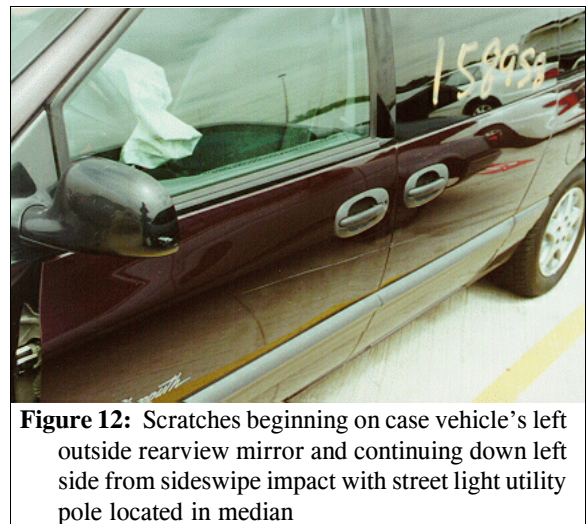
Figure 12: Scratches beginning on case vehicle's left outside rearview mirror and continuing down left side from sideswipe impact with street light utility pole located in median

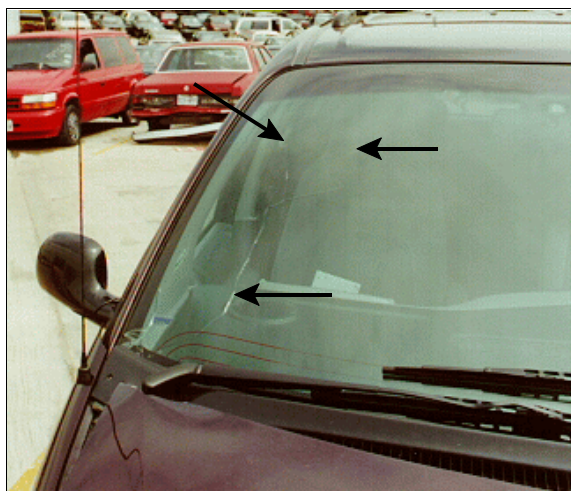
**Figure 14:** Hairline cracks to case vehicle's right windshield from impact with other vehicle's left front; Note: arrows highlight cracks

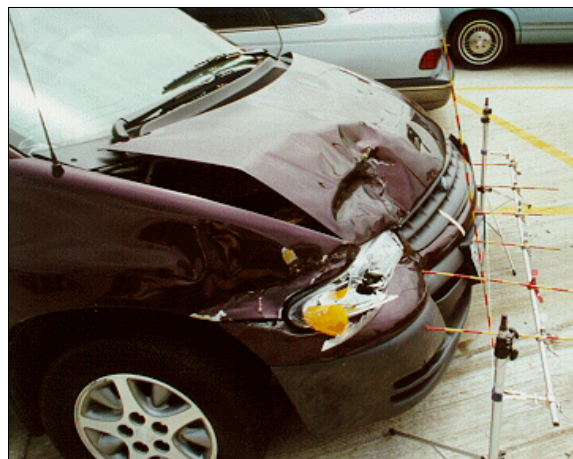
The case vehicle's initial contact with the Dodge Dakota involved the right half of the case vehicle's front. Direct damage began 12 centimeters (4.7 inches) left of center (**Figures 4 and 5** above) and extended to the right bumper corner, a measured distance of 62 centimeters (24.4 inches). The case vehicle's front bumper, bumper fascia, grille, hood, right headlight and turn signal assemblies, and right fender were directly damaged and crushed rearward. There was induced damage to the right windshield (i.e., cracked from impact forces; **Figure 14**) and to the left headlight and turn signal assemblies. Remote buckling was also found on the left fender (**Figures 11 and 12** above). The wheelbase on the case vehicle's right side was shortened 1 centimeter (0.4 inches) while the left side was not shortened. Maximum crush—*{See End Note A. (9)}*, was measured as 16 centimeters (6.3 inches) at C<sub>5</sub> (**Figure 15** below). The side slap contact was

**Figure 15:** Reference line view from right of case vehicle's frontal damage with contour gauge present showing crush profile

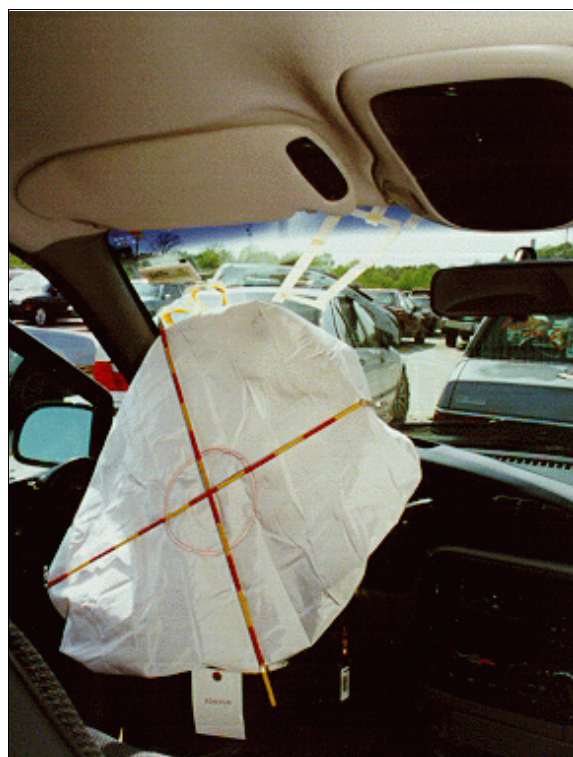
**Figure 16:** Vertical view of case vehicle's driver seating area showing contacts to front left header and windshield from impact by "out-of-position" (i.e., standing on driver's lap) front left infant passenger

An examination of the case vehicle’s interior revealed evidence of occupant contact on the interior surfaces. Contact evidence was found on the front header on the driver’s side to the left of the rearview mirror (i.e., scuff with hair) from contact by the head of the “on-lap” infant passenger, and there was a grease smudge on the windshield to the left and below of the mark on the header (Figure 16 above and Figure 17). In addition, the rearview mirror was tilted, with its left side down, but most likely not from direct contact, and the glove compartment door and right most air vent were dislodged (i.e., blown outwards from deployment of the front right passenger air bag)–{See End Note A. (13)}.

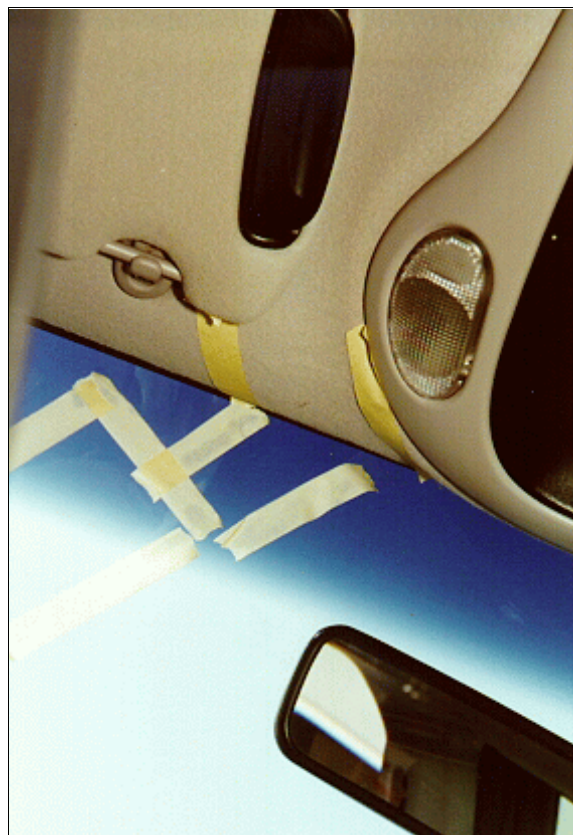
**Figure 17:** Close-up of contact evidence on case vehicle’s front left header and windshield (i.e., smudging) from impact by “on-lap” infant, front left passenger

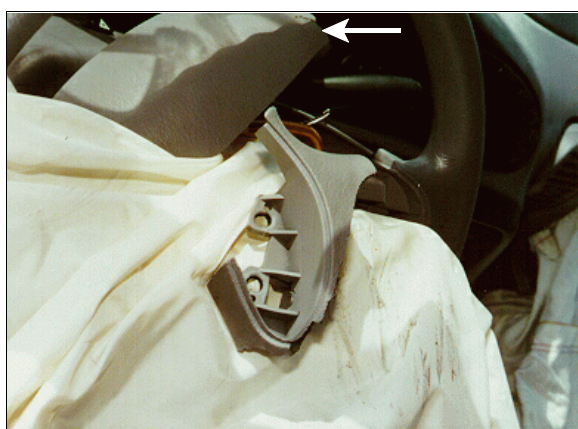
**Figure 18:** Close-up of case vehicle’s driver air bag module showing top cover flap with corner torn off and piece torn out from inside of module

The case vehicle's driver made no known pre-crash avoidance maneuvers. As a result and independent of the nonuse of the available safety belts and the child safety seat, the front left, “on-lap” infant passenger’s pre-impact body position did not change just prior to impact. The case vehicle's primary impact with the Dodge Dakota enabled the infant and driver (i.e., mother) to move forward, with the infant’s head falling forwards over the top of the steering wheel rim, and slightly to the right toward the 10 degree Direction of Principal Force as the case vehicle decelerated. The driver’s safety belt usage prevented the mother from completely compressing the infant against the steering wheel and deploying air bag during the initial impact. Based on this contractor’s inspection of the driver’s air bag module, it was obvious that the air bag’s path was momentarily blocked by the combination of the case vehicle’s driver and infant, causing the air bag to distort the module’s cover flaps as it expanded outwards (**Figures 18 and 20** above).

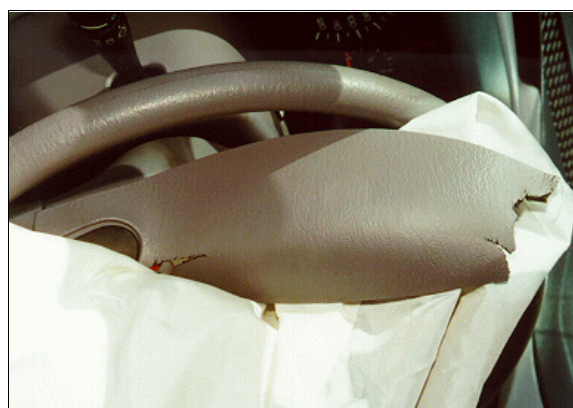
**Figure 19:** Close-up of right side of case vehicle driver air bag module’s top cover flap showing that part of corner that has been torn away

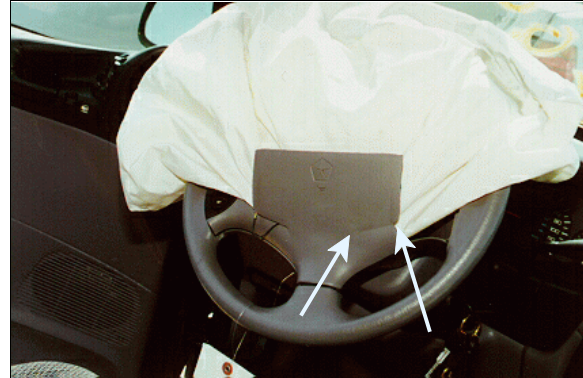
overall dimensions of 18 centimeters (7.1 inches) at the top horizontal seam, 8 centimeters (3.1 inches) at the left and right vertical seams, and 6 centimeters (2.4 inches) along the oblique left and right seams (**Figure 20**). An inspection of the air bag module's cover flaps and air bag fabric revealed that the cover flaps failed to open at the designated tear points [i.e., there was a 4 centimeter (1.6 inch) tear point that failed to open], most likely because the air bag's deployment path was blocked by one or both of the front left occupants (**Figure 20**). In addition, there was also a corner piece of the top cover flap that was torn off at some point because the deployment path was blocked (**Figures 18 and 19** above). Furthermore, there appeared to be smudges on the driver air bag module's cover flaps. The driver's air bag was designed with two tethers, each 5 centimeters (2.0 inches) wide, sewn to the middle of the air bag at the 9 and 3 o'clock positions. The driver's air bag had no vent ports. The deployed driver's air bag was round with a diameter 66 centimeters (26.0 inches). There was no contact evidence readily apparent on the driver's air bag, except for a small red dot in the upper left quadrant (**Figure 21**). There were a large amount of black scuffs on the front and back of the air bag shell and an exceptional amount to the backside of the air bag's upper right quadrant. These black scuffs are a result of the friction between the underside of the cover flaps and the air bag's fabric, and they occurred when the air bags deployment path was being blocked.

**Figure 20:** Case vehicle's deployed driver air bag and air bag module's irregular-shaped bottom cover flap showing seam in cover flap that did not tear during deployment

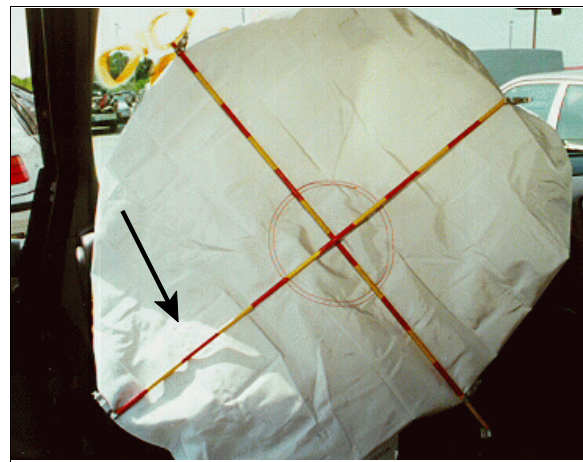
**Figure 21:** Case vehicle's deployed driver air bag showing small red mark (e.g., lipstick, nail polish) indicative of occupant contact

preventing her from contacting the knee bolster. An inspection of the driver's air bag showed only a small unknown red spot to the left side (**Figure 21** above) but no visible skin evidence. At maximum engagement the case vehicle was redirected slightly counterclockwise. The subsequent side slap impact caused the mother to move to the right; however, her use of her available restraints minimized her movement. The case vehicle's impact with the raised median curb caused the driver to move forwards and slightly upwards again, towards the steering wheel and deployed driver's air bag module, and reload her safety belts. As the case vehicle continued traveling in an east-northeasterly direction, it sideswiped a metal light pole. This sideswiping impact had little or no effect on her movement. According to the case vehicle's driver, she was able to regain control of her vehicle and prevent it from traveling completely over the median into the westbound travel lanes. The case vehicle came to a stop straddling the raised median with the left tires on the inside through lane of the westbound roadway heading east. At final rest, according to the case vehicle's driver, she remained in her seat near her original seat position and immediately exited the case vehicle cradling her infant child.

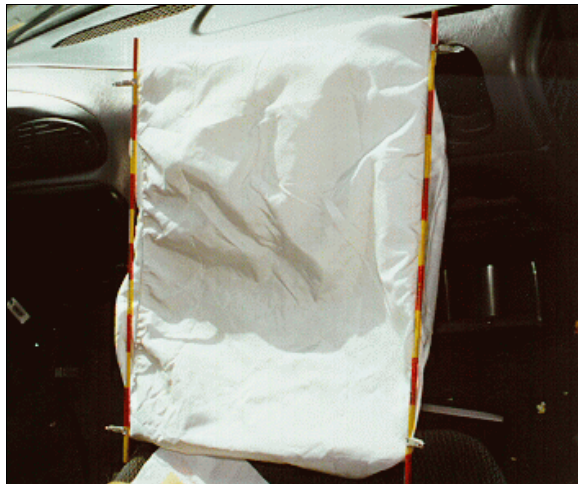
passenger's air bag was designed without any tethers or vent ports. The deployed front right air bag was rectangular—*{See End Note A. (16)}*, with a height of approximately 65 centimeters (25.6 inches) and a width of approximately 47 centimeters (18.5 inches). There was no contact evidence readily apparent on the front right air bag (**Figure 23**).

**Figure 23:** Case vehicle's deployed front right passenger air bag showing no evidence of occupant contact

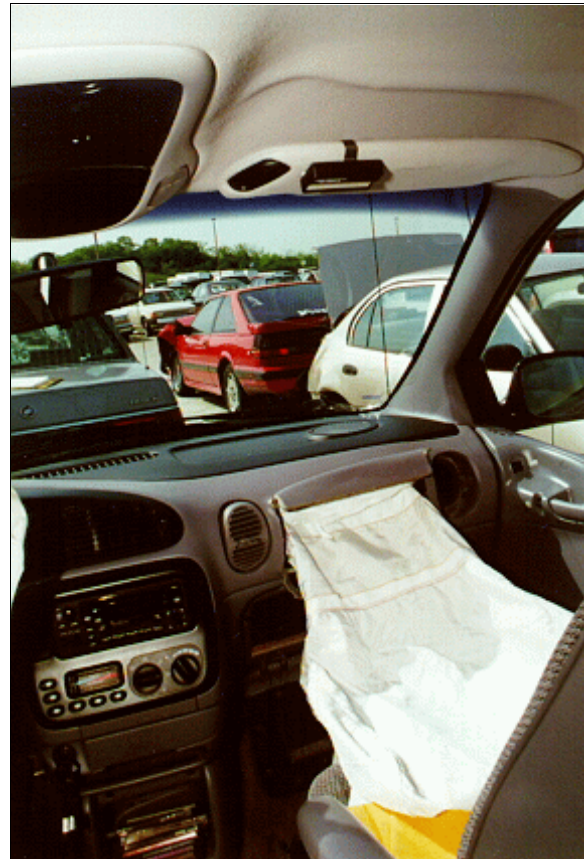
The front right passenger's air bag was located in the middle of the instrument panel (**Figure 22** below). There were two, asymmetrical, rectangular, modular cover flaps—{See End Note A. (15)}. The cover flaps were made of a thick vinyl over a sheet metal frame/liner which acted as the hinge point for the deploying flaps. The flap's dimensions were: 29 centimeters (11.4 inches) at both the forward and rear (i.e., toward the windshield) horizontal seams, 8 centimeters (3.1 inches) along the top flap's right and left vertical seam, and 5 centimeters (2.0 inches) along the both flap's right and left vertical seam. The profile of the case vehicle's instrument panel resulted in a 0 centimeter (0.0 inch) setback of the leading edge of the cover flap relative to the protruding right instrument panel. An inspection of the front right air bag module's cover flaps and air bag fabric revealed that the cover flaps opened at the designated tear points and the plastic frame of the upper flap was cracked at the midway point causing it to hang down. There was no evidence of other damage during the deployment to the air bag or the cover flaps. The front right

**Figure 22:** Vertical view of case vehicle's front right seating position showing front right passenger air bag module's top cover flap and deployed air bag

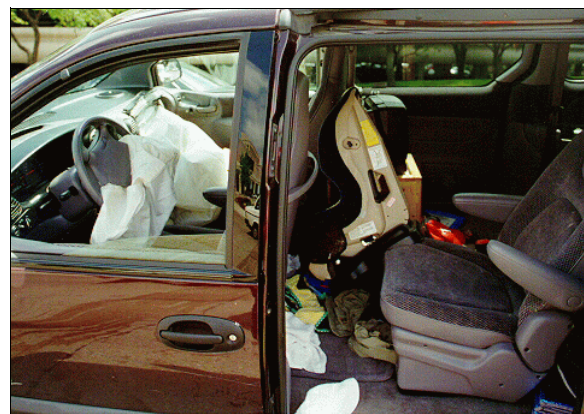
The case vehicle's "on-lap" infant passenger was neither secured in the available child safety seat (**Figure 24**) nor any of the available, active, three-point, lap-and-shoulder, safety belt systems. The case vehicle's driver, however, was wearing

**Figure 24:** On-scene view of case vehicle's second seating area with unsecured child safety seat leaning forward against front right seat back

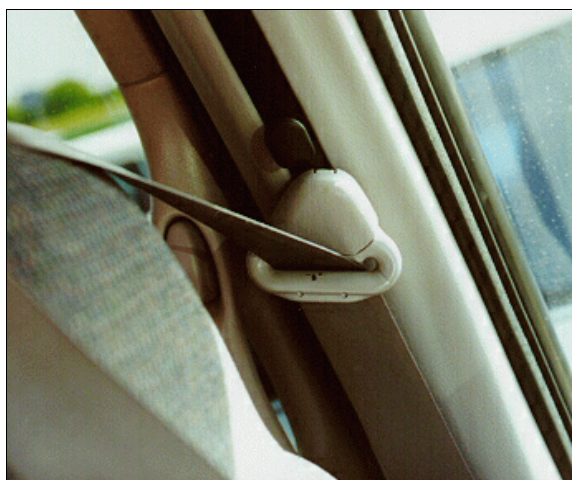
**Figure 26:** Close-up of plastic transfer to case vehicle's driver "D"-ring from friction with safety belt webbing

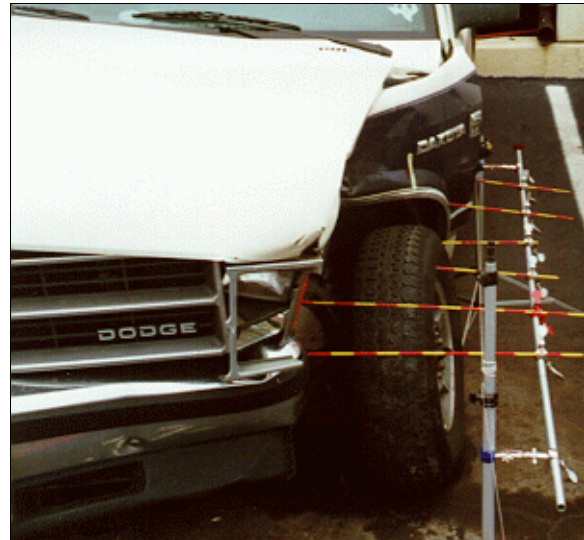
Based on the vehicle inspection, the primary CDC for the Dodge Dakota (Figures 27 and 28) was determined to be: **09-LFEW-3 (270)**—{See End Note A. (8)}. Maximum crush was 53 centimeters (20.9 inches) at C<sub>5</sub>—{See End Note A. (10)}. For the side slap impact, the CDC was determined to be: **09-LBEW-02 (270)**. Maximum crush was 55 centimeters (21.7 inches). The WinSMASH reconstruction program, damage only algorithm, was used on the Dodge Dakota's highest severity impact. The Total, Longitudinal, and Lateral Delta Vs are, respectively: 20.3 km.p.h. (12.6 m.p.h.), 0.0 km.p.h. (0.0 m.p.h.), and +20.3 km.p.h. (+12.6 m.p.h.)—{See End Note A. (11)}. No reconstruction program was used on the Dodge Dakota's side slap impact because the impact is out of scope of the NASS, CDS, WinSMASH algorithm requirements; however, this contractor's visually estimated Delta V for the side slap impact is minor [2-13 km.p.h. (1-8 m.p.h.)]. The Dodge Dakota was towed due to damage.

**Figure 27:** Reference line view from front of damage to other vehicle's left front with contour gauge present showing crush profile

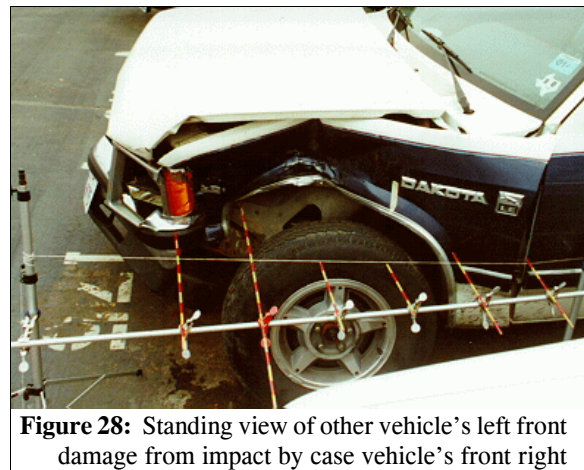
**Figure 28:** Standing view of other vehicle's left front damage from impact by case vehicle's front right
