**VERIDIAN ON-SITE REDESIGNED AIR BAG INVESTIGATION
VERIDIAN CASE NO. CA00-004
VEHICLE: 1998 FORD CONTOUR
LOCATION: NORTH CAROLINA
CRASH DATE: JANUARY 2000**

14. <i>Sponsoring Agency Code</i>	
15. <i>Supplementary Notes</i> On-site investigation of a three-vehicle crash that involved a 1998 Ford Contour equipped with redesigned frontal air bags.

VERIDIAN ON-SITE REDESIGNED AIR BAG DEPLOYMENT INVESTIGATION
VERIDIAN CASE NO. CA00-004
VEHICLE: 1998 FORD CONTOUR
LOCATION: NORTH CAROLINA
CRASH DATE: JANUARY 2000

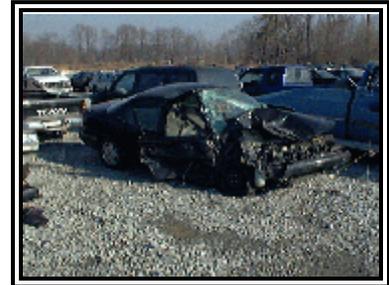
This on-site investigation focused on the injury mechanism that resulted in the death of a five year old female front right passenger of a 1998 Ford Contour. The Contour (**Figure 1**) was involved in a severe head-on crash with a 1985 Chevrolet Camaro that resulted in deployment of the Contour's redesigned frontal air bag system. The child passenger was improperly restrained by the 3-point lap and shoulder belt system. She positioned the shoulder belt webbing behind her back which induced slack into the manual system. At impact, she initiated a forward trajectory into the deployed redesigned front right air bag. The air bag provided a sufficient ride down of her initial trajectory. The Camaro subsequently engaged with the right side of the Contour which redirected the child passenger laterally to her right. Her head impacted the intruding right upper A-pillar which resulted in a laceration of the right face/scalp, severe cerebral edema with obliteration of the basilar cisterns, and a small left subdural hematoma. She was flown to a regional trauma center where she expired within two hours of the crash.

Figure 1. Overall view of the damage to the Ford Contour.

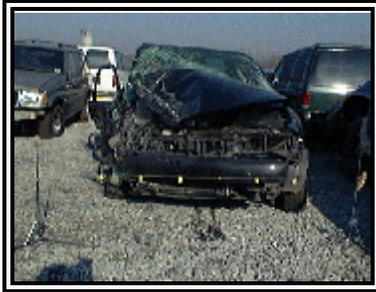
The Ford Contour sustained severe damage as a result of the off-set head-on crash with the 1985 Chevrolet Camaro. The Camaro initially impacted the front center and right areas of the Contour (**Figure 4**), crushing the frontal structure to a maximum depth of 78.1 cm (30.75"). The direct contact damage began 5.7 cm (2.25") right of center and extended 64.1 cm (25.25") to the front right corner. The impact deformed the full width of the frontal structure resulting in a combined induced and direct damage length

Figure 4. Frontal damage to the Ford Contour.

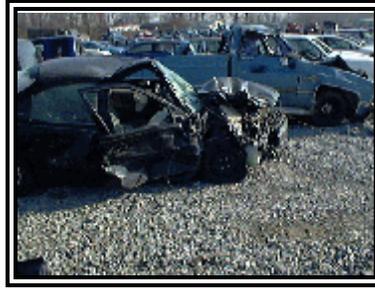
of 116.8 cm (46.0"). The front bumper fascia was separated from the vehicle, therefore the crush profile was documented at the level of the bumper reinforcement bar. The profile was as follows: C1 = 3.5 cm (1.4"), C2 = 10.9 cm (4.3"), C3 = 22.2 cm (8.75"), C4 = 35.6 cm (14.0"), C5 = 49.5 cm (19.5"), C6 = 78.1 cm (30.75"). **Figure 5** documents the overall damage to the Ford Contour.

Figure 5. Profile view documenting the extent of crush.

The Collision Deformation Classification (CDC) for this impact sequence was 12-FZEW-4. In addition to the frontal deformation, the right wheelbase was reduced in length by 33.0 cm (13.0").

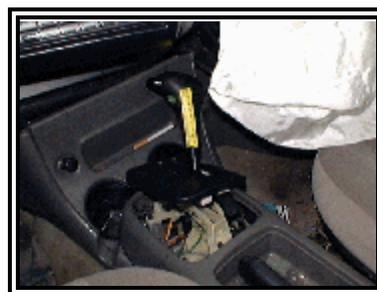
Figure 6. Deflection of the transmission shifter.

At this point, the driver began to moved laterally to the right. Her right lateral thigh impacted the console mounted automatic transmission shifter and fractured the "soft metal" shaft. As a result, the shifter was deflected toward the 1 o'clock sector. Her right upper arm and/or shoulder area impacted the mid upper instrument panel mounted vent louvers and displaced the louver assembly into the venting cavity. No injuries resulted from these latter contact points. **Figure 14** is an overall view of the driver's trajectory and contact points.

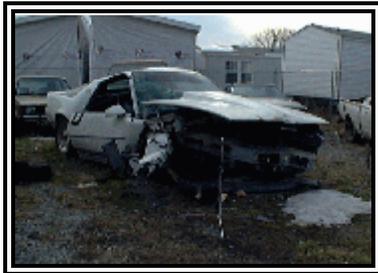
The 1985 Chevrolet Camaro sustained severe frontal damage from its impact sequence with the Ford Contour. The direct damage length was 147.3 cm (58.0") which extended across the full width of the frontal plane. The fascia and filler panel separated from the bumper assembly, therefore the crush profile was documented at the reinforcement bar. Maximum crush was 111.1 cm (43.75") located at the front right corner. The crush profile at this level was as follows: C1 = 16.8 cm (6.6"), C2 = 43.8 cm (17.25"), C3 = 74.3 cm (29.25"), C4 = 101.0 cm (39.75"), C5 = 105.4 cm (41.5"), C6 = 111.1 cm (43.75"). The CDC for this impact sequence was 12-FDEW-4 (**Figure 7**).

Figure 7. Frontal damage to the Chevrolet Camaro.

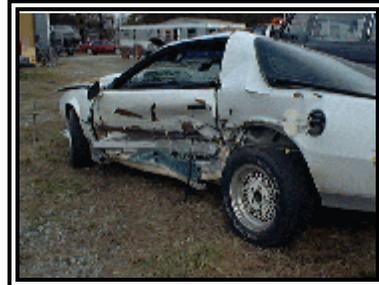
The Camaro was subsequently struck on the left side by the Ford Thunderbird following the impact with the Ford Contour. The left side direct contact damage began 15.2 cm (6.0") rearward of the left rear axle position and extended 195.6 cm (77.0") forward to the leading edge of the front door. The combined induced and direct contact damage was 259.1 cm (102.0") which began 76.2 cm (30.0") rearward of the referenced axle, extending forward. The crush profile at the mid door level (**Figure 8**) was as follows: C1 = 0 cm, C2 = 7.4 cm (2.9"), C3 = 38.1 cm (15.0"), C4 = 44.4 cm (17.5"), C5 = 29.4 cm (11.6"), C6 = 0 cm. The CDC for this impact was 08-LZEW-3.

Figure 8. Left side damage from impact with the Ford Thunderbird.

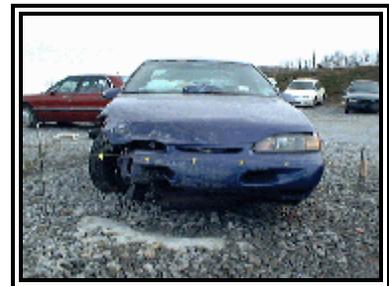
The Thunderbird sustained moderate frontal damage from its impact sequence with the side of the Camaro. The direct contact damage began 37.4 cm (14.75") left of center and extended 104.1 cm (41.0") to the front right corner. The combined induced and direct damage length was 143.5 cm (56.5") which involved the full frontal width. The crush profile at bumper level was as follows: C1 = 0 cm, C2 = 2.9 cm (1.1"), C3 = 4.4 cm (1.75"), C4 = 7.0 cm (2.75"), C5 = 5.7 cm (2.25"), C6 = 21.3 cm (8.4"). The damage continued onto the right front fender, terminating 63.5 cm (25.0") rearward of the leading edge

Figure 9. Frontal damage to the Ford Thunderbird.

of the fender. This segment of the fender was crushed rearward 21.6 cm (8.5"). The CDC for this impact was 01-FZEW-1.

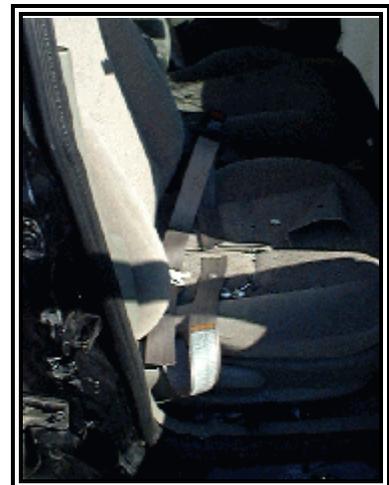
The front right child passenger was improperly restrained by the 3-point system with the shoulder belt webbing positioned behind her back due to her small stature. Rescue personnel cut the lap and shoulder belt webbings, leaving the latchplate fastened into the mid mount buckle.

The lap belt webbing was cut 29.2 cm (11.5") from the latchplate while the shoulder belt webbing was cut 57.2 cm (22.5") above the latchplate (**Figure 10**). An 47.0 cm (18.5") length of lap belt webbing remained affixed to the outboard anchorage with the front right seat cushion. A body fluid stain (probable CSF fluid) was noted to the webbing in the area of the latchplate. A loading abrasion was observed to the plastic coating over the latchplate. The belt related abrasion was on the inboard aspect of the latchplate and was 6.4 cm (2.5") in width and 7.9 mm (7/16") in depth. There was no corresponding abrasion on the belt webbing. The latchplate was identified as TRW 326048A.

Figure 10. Cut front right belt webbing.

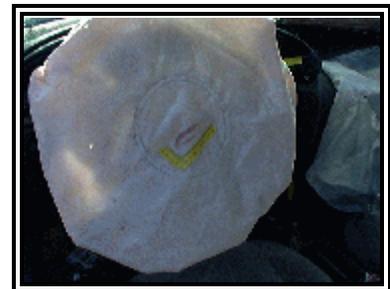
The driver's face contacted the deployed front left air bag as it was fully inflated. This was evidenced by a lipstick transfer to the center face of the bag over the tether reinforcement (**Figure 12**). The upper and lower lip transfer began in a distinct pattern then smeared laterally to the right as the driver's trajectory was modified to the right. The transfer began 4.4 cm (1.75") left of center and extended 8.3 cm (3.25") to the right. Vertically, the transfer was located 0-3.2 cm (0-1.25") below the bag's horizontal center line.

Figure 12. Lipstick transfer on the front left air bag.

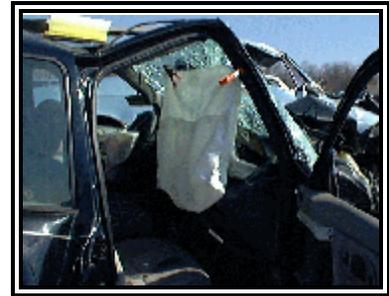
The air bag membrane was tethered by two 7.6 cm (3.0") wide straps that were sewn to the face of the bag, positioned 22.9 cm (9.0") inboard of the vertical side seams. The overall dimensions of the bag was 48.3 cm (19.0") vertically and 68.6 cm 27.0") horizontally (**Figure 13**). The bag was vented by a single port located at the 9 o'clock sector of the bag at the upper inboard corner. The port was 3.6 cm (1.4") in diameter. There was no damage or contact evidence to the bag.

Figure 13. Overall view of the deployed front right air bag.

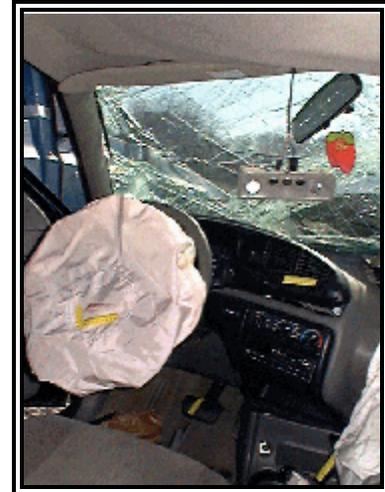
Figure 14. Driver trajectory and contact points.

The driver's torso loaded the deployed front left air bag and compressed the bag against the steering assembly. This loading through the bag into the steering assembly resulted in police reported rib fractures. There was no deformation of the steering wheel rim or compression of the convoluted lower steering column shaft.

As the Camaro engaged the right side of the Ford Contour, the driver's trajectory was deflected toward the 1 o'clock sector. This was evidenced by the elongation of the lipstick transfer on the deployed air bag and the continuation of the right knee contact. The scuff mark and fabric transfer from the right knee continued into the center mid panel and console components.

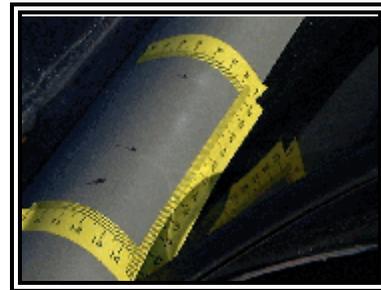
The child passenger loaded the deployed front right air bag. No contact evidence was visible on the bag. She continued to move laterally as the Camaro engaged the right side of the Contour. Her face and head impacted the intruding right upper A-pillar. A tissue transfer surrounded by body fluid and a scuff mark

evidenced the contact to the rigid plastic component. The contact began 14.0 cm (5.5") above the base of the pillar and extended 7.9 cm (3.1") vertically.

As the Camaro engaged the right side surface of the Ford Contour, the child passenger responded by moving laterally right and forward. Her head moved outboard of the protective area of the front right air bag and impacted the intruding right upper A-pillar. A scuff mark with a tissue transfer and body fluid transfers were noted to the rigid plastic trim cover of the pillar. The contact was located 14.0-21.8 cm (5.5-8.6") above the base of the cover (**Figure 15**). As a result of the contact to this rigid component, the child sustained a linear laceration of the right temporal and zygomatic area, severe cerebral edema with obliteration of the basilar cisterns, a small subdural hematoma, and bilateral ecchymosis.

Figure 15. Head contact evidence to the right A-pillar cover.
