On-scene Investigation / Vehicle to Vehicle
Dynamic Science, Inc. / Case Number: DS00005
2000 Mercury Sable LS
Texas
March, 2000

Technical Report Documentation Page	
1. Report No.	2. Government Accession No.		3. Recipient Catalog No.	
DS00005				
4. Title and Subtitle In-Depth Accident Investigation			5. Report Date	
			January 17, 2001

Dynamic Science, Inc. Accident Investigation Case Number: DS00005

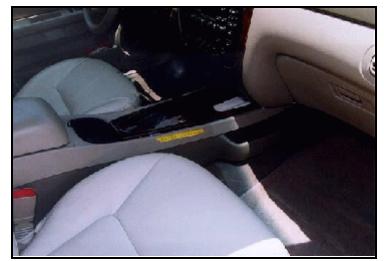
The center console of the case vehicle was displaced somewhat–possibly by the left leg of the front right seat occupant. There were, however, no injuries reported by any of the parties involved.

Figure 10. Contact to center console

This occupant responded to the -70 degree direction of force by moving laterally to the left. She likely engaged the center console with her leg-causing it to be displaced to the left. There were, however, no reported injuries to this occupant.
