**TRANSPORTATION SCIENCES
Crash Data Research Center**

Veridian Engineering
Buffalo, New York 14225

**VERIDIAN ON-SITE AIR BAG RELATED
ADULT DRIVER FATALITY INVESTIGATION
VERIDIAN CASE NO. CA00-022
VEHICLE: 1993 CHEVROLET CORSICA
LOCATION: NEW YORK
CRASH DATE: JUNE 2000**

1. <i>Report No.</i> CA00-022	2. <i>Government Accession No.</i>	3. <i>Recipient's Catalog No.</i>	
4. <i>Title and Subtitle</i> Veridian On-Site Air Bag Related Adult Driver Fatality Investigation Vehicle: 1993 Chevrolet Corsica Location: New York		5. <i>Report Date:</i> April 2001

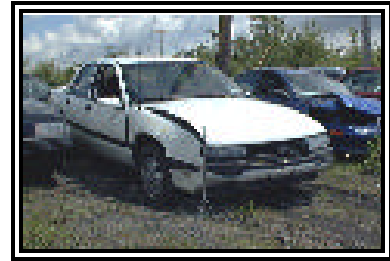
Figure 1. Frontal damage to the Chevrolet Corsica.

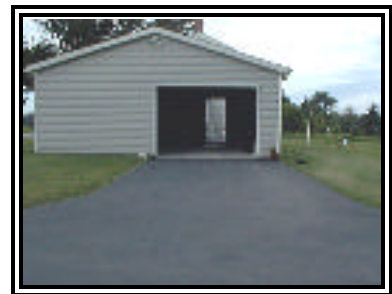
Figure 2. Trajectory of the Corsica into the garage.

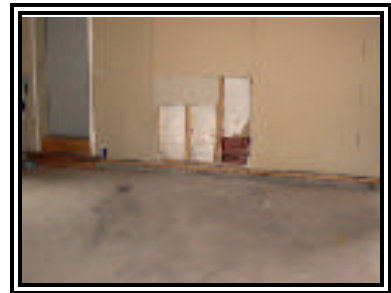
The vehicle impacted the wall and fractured the garage drywall, two 5x10 cm (2x4") studs, split a third stud at the sill plate, and displaced the interior wall of the house, fracturing the brick veneer. The Corsica did not penetrate through the garage wall.

The acceleration marks continued 5.8 m (19.0') and 5.5 m (18.0') respectively for the left and right tires to impact against the back wall of the garage. Due to the angled trajectory of the vehicle, the front right area of the Corsica impacted the wall (**Figure 3**) resulting in a 12 o'clock direction of force impact. The front bumper of the Corsica crushed to a maximum depth of 18.4 cm (7.25") located at the right corner. Although the wall yielded, the WinSMASH program was utilized to compute a total velocity change of 17.0 km/h (10.6 mph). The specific longitudinal and lateral components were -17.0 km/h (-10.6 mph) and 0 km/h respectively. The impact induced deceleration was sufficient to deploy the frontal driver air bag. Due to the yielding wall, the air bag probably deployed late in the crash sequence.

Figure 3. Impact damage to the garage wall.

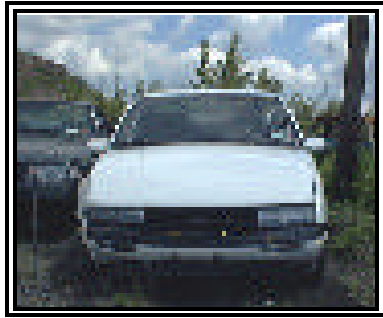
The frontal damage that resulted from the impact with the garage wall began 29.5 cm (11.6") right of center and extended 34.5 cm (13.6") to the right bumper corner (**Figure 4**). Maximum crush was 18.4 cm (7.25") located at the right corner of the bumper system. The corner impact deflected the full width of the bumper resulting in a combined direct and induced damage length of 124.5 cm (49.0"). The crush profile at bumper level was as follows: C1 = 3.2 cm (1.25"), C2 = 7.0 cm (2.75"), C3 = 10.2 cm (4.0"), C4 =

Figure 4. Frontal damage to the Corsica.

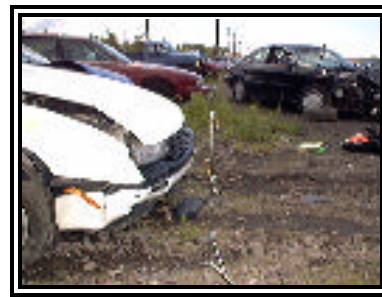
12.9 cm (5.1 cm), C5 = 16.5 cm (6.5"), C6 = 18.4 cm (7.25"). The CDC for this impact was 12-FREE-1. The depth of crush is depicted in **Figure 5**.

Figure 5. Profile view documenting the extent of crush.

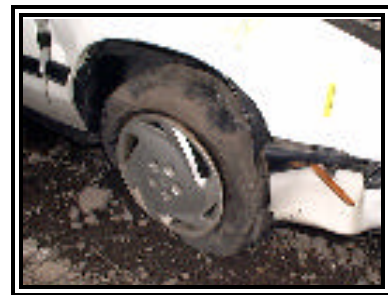
Post-crash, the engine was running at a presumed full throttle position with the frontal area of the Corsica engaged against the back wall of the garage. Due to the high engine RPMs, the front tires broke traction of the concrete floor surface and spun to a point of deterioration. The right front tire was spun bald with cord exposed through the casing of the tire (**Figure 6**). The tire was flat with fragments of rubber tread fused to the inner fender of the vehicle. The left front tire was spun bald, however, the tire remained inflated. Fragments of the rubber tread compound were fused to the inner fender. Tire fragments from both front tires were reportedly scattered across the garage floor. The front tires were identified as Sears SuperGuard 60 P185/75R14.

Figure 6. Damage to the right front tire.

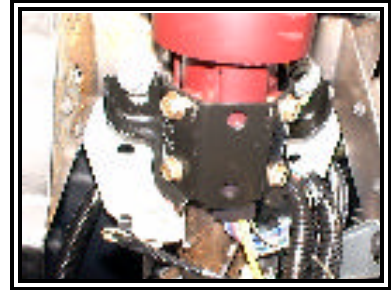
The left aspect of the upper air bag module cover flap contacted the chest of the driver as the air bag system deployed. A vertically oriented abrasion was noted to the flap which extended 8.2 cm (3.25") laterally and 3.8 cm (1.5") vertically. The upper right aspect of the module cover was partially displaced from the steering assembly due to the restricted bag expansion against the forward positioned driver. The combination of air bag expansion against the driver, and the driver's forward motion in response to the crash forces, resulted in 0.9 cm (0.375") of steering column shear capsule compression (**Figure 7**).

Figure 7. Steering column shear capsule displacement.

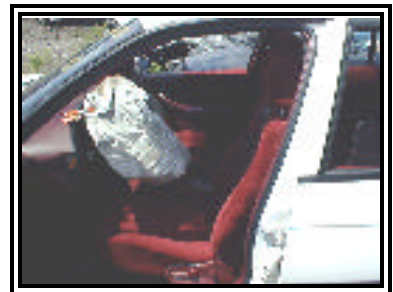
The 1993 Chevrolet Corsica was equipped with a frontal air bag for the driver's position. The driver air bag deployed (**Figure 8**) as a result of frontal impact with the back wall of the garage. The system consisted of single front mounted crash sensor affixed to the upper radiator support panel, an interior mounted safeing sensor that was located in the forward aspect of the center mid instrument panel, a Diagnostic Energy Reserve Module (DERM) that was located in the right instrument panel area, and the steering wheel mounted driver air bag module. Although the DERM did contain minimal crash related data, the module was not downloaded for this SCI investigation.

Figure 8. Deployed driver's air bag.

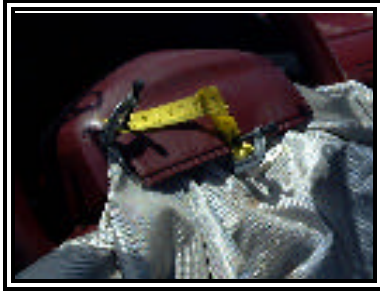
Figure 9. Vertically oriented abrasion of the upper cover flap.

flaps respectively. The left aspect of the upper flap contacted the chest of the driver. A vertically oriented abrasion that measured 3.8x8.3 cm (1.5x3.25") evidenced the contact point (**Figure 9**). The expanding air bag was restricted by the forward positioned driver. As the bag began to deploy, the membrane expanded within the module cover and partially separated the upper right quadrant of the cover from the steering wheel. The bag continued to deploy from the H-configuration flaps.

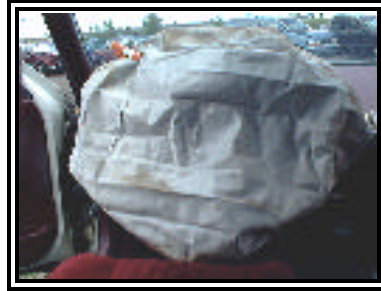
Figure 10. Deployed non-tethered driver air bag.

The diameter of the air bag was 67.3 cm (26.5") in its deflated state. The driver air bag was not tethered (**Figure 10**) and was vented by two 1.3 cm (0.5") diameter ports located the 10 and 2 o'clock sectors. There was no evidence of driver contact to the air bag (i.e., tissue or fabric transfers). A bar coded label was affixed to the air bag adjacent to the module at the 12 o'clock sector and was as follows: PUT1057-01N. A second label was affixed to the 6 o'clock sector and read as follows: TBF226111486.

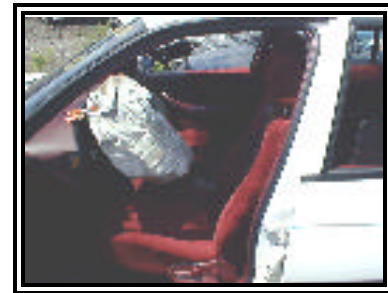
The 86-year old female driver of the 1993 Chevrolet Corsica was seated in a presumed upright driving posture with the seat track adjusted to a near full forward position and the seat back set to a near vertical position (**Figure 11**). She was restrained by the manual belt system, however, the system was used improperly. Due to her short stature, her seated height was low, therefore the driver positioned the shoulder belt behind her back to prevent contact against her neck and face. This was observed by the witness who arrived at the residence approximately two hours post-crash. He further noted that the driver's head was barely visible over the top of the seat back support. This, in combination with her forward position, placed her face in a close proximity to the steering assembly and the driver air bag module.

Figure 11. Driver's forward seated position.

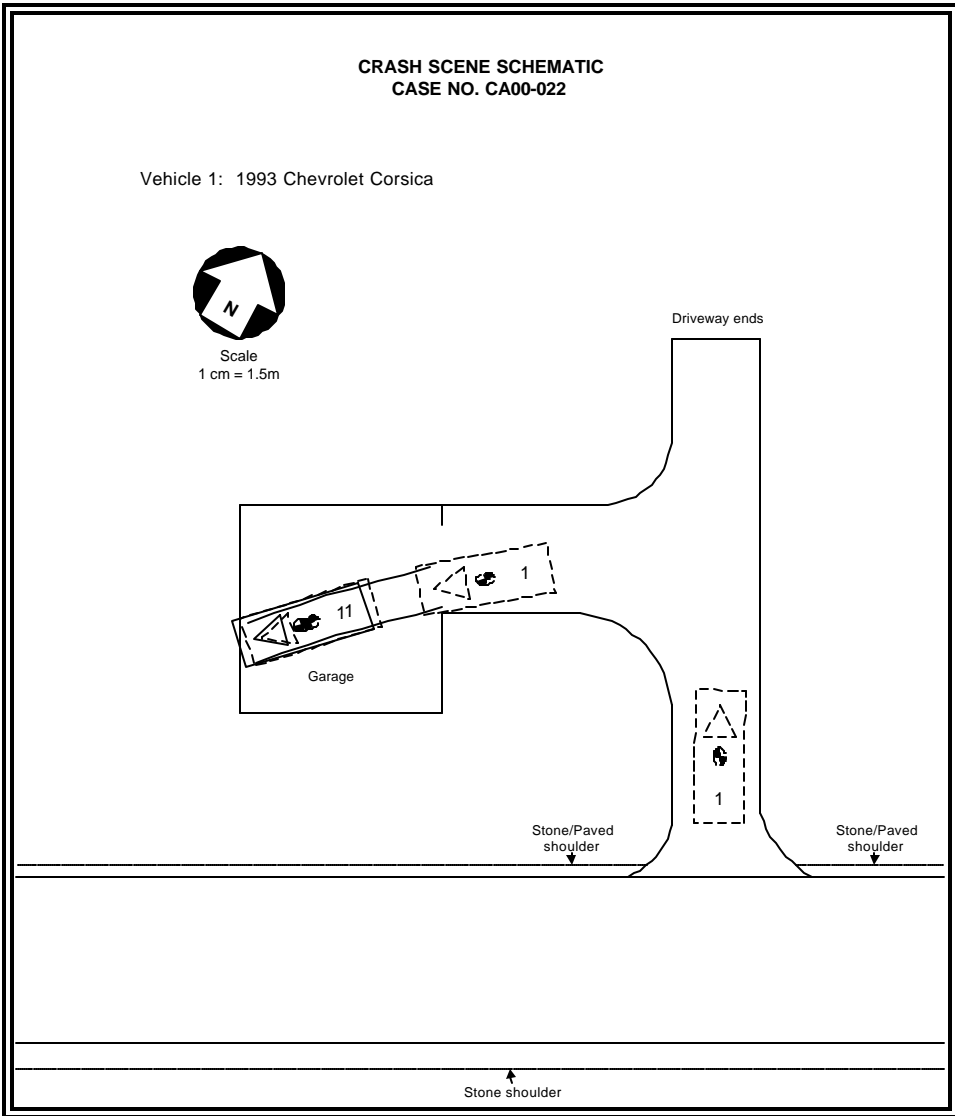
Figure 12. Crash Schematic

The driver of the Chevrolet Corsica had completed errands and was returning to her residence. She approached her driveway from an easterly direction and initiated a left turn from the two-lane county road. The driver proceeded into her driveway at a slow rate of speed and traveled the 9.2 m (30.2') before turning 90 degrees on her approach to the garage (**Figure 2**). At this time, the driver probably activated the remote to open the overhead door to the garage. The crash schematic is attached as **Figure 12**, Page 12.
