REMOTE AIR BAG RELATED CHILD FATALITY INVESTIGATION

VERIDIAN CASE NO. CA00-029

VEHICLE - 1995 HYUNDAI ACCENT

LOCATION - LOUISIANA

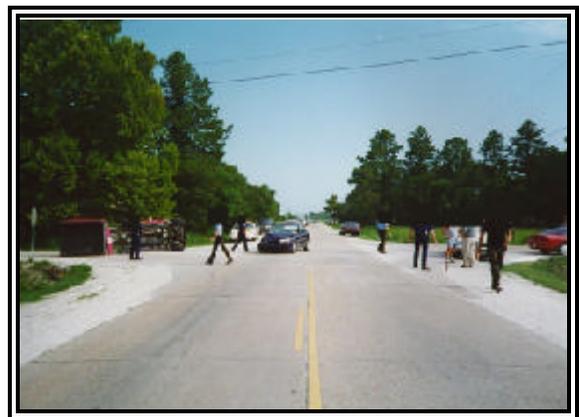
Figure 1: Southward view into the intersection.

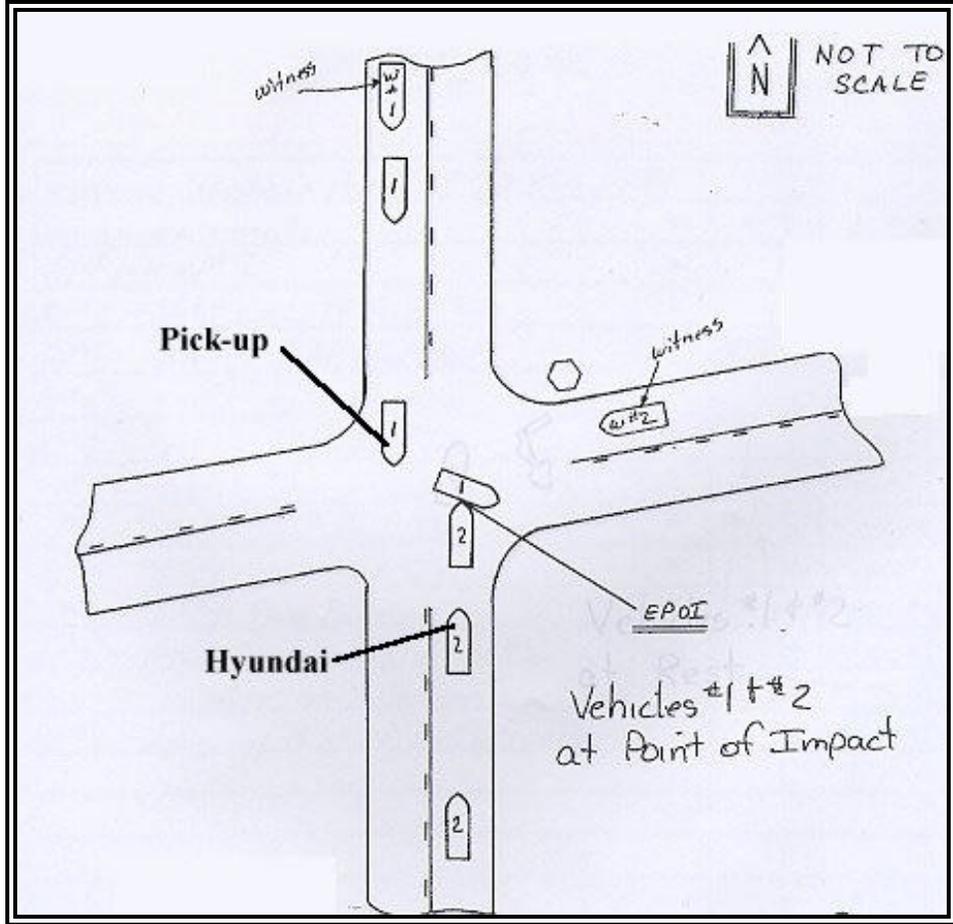
The crash occurred with the right and center aspects of the Hyundai's front plane impacting the right side passenger compartment of the Ford. The right frontal aspect of the Hyundai underrode Ford's right side. As the Ford continued its southeastward trajectory, its right rear tire rolled up and over the Hyundai's right front corner. The Ford then rolled 1/4 turn onto its left side and slid to rest in the southeast intersection quadrant. The Ford came to rest on its left side approximately 8 m (25 ft) from the point of impact. The pick-up truck's cargo bed separated as a result of the rollover.

Figure 2: Police sketch of the crash.

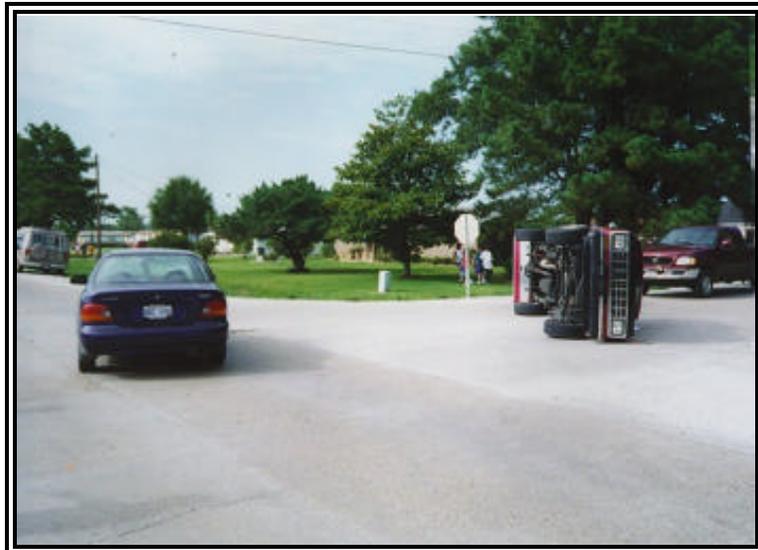
The lateral momentum of the Ford caused the Hyundai to rotate approximately 20 degrees clockwise. The Hyundai came to rest facing northeastward approximately 2.1 m (7 ft) from the point of impact. The force of the 11/2 o'clock impact caused the deployment of frontal air bags in the Hyundai. The Hyundai's delta V was an estimated 19 to 23 km/h (12 to 14 mph). **Figure 2** is a police sketch of the crash. **Figure 3** is a northward view of the vehicles at final rest.

Figure 3: View of the vehicle's final rest positions.

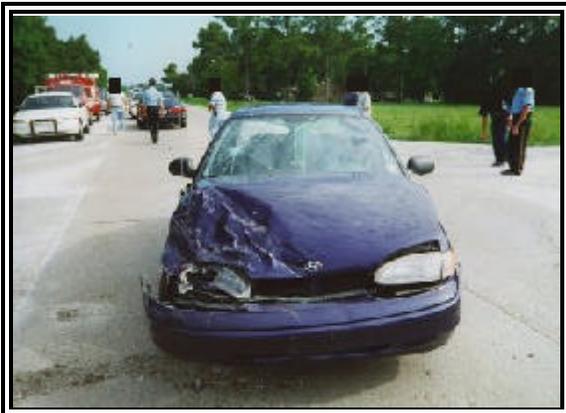
Figures 4 and 5 are the front and right side views of the damaged vehicle. The Hyundai sustained an estimated 76 cm (30 in) of direct contact damage to the center and right aspects of its frontal plane. The direct contact began approximately at the vehicle's centerline and extended to the right corner of the front bumper. The damaged components included the front bumper and fascia, right head lamp assembly, hood, upper radiator support and right front fender. The longitudinal damage on the hood extended rearward an estimated 81 cm (32 in) as a result of the Ford's rear tire rolling up and over the right front corner of the vehicle. The crash dynamics were beyond the scope of the WINSMASH model. Analysis of the damage indicated the Hyundai's delta V in this impact was approximately 19 to 23 km/h (12 to 14 mph) based on SCI experience. The Collision Deformation Classification (CDC) was 11-FZEW-1.

Figure 4: Front view of the damaged Hyundai.

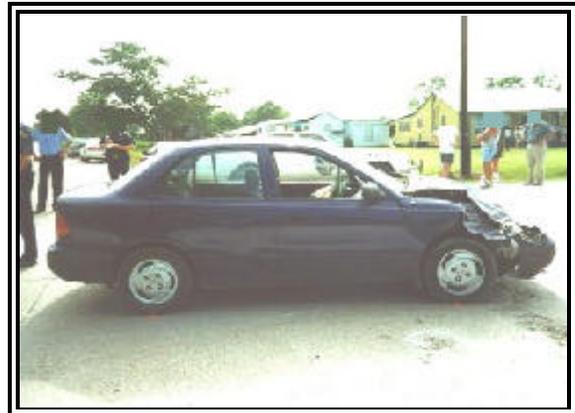
Figure 5: Right side view of the Hyundai.

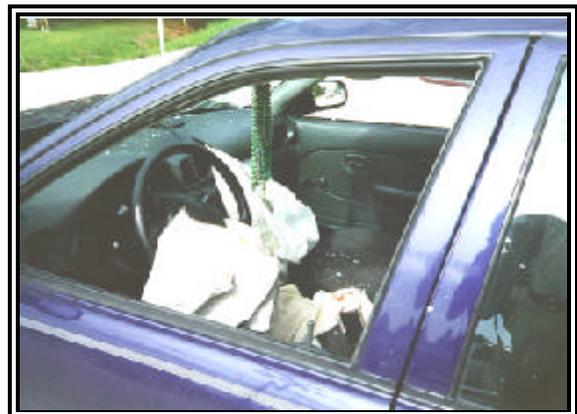
The front Supplemental Restraint System (SRS) in the 1995 Hyundai Accent consisted of driver and right passenger air bags that deployed as a result of the intersection crash. **Figure 6** is a view of the front interior and deployed air bags taken during the police investigation. The driver air bag was designed in the typical manner and located in the center of the steering wheel rim. The passenger air bag was a mid-mount design located in the right aspect of the instrument panel. A single point sensing control module located under the center aspect of the instrument panel monitored and commanded the deployment of the system. Upon impact, the control module sensed the above-threshold deceleration of the crash and deployed the vehicle's Supplemental Restraint System.

Figure 6: View of the deployed air bags.

Prior to the crash, the 3 year old child was seated in the front right passenger position in a presumed upright posture. The passenger seat was adjusted to a rear track position as identified by a photograph of the vehicle's interior (Figure 6) taken during the on-scene police investigation. The child was improperly restrained by only the lap portion of the manual 3-point restraint as evidenced by the post-crash abdominal abrasion. The shoulder portion of the belt was positioned behind her back. The kinematics of the child (described below) were indicative of the lack of any upper torso restraint. Additionally, given the short seated height of the child, if the shoulder belt had been positioned over the shoulder, it would have cut across the child's face and/or neck. The child would have repositioned the belt behind her back for her comfort.
