**ADVANCED OCCUPANT PROTECTION SYSTEM STUDY
2000 FORD TAURUS INVESTIGATION**

VERIDIAN CASE NO. CA00-041

LOCATION - MICHIGAN

CRASH DATE - SEPTEMBER 2000

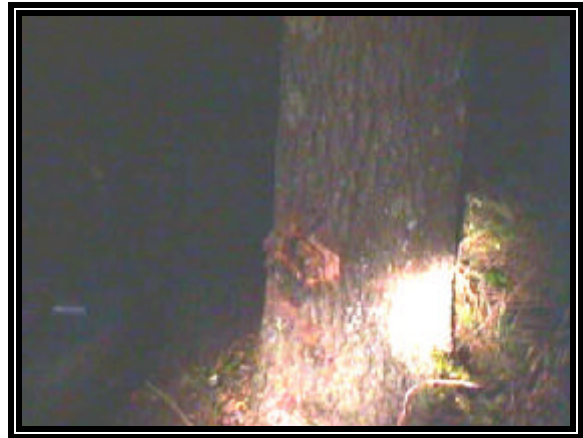
The crash occurred with the right aspect of the front bumper impacting a 61 cm (24 in) diameter tree, **Figure 1**. The Principle Direction of Force was in the 1 o'clock sector. The tree was located approximately 6 m (20 ft) off the road. The total velocity change calculated by the WINSMASH model was approximately 39.1 km/h (24.2 mph). The longitudinal and lateral delta V components were -33.9 km/h (-21.1 mph) and -19.6 km/h(-12.2 mph), respectively. The force of the impact caused the deployment of the vehicle's frontal air bag system. The Taurus rotated counterclockwise upon disengagement from the tree and came to rest facing westward.

Figure 1: On-scene police photograph of the point of impact.

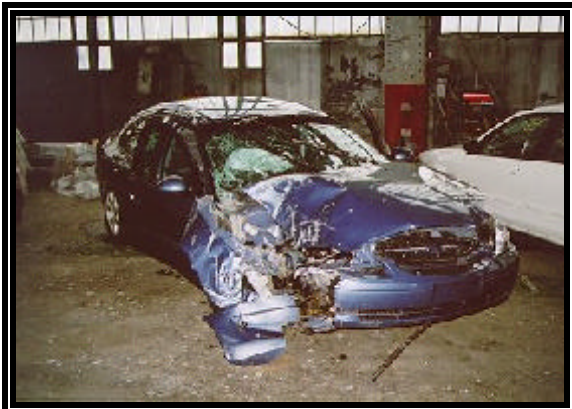
Figures 3 and 4 are the right front and right side views of the damaged Taurus. The vehicle sustained 14.0 cm (5.5 in) of direct contact damage to the frontal plane that began 67.3 cm (26.5 in) right of center and extended to the right front corner. The direct contact deflected the outboard end of the bumper reinforcement (bumper beam) rearward. The damage pattern extended rearward along the uni-body frame rail into the structural members of the right front suspension. The maximum penetration of the tree measured approximately 72 cm (28 in). The lateral dimension of the damage measured 25 cm (10 in) at the center of the right front wheel opening. The right aspect of the roof was buckled above the right front door opening. The right wheelbase was foreshortened 23 cm (9 in). The right front wheel was in direct engagement with the tree. The windshield was fractured by the exterior crash forces. All the doors remained operational. The side windows and backlight remained intact. The Collision Deformation Classification was 01-FREE-5.

Figure 3: Right front view of the Taurus.

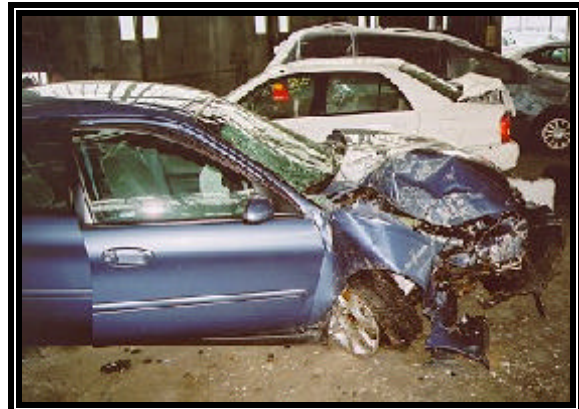
Figure 4: Right side view of the Taurus.

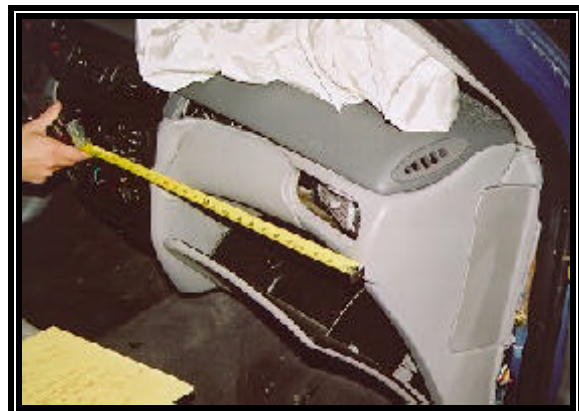
Inspection of the vehicle's interior identified intrusion consistent with the exterior forces of the crash and damages consistent with the deployment of the frontal air bag system. The force of the crash displaced the right front suspension components rearward into the right aspect of the cowl. This deformation caused the right corner of the instrument panel to intrude rearward approximately 3.8 cm (1.5 in). The rearward displacement buckled the right aspect of the mid-panel immediately below the front passenger air bag module, **Figure 5**. The right side of the front passenger's toe pan was buckled approximately 5 cm (2 in) at its outboard edge. Inspection of the vehicle's interior did not identify any specific occupant contact points.

Figure 5: View of the deformed mid panel below the passenger air bag module.

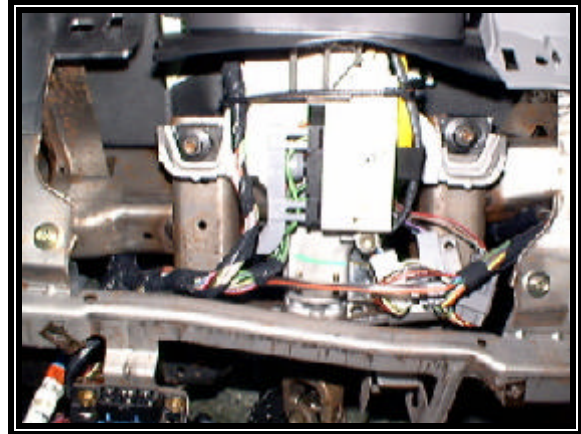
The driver seat was adjusted to a rear track position and measured 7.1 cm (2.8 in) forward of full rear. The total seat track travel measured 24.9 cm (9.8 in). The 4-spoke adjustable steering wheel rim was adjusted to the center position. There was no rim deformation. Inspection of the steering column shear capsules, **Figure 6**, identified 13 mm (0.5 in) of separation on the inboard (right) side. There was no separation of the outboard (left) capsule. The inboard side of the bend bracket supporting the mid-aspect of the steering column was deformed. The shear coupling on the lower aspect of the column was intact.

Figure 6: View of the shear capsules.

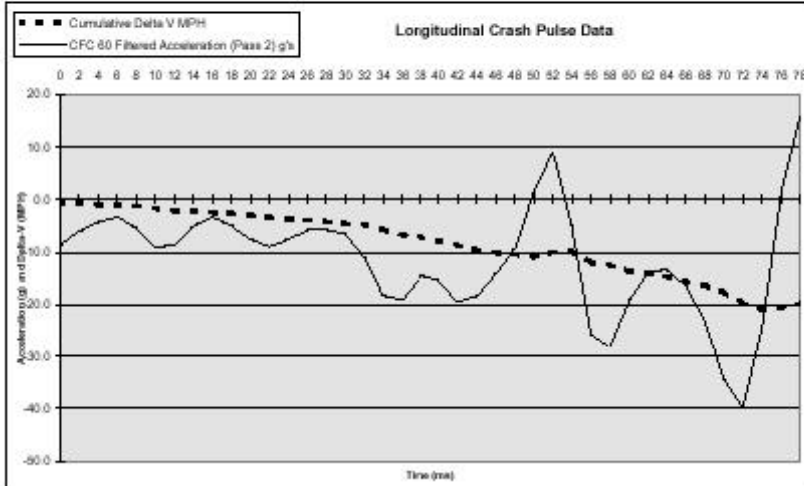
Longitudinal Cumulative Delta-V

The data indicated the front belt systems were not buckled at the time of the crash and the buckle pre-tensioners did not fire. The driver seat was not adjusted to a forward position and a stage 1 frontal air bag deployments were commanded to fire 25 milliseconds into the crash. (The second stage of the dual-stage system was disposed of approximately 100 milliseconds after the stage 1 deployment.) The RCM sensed and recorded the crash acceleration pulse for a duration of 78 milliseconds. The 78 millisecond longitudinal delta V recorded by the RCM was approximately -31.5 km/h (-19.7 mph). The 78 millisecond lateral delta V was approximately -21.6 km/h (-13.4 mph). Analysis of the acceleration pulse and velocity curves indicated the majority of the crash event was captured by the recording. The velocity curves had begun to plateau. There was reasonable agreement between the WINSMASH analysis and the crash event data.

Time (ms)	0	10	20	30	40	50	60	70	78
Delta-V (MPH)	-0.6	-1.4	-2.2	-3.1	-4.0	-4.9	-5.8	-6.7	-7.6

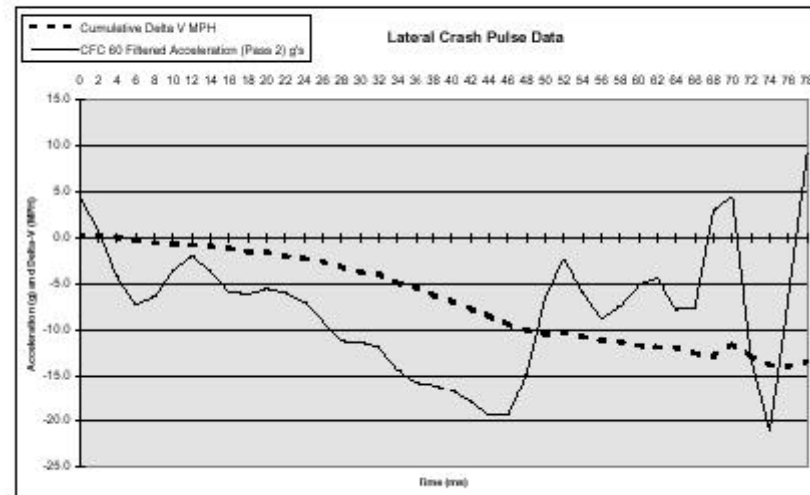
Lateral Cumulative Delta-V

Time (ms)	0	10	20	30	40	50	60	70	78
Delta-V (MPH)	-0.2	-0.7	-1.2	-1.7	-2.3	-2.9	-3.5	-4.1	-4.8
