On-scene Investigation / Vehicle to Vehicle
Dynamic Science, Inc. / Case Number: DS01-010
2000 Honda Insight
Arizona
March, 2001

1. Report No. DS01-010		2. Government Accession No.		3. Recipient Catalog No.	
4. Title and Subtitle In-Depth Accident Investigation				5. Report Date	
				6. Performing Organization Report No.

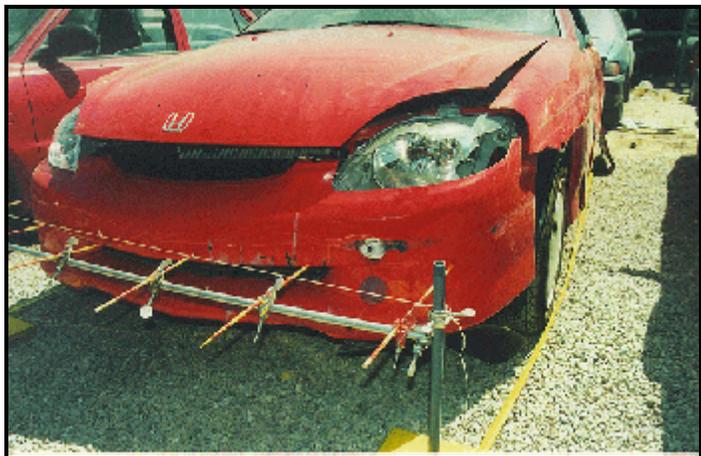
Figure 1. Front left side, case vehicle

The right side of the case vehicle (03RDEW1) came into contact with the left side of the other vehicle. The driver of the case vehicle steered to the left and lost control. The vehicle traveled through three southbound travel lanes before entering the center median and striking a three-strand cable guardrail with its front end (12FYEW1) and along its left side (12LDAS1). It appears that the case vehicle penetrated the cable guardrail to some degree and several of the cables may have come free. Generating a valid delta v is not possible due to the yielding nature of the guardrail, but it would appear that it was below 25 km/h (10 mph). Neither frontal air bags deployed.

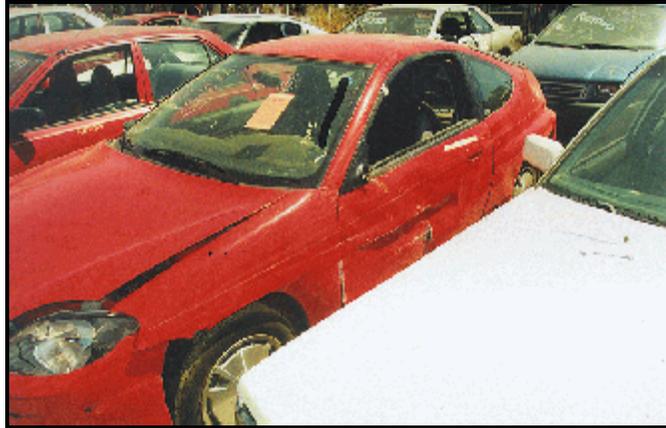
Figure 2. Left side, case vehicle

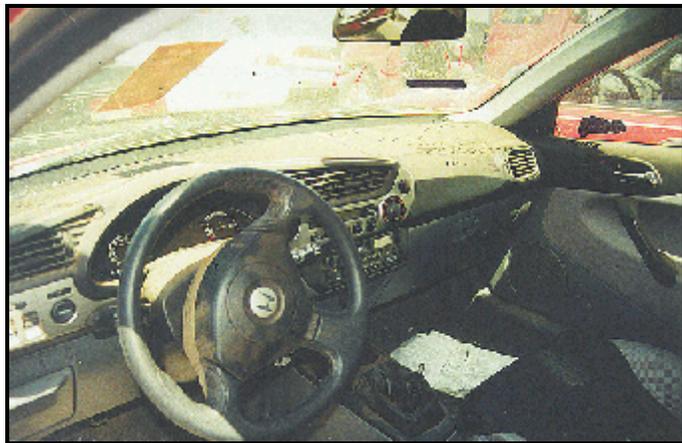
Figure 3. Interior, case vehicle

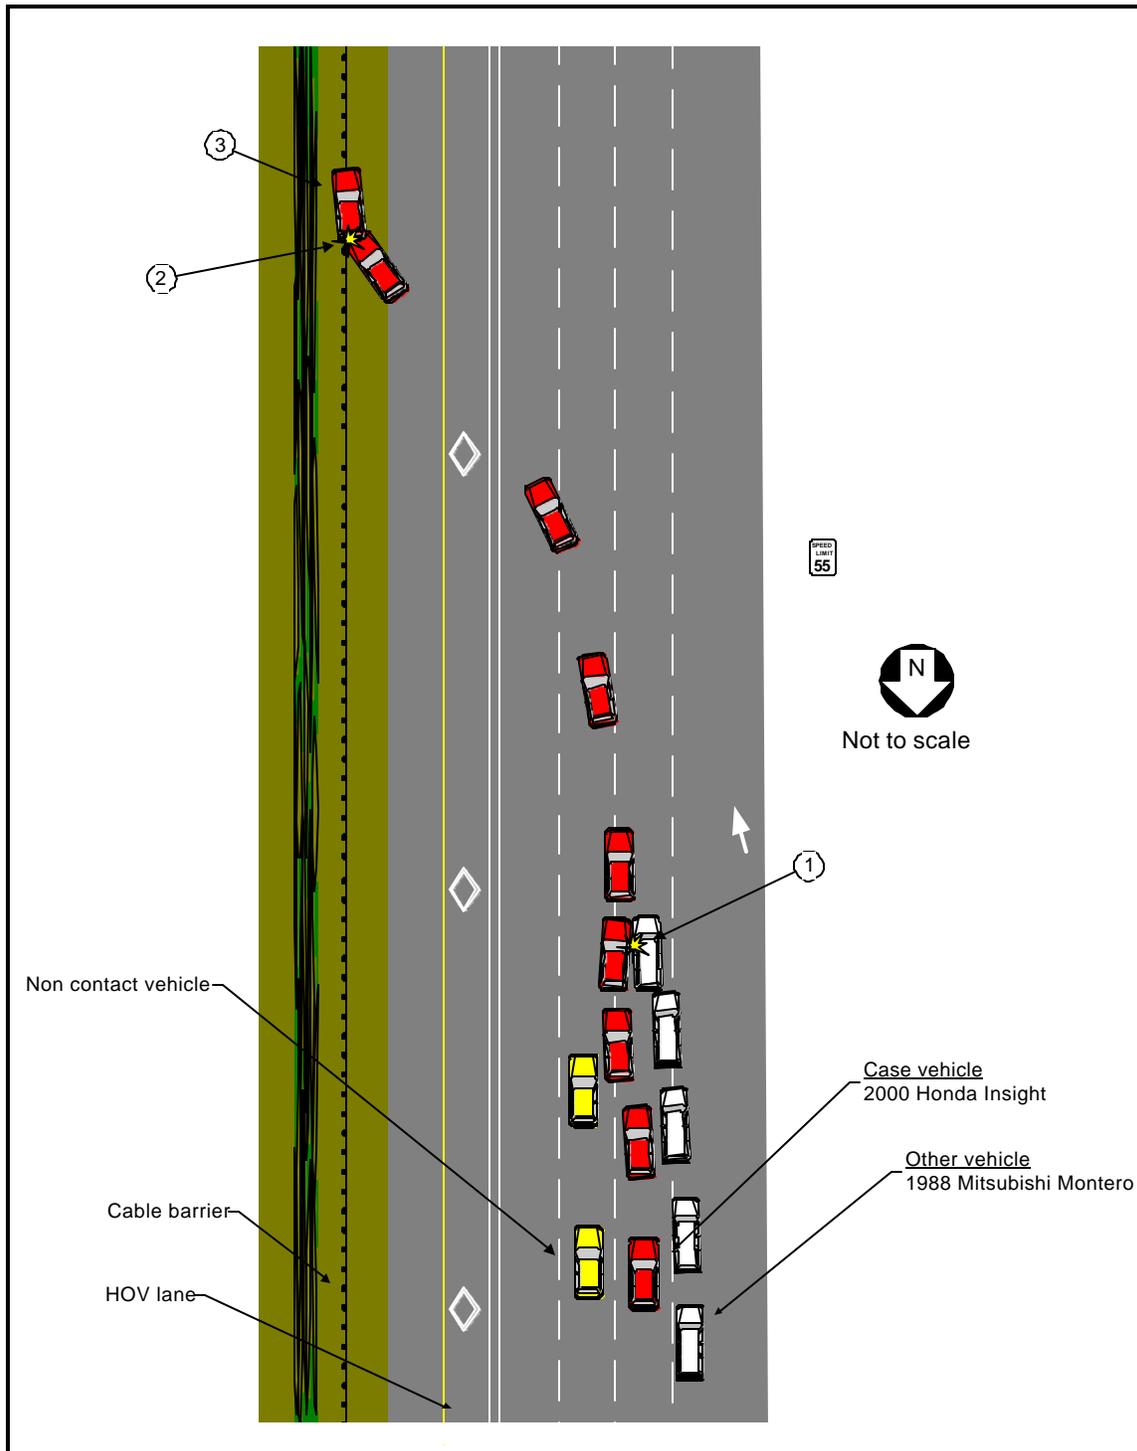
Figure 4. Scene diagram

Both vehicles were traveling southbound on a five-lane divided interstate highway at a police estimated speed of 89 km/h (55 mph). The case vehicle was in the second lane from the right. The other vehicle was in the lane to the right of the case vehicle. The driver of the case vehicle began a lane change to the left. At this point he noticed a vehicle to his left. He steered back to the right to return to his original lane of travel. In the meantime, the Mitsubishi had changed lanes to the left and was now partially in the case vehicle's original lane of travel.

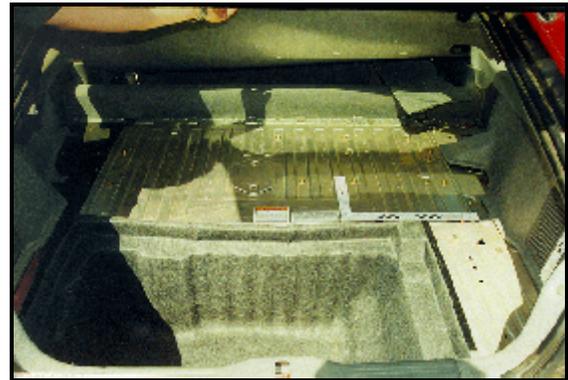
Figure 5. Rear battery compartment, with cover on

1. There were no indications of electrolyte spillage from the propulsion battery.
2. There was no movement of the battery module.
3. The electrical isolation test could not be conducted. The propulsion battery was not charged. There were no indications, however, of any arcing, fire, or component meltdown.
