ON-SITE AIR BAG INVESTIGATION

CASE NUMBER - IN01-016
LOCATION - TENNESSEE
VEHICLE - 1995 DODGE NEON
CRASH DATE - May, 2001

1. <i>Report No.</i> IN01-016	2. <i>Government Accession No.</i>	3. <i>Recipient's Catalog No.</i>	
4. <i>Title and Subtitle</i> On-Site Air Bag Fatality Investigation Vehicle - 1995 Dodge Neon Location - Tennessee		5. <i>Report Date:</i> September 23, 2002

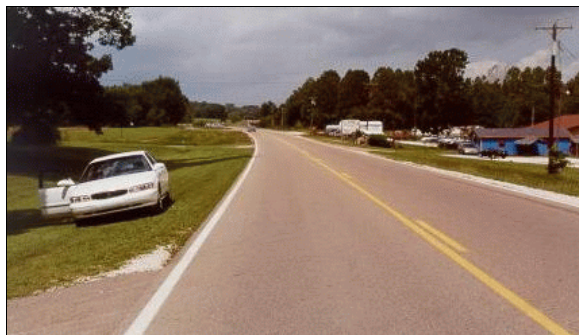
Figure 1: Westerly view, looking back from beyond point of impact, showing case vehicle's and Plymouth's pre-crash travel path in "gentle" right-hand curve; Note: driveway, where noncontact vehicle turned, in lower left-hand corner of photo (case photo #01)

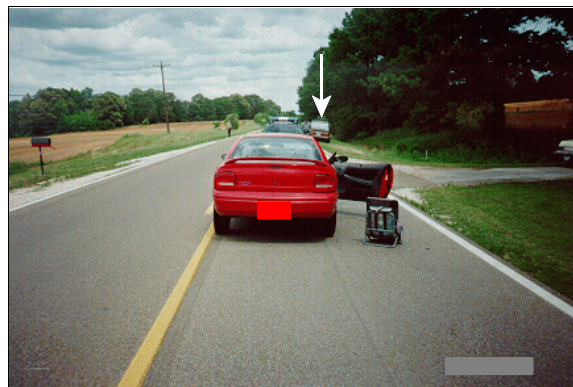
Figure 2: On-scene view looking east at case vehicle's pre-impact skid marks leading to final rest; Note: other vehicle at final rest on shoulder further eastward (case photo #48)

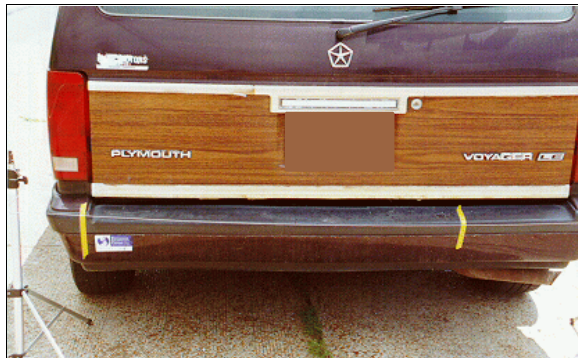
Figure 4: Contact (taped) on Plymouth's bumper showing minimal deformation (case photo #41)

The Plymouth's contact with the case vehicle involved the entire back bumper. Direct damage began 37.5 centimeters (14.8 inches) right (toward the passenger side) of center and extended, a measured distance of 113 centimeters (44.5 inches), along the back bumper toward the back left bumper corner. Residual maximum crush was measured as only 1 centimeters (0.4 inches) at C₁ through C₃.

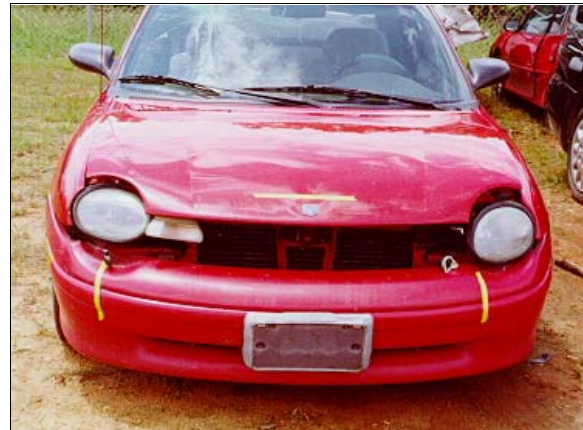
Figure 3 Case vehicle's minor frontal damage from underride impact; Note: tape indicates area of direct contact (case photo #05)

The case vehicle's initial contact with the Plymouth involved the entire front (**Figure 3** above). Direct damage began 50 centimeters (19.7 inches) left of center (towards the driver's side) and extended rightward, a measured distance of 109 centimeters (42.9 inches). Because of the underride-type impact, the direct damage extended rearward on the hood approximately 10 centimeters (3.9 inches—**Figure 3** above). Residual maximum crush was measured as 2 centimeters (0.8 inches) at C_1 and C_6 on the bumper and 7 centimeters (2.8 inches) uniformly above the bumper. The wheelbase on the case vehicle's left (driver's side) was shortened approximately 1 centimeter (0.4 inches) while the right side was extended 1 centimeter (0.4 inches). The case vehicle's grille was knocked out and the hood was folded slightly rearward. There was direct damage to the top of the front bumper fascia and to the hood, grille, radiator support, hood latch, and left turn signal assembly (**Figures 7** and **8**). None of the case vehicle's tires were damaged, deflated, or physically restricted. Both the right and left headlight and the

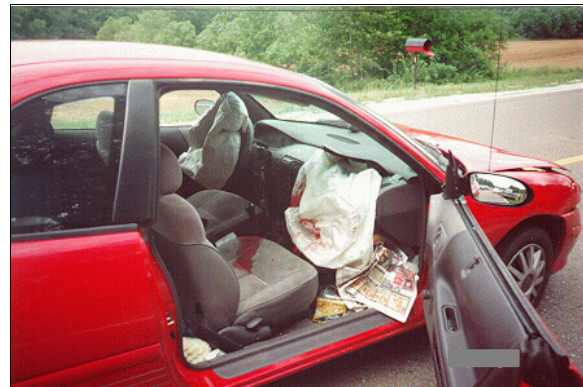
Figure 5: On-scene view of case vehicle's front right seating area showing excessive blood on seat and deployed passenger air bag; Note: front right seat track was moved backward by rescue personnel (case photo #49)

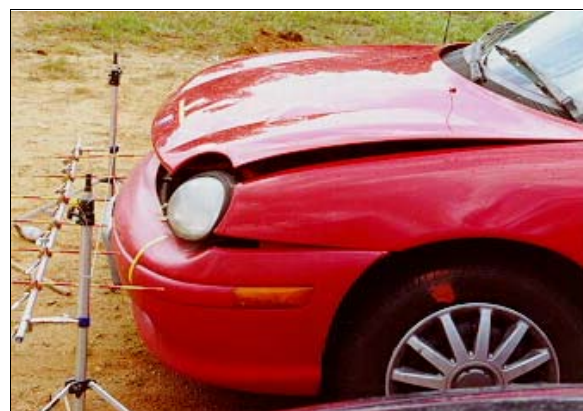
Figure 6: Reference line view from left showing case vehicle's front deformation; Note: damage primarily above bumper (case photo #09)

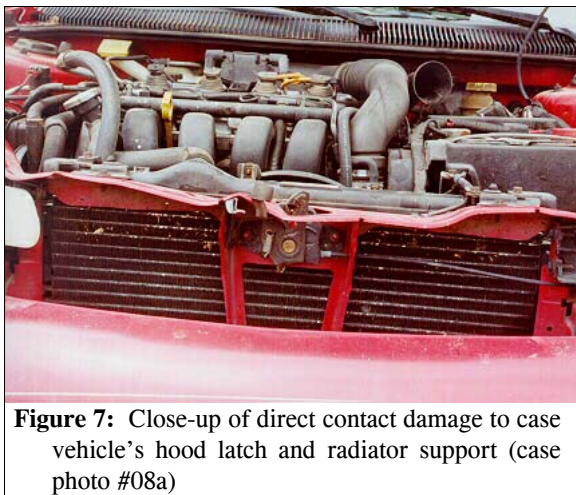
Figure 7: Close-up of direct contact damage to case vehicle's hood latch and radiator support (case photo #08a)

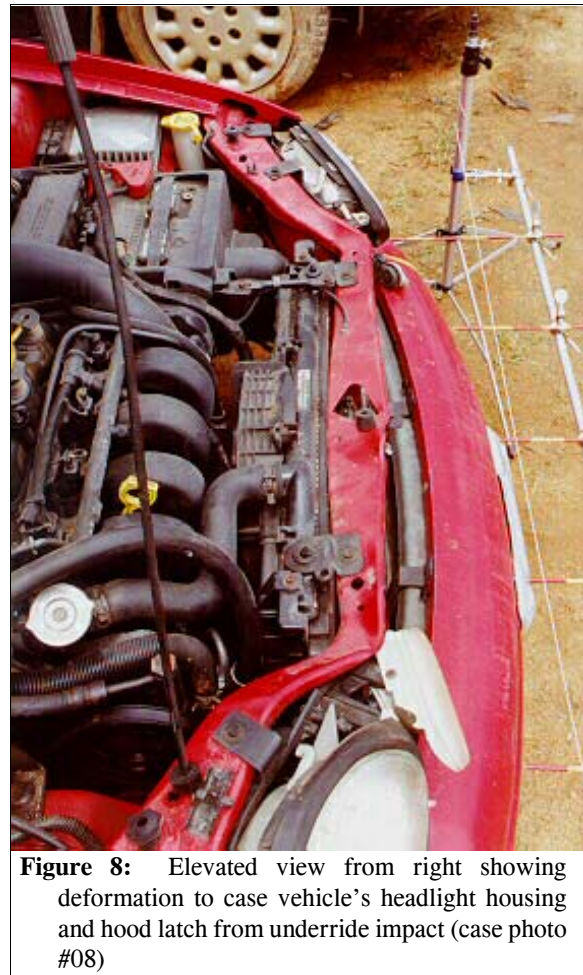
Figure 8: Elevated view from right showing deformation to case vehicle's headlight housing and hood latch from underride impact (case photo #08)

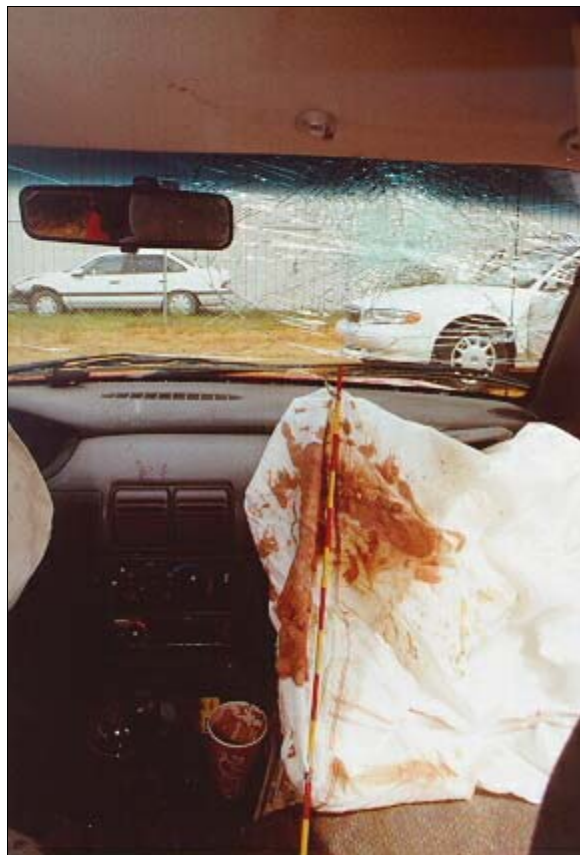
Figure 9: Vertical view of case vehicle's front right passenger seating area showing bloody air bag and contacts to windshield's glazing and windshield's header (case photo #31)

The inspection of the case vehicle's interior revealed a spider web impact to the right windshield's glazing (**Figure 9**), with embedded hair fibers from contact by the front right passenger's decapitated head. Hair fibers were also found on the front right header area (**Figure 10**) and on the front right sun visor (**Figure 11**). Blood contact evidence was found on the left side of the back seat's seat back and on the driver's seat back (**Figure 12**). These bloody areas are believed to have been directly contacted by the front right passenger's head as it travel backward after rebounding on the right windshield's glazing. Furthermore, blood splatter was found on the roof, approximately over the driver's seat back, and

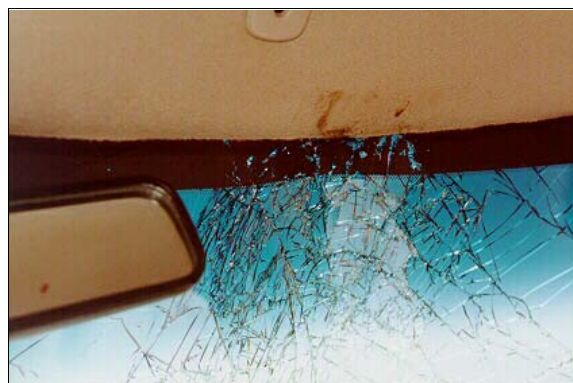
Figure 10: Close-up of hair and blood evidence on case vehicle's windshield glazing and front header from front right passenger (case photo #26)

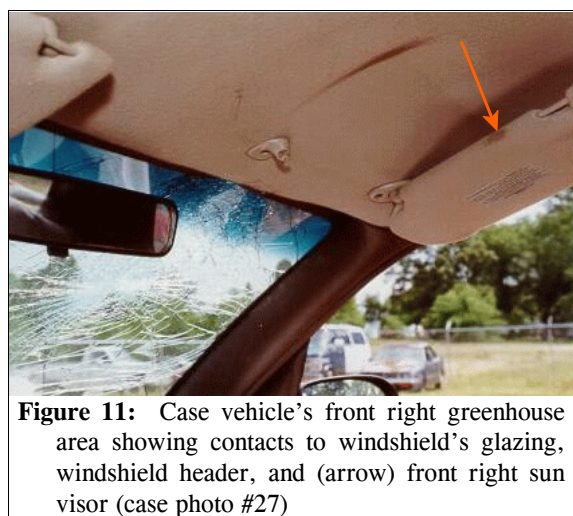
Figure 11: Case vehicle's front right greenhouse area showing contacts to windshield's glazing, windshield header, and (arrow) front right sun visor (case photo #27)

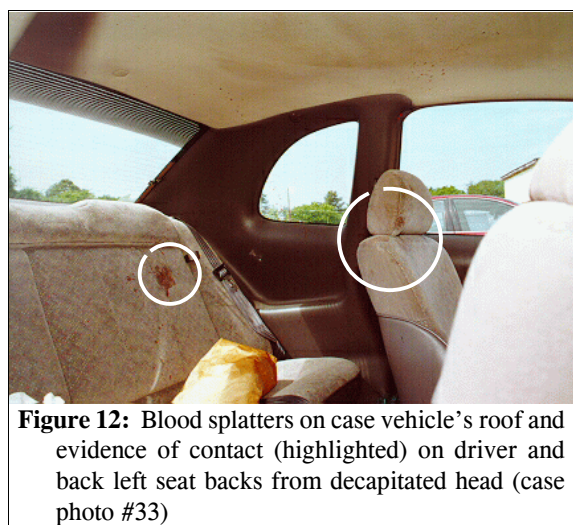
Figure 12: Blood splatters on case vehicle's roof and evidence of contact (highlighted) on driver and back left seat backs from decapitated head (case photo #33)

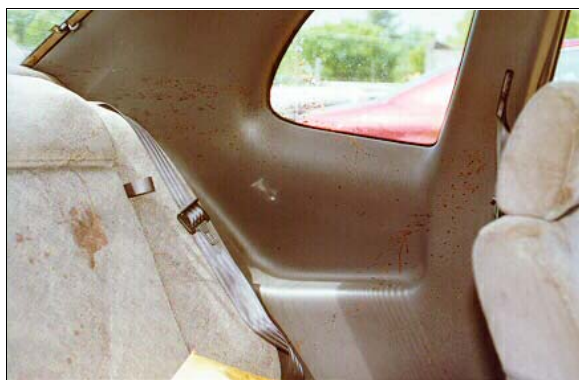
on the left rear side panel and window's glazing (**Figure 13**). In addition, there was a large bloody area on the inward side of the front right seat and center console. This is the area where the front right passenger's head came to rest (**Figure 14**). According to the case vehicle's driver, the right front door glazing was disintegrated by rescue personnel who were attempting to get to the front right passenger. Finally, there was no evidence of intrusion to the case vehicle's interior, no evidence of compression to the energy absorbing sheer capsules in the steering column, and no deformation to the steering wheel rim.

Figure 13: Close-up of blood from head contact on case vehicle's seat backs and blood splatters on left rear side panel and window glazing (case photo #34)

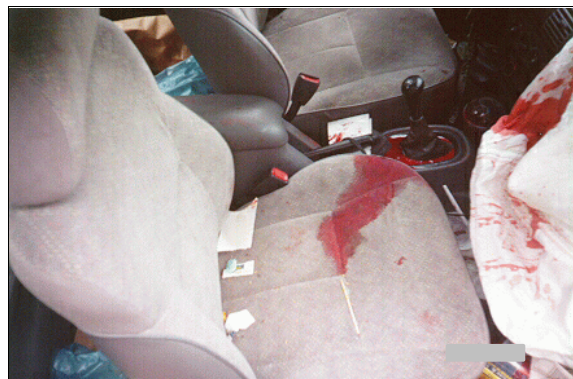
Figure 14: On-scene close-up of case vehicle's front right seat showing bloody area where front right passenger's head came to final rest on manual gear shifter; Note: torso and extremities remained in car seat on seat cushion (case photo #23)

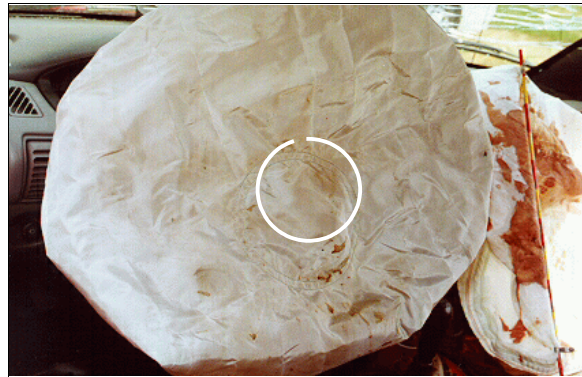
inches). An inspection of the driver's air bag fabric revealed a 9 x 7 centimeter (3.5 x 2.8 inch) area of dark area of skin and oil transfer on the upper right portion of the circular center stitching (Figure 15). In addition, there were scattered blood splatters on the fabric with the majority of the spots aligned along a line between the center of the air bag and the 5 o'clock position.

Figure 15: Case vehicle's deployed driver air bag with contact evidence highlighted (case photo #20)

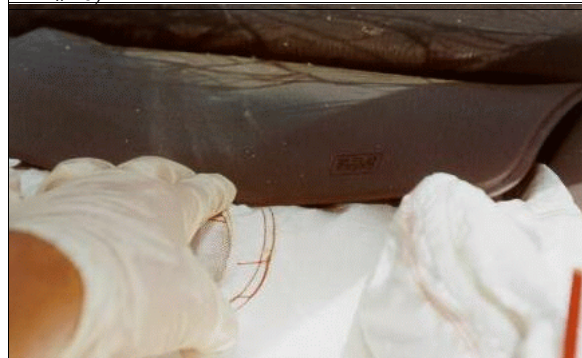
Figure 16: Deformation and contact evidence on cover flap of case vehicle's front right air bag module (case photo #32)

the air bag. However, the front right air bag module's cover flap was deformed from contact with the front right child passenger's chin and neck, and there appeared to be dried saliva residue and skin on the module's cover flap (Figure 16). The module's cover flap, in association with the air bag's fabric which followed, decapitated the front right child passenger's head. The front right passenger's air bag was designed with four tethers, each 7.5 centimeters (3.0 inches) wide. The front right air bag had one vent port, approximately 5 centimeters (2.0 inches) in diameter, located at the 12 o'clock position. The deployed front right air bag was rectangular with a height of approximately 57 centimeters (22.4 inches) and a width of approximately 47 centimeters (18.5 inches). An inspection of the front right air bag's front surface revealed a large area of blood with skin from the center of the air bag toward the 10:30 o'clock area (Figure 9 above) and smaller areas of blood at the 7 o'clock area and toward the 12 o'clock area. Furthermore, there was a very large area [32 x 12 centimeters (12.6 x 4.7 inches)] of blood with skin on the air bag's left side surface (Figure 15 and Figure 9 above). In addition, there was a large area of skin deposited

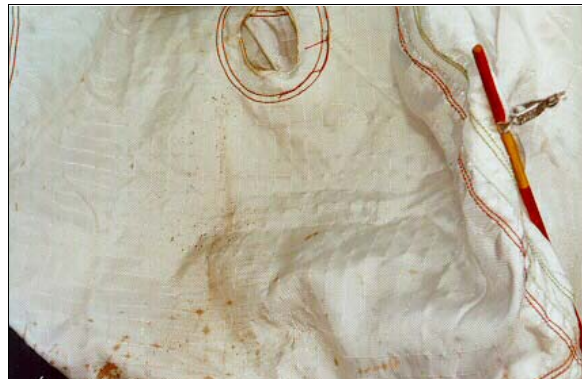
Figure 17: Close-up of dark skin transfer on top surface of case vehicle's front right passenger air bag (case photo #30)

[8 centimeters wide by over 20 centimeters long (3.1 x 7.9 inches)] on the top surface of the air bag, beginning just to the left and below the vent port and running forward and down onto the air bag's front surface (**Figure 17** above).

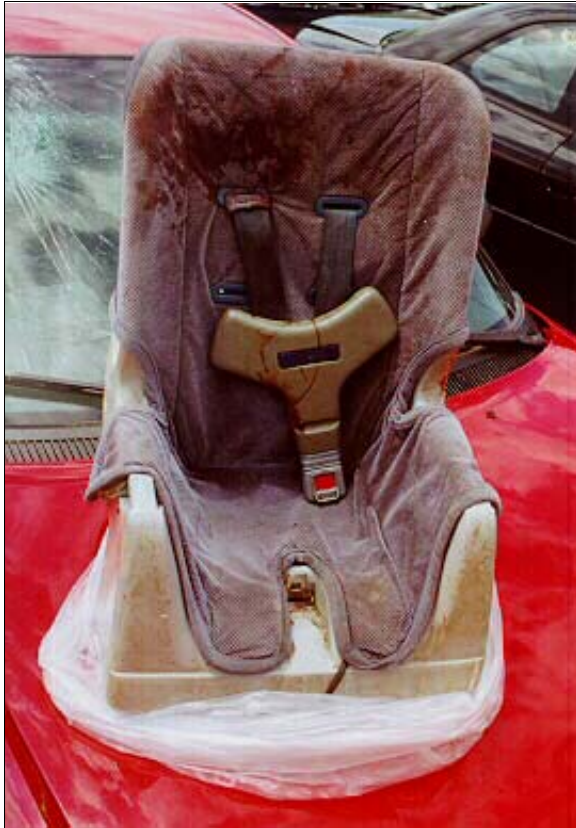
Figure 18: Frontal view of bloodied Fischer/Price model 9100 convertible child safety seat used by case vehicle's front right passenger (case photo #37)

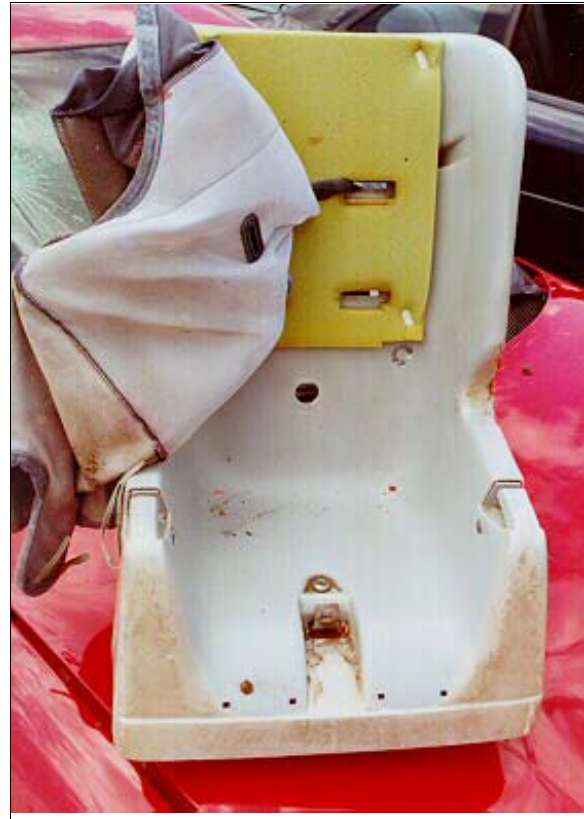
Figure 19: Fischer/Price model 9100 child safety seat used by case vehicle's front right passenger with bloodied cover pulled away showing no visible stress to plastic shell (case photo #37a)

The child safety seat used by the case vehicle's front right passenger was a convertible seat manufactured by Fischer-Price Products in 1984 and was identified by Model number 9100. The seat was equipped with a three-point harness with "T"-shield (**Figure 18**). The seat was designed with two different shoulder height levels (i.e., slots) that the harness webbing could be adjusted through (i.e., dependent on height and size of child—**Figure 19**). In addition, the seat was designed with a retractor for the three-point harness and "T"-shield. The child seat was designed with only one slot between the child's legs for buckling the "T"-shield/harness portion (**Figure 19**). A close inspection of the front right passenger's forward facing child safety seat showed visible evidence of stress to one of the metal reinforcement braces (**Figures 20 and 21** below) but nothing to the plastic shell of the seat itself.

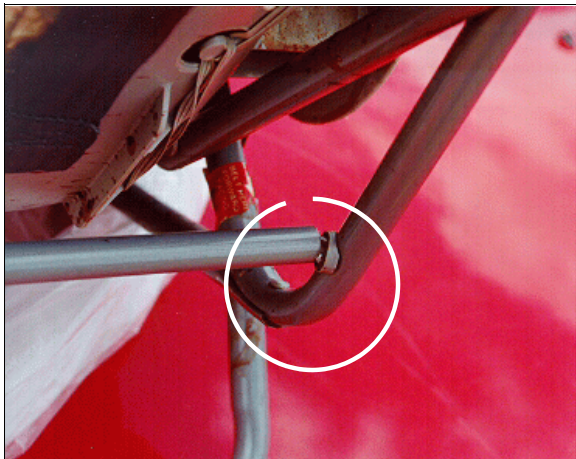
Figure 21: Close-up of metal brace displacement on Fischer/Price child safety seat used by case vehicle's front right passenger (case photo #35a)

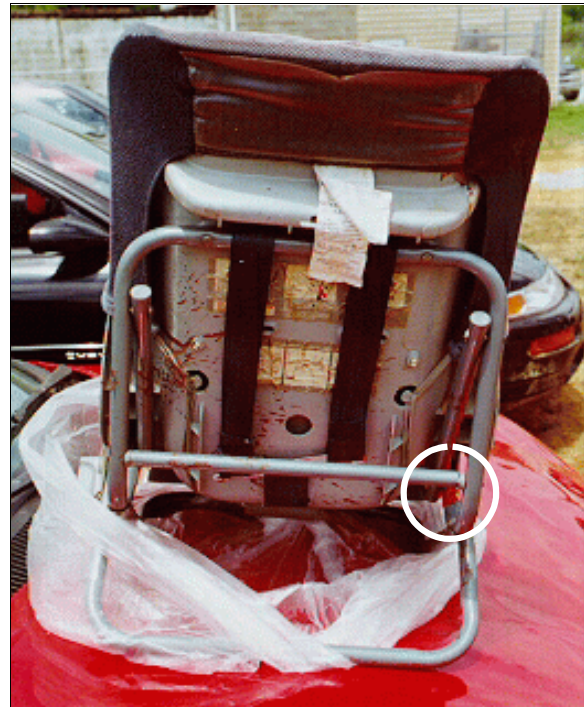
Figure 20: Back view of Fischer/Price model 9100 used by case vehicle's front right passenger showing blood splatters and highlighted area of brace displacement (case photo #35)

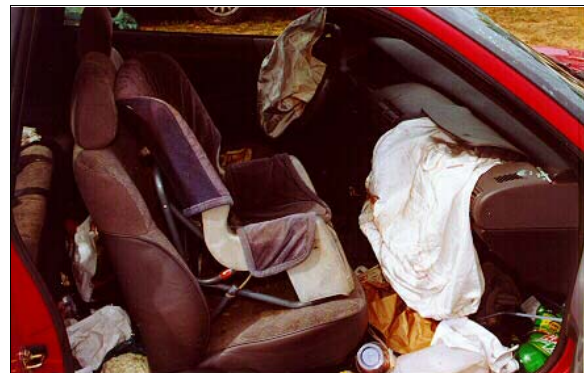
Figure 22: Case vehicle's front seating area showing deployed air bags and unsecured forward facing child safety seat in its pre-impact position (case photo #22)

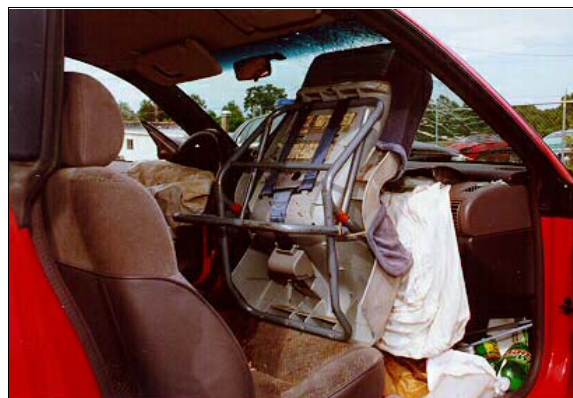
in conjunction with the seat track's location, the child's head was immediately in front of or atop the front right air bag module's cover flap at the instant of deployment (**Figure 23**). The deploying cover flap contacted the child's right lower cheek and chin, hyper extending the head backwards. As the cover flap continued to expand upwards, followed by the deploying air bag, the front right passenger's head was severed from his torso by the cover flap while his torso remained restrained in the forward facing child safety seat. The expanding cover flap and air bag propelled his head forward, with his scalp leading, into the windshield's glazing (**Figure 10** above). Because of the short term resistance provided by the child seat and the occupant's torso, as the air bag continued to expand the air bag's fabric was directed upwards as the course of least resistance. As a consequence the child's head was lifted upwards, driving the back of his head upwards into the sun visor and front right portion of the windshield's header (**Figure 11** above). The combination of the kinetic energy from the air bag's expansion and the elasticity of the windshield's glazing and front header, resulted in the front right passenger's head being redirected backward toward the back left interior of the vehicle. The front right passenger's head contacted the back left seat's seat back prior to rebounding forward where it contacted the inside upper right corner of the driver's seat back (**Figure 12** above), prior to coming to rest near the inward portion of the front right seat's cushion on the center floor-mounted console (**Figure 14** above). The deploying air bag knocked the free-floating forward facing child safety seat, along with the front right passenger's torso, backwards into the front right seat back. Based on witness statements, the unsecured forward facing child safety seat, along with the front right passenger's torso, were found lying on their left side atop the front right seat's cushion, facing forward.

Figure 23: Case vehicle's front right seating area showing approximation of position of unsecured forward facing child safety seat at deployment (case photo #36)
