**TRANSPORTATION SCIENCES  
CRASH DATA RESEARCH CENTER**

**ADVANCED OCCUPANT PROTECTION SYSTEM STUDY  
2001 FORD TAURUS INVESTIGATION**

**VERIDIAN CASE NO. CA01-033**

**CRASH DATE - APRIL 2001**

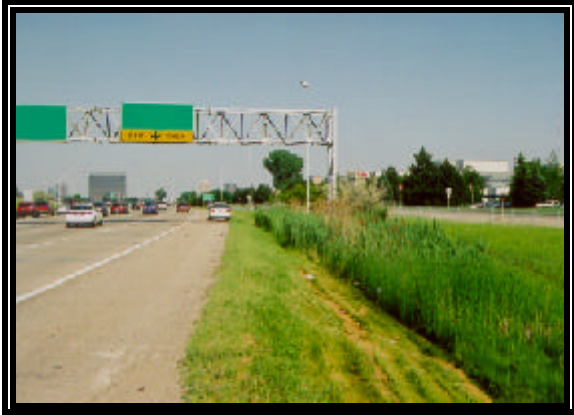
Figure 1: Approach view of the Ford Taurus.

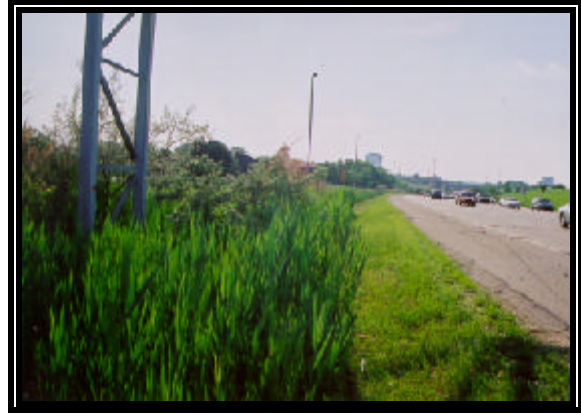
Figure 2: Look back view from final rest.

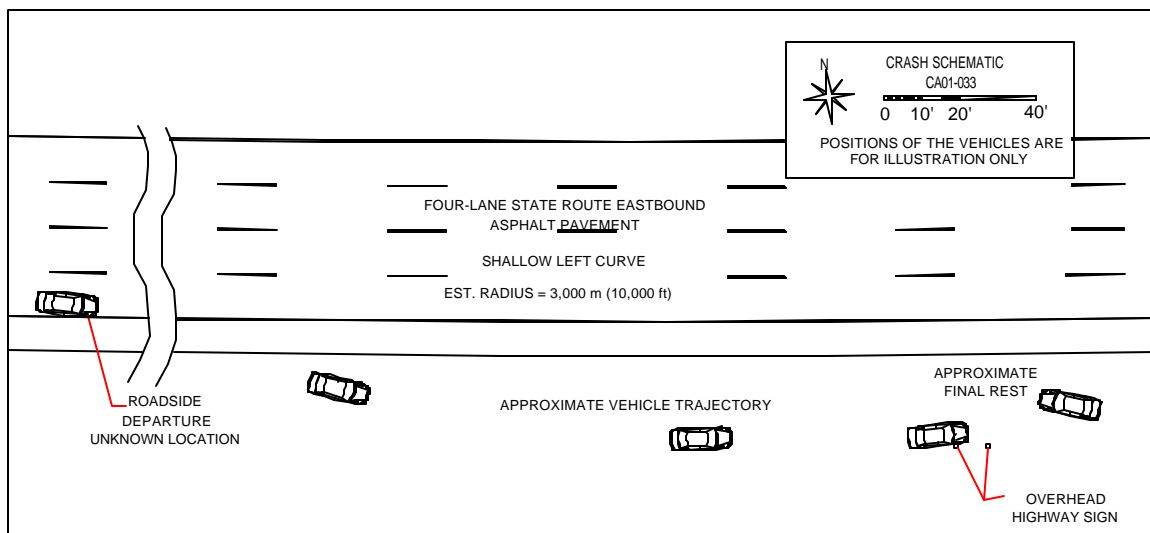
Evidence of the vehicle's trajectory had deteriorated due to the delay in crash notification and the growth of vegetation at the scene. Vehicle debris (including the exterior sheet metal of the right front door) was found in the ditch and paint transfers on the support post identified the point of impact. **Figure 3** is a schematic of the crash depicting the vehicle's approximate trajectory.

Figure 3: Crash schematic.

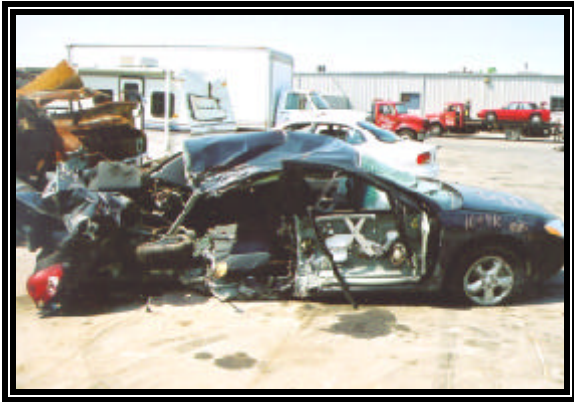
The Ford Taurus initially impacted the 25 cm x 25 cm (10 in x 10 in) support post with the right side of the vehicle in a sideswiping manner. The right side contact with the post began at the leading aspect of the right front door and extended rearward. As the vehicle continued on its eastward trajectory, its interaction with the post increased until the post pocketed the side structure and engaged the right rear suspension. The engagement with the right rear suspension caused the deployment of the vehicle's frontal air bag system. The force of the impact compromised the right C-pillar, and separated the right rear suspension components and right rear quarter from the vehicle's central uni-body structure, refer to **Figures 4 and 5**. Analysis of this impact damage was beyond the scope of the WINSMASH collision model. The delta V of this impact was in excess of 25.0 km/h (15.5 mph) and had a long duration. The vehicle then rotated approximately 180 degrees clockwise and came to rest facing westward. The left front corner of the vehicle contacted and over-rode an 8 cm (3 in) diameter sapling prior to coming to rest.

**Figure 4:** Right side view of the Taurus.

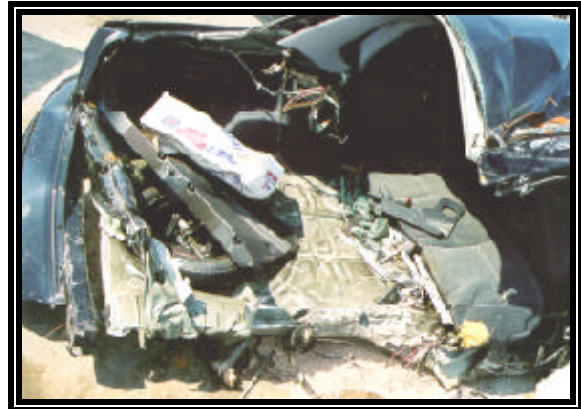
**Figure 5:** Taurus right rear quarter damage.

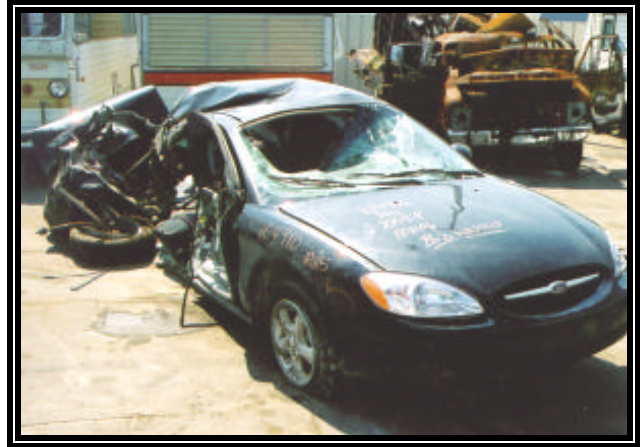
**Figure 6:** Right front view of the Ford Taurus.

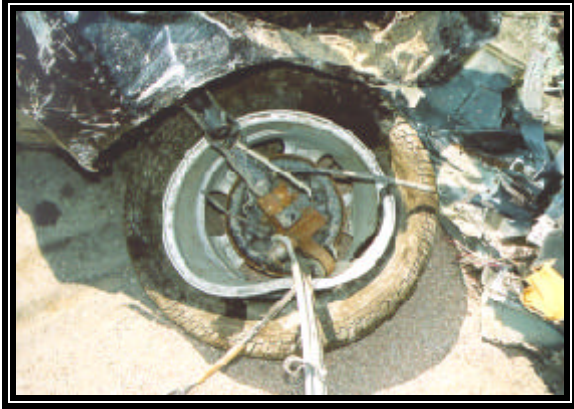
This contact pattern continued rearward along the right side toward the C-pillar as the vehicle's momentum carried it eastward. Coincident to this movement, the vehicle's heading was changing counterclockwise. The effect of these dynamics was to increase the magnitude of the direct contact as the PDOF moved into the 1 o'clock sector. As the crash sequence continued the interference pattern between the vehicle and sign post buckled the roof and comprised the C-pillar. The sign post impacted the right rear wheel fracturing the suspension. The right rear wheel rim displayed evidence of direct impact, **Figure 7**. The force of the impact separated the right rear wheel and suspension components, quarterpanel and trunk lid from the vehicle, **Figure 8**. The Collision Deformation Classification (CDC) of this impact was 01-RZAW-4. The vehicle's damage was beyond the scope for analysis utilizing the WINSMASH collision model. The vehicle dynamics and nature of the damage indicate that the crash pulse had a long duration. The delta V of the impact was in excess of 25.0 km/h (15.5 mph) and warranted deployment of the vehicle's frontal air bags.

**Figure 7:** Right rear wheel impact damage.

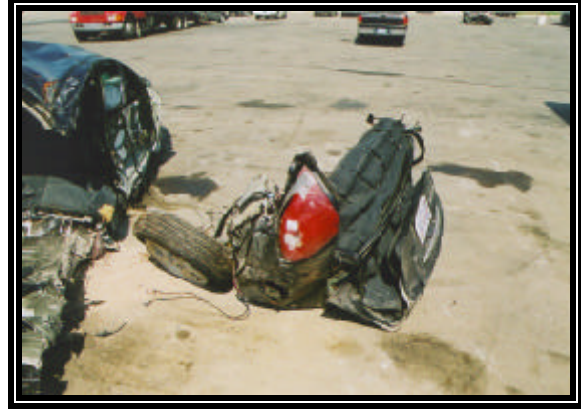
**Figure 8:** Components dislodged due to the force of the impact.

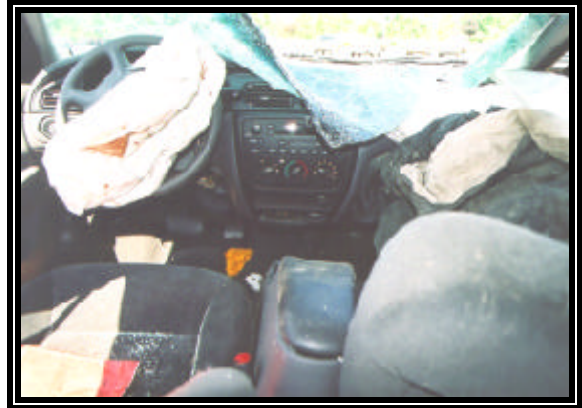
The integrity of the driver's occupant space was intact. There was no intrusion into the driver's area. A 2.5 cm x 2.5 cm (1.0 in x 1.0 in) area scuff was noted on the right upper aspect of the knee bolster. The scuff was located 11.4 cm (4.5 in) right of the steering column and was attributed to a right lower extremity contact. This contact did not produce any injury. The rear view mirror was displaced from its mounting and found on the left side of the instrument panel, forward of the driver. The center console was impacted and rotated to the right approximately 3.8 cm (1.5 in) from a right upper extremity contact, **Figure 9**. Post-crash blood evidence was noted on the center console right front seat cushion, and driver air bag.

**Figure 9:** Front interior view and center console deformation.

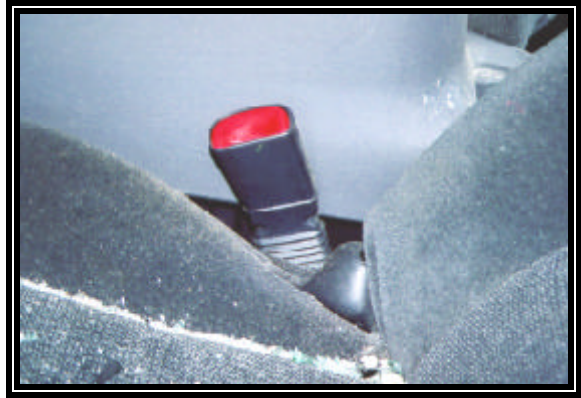
Upon inspection, the driver's restraint webbing was stowed within the retractor and the retractor was operational. The left front D-ring was adjusted to the full up position. Inspection of the driver's belt found minimal historical usage evidence on the latch plate and the webbing was evidence free. There was no evidence on the hard surfaces of the latch plate or D-ring indicative of use during the crash. The driver's buckle pretensioner had not fired, **Figure 10**. The post-crash measurement of the pretensioner's piston barrel measured 110 mm (4.3 in). This measurement was the pretensioner's unfired specification. All the evidence identified during the inspection indicated the driver was unrestrained at the time of the crash.

**Figure 10:** Driver's unfired buckle pretensioner.

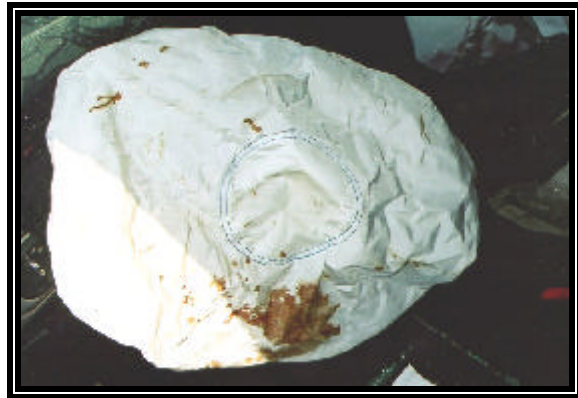
The driver air bag module was configured in the typical manner and located in the center of the steering wheel. The driver air bag had deployed from the H-configuration module cover flaps, **Figure 11**. The cover flaps opened along the designated tear seams. The height of the upper and lower flaps measured 6.4 cm (2.5 in) and 4.6 cm (1.8 in), respectively. The width of the flaps measured 17.2 cm (6.8 in). The deployed driver air bag measured 53 cm (21 in) in diameter. It was tethered by four straps sewn to the face of the bag. The bag was vented by two 2.9 cm (1.1 in) ports located in the 10/2 o'clock position on the back side of the bag. Post-crash blood evidence was concentrated in the 6 to 7 o'clock sector, with minor spattering noted in the 11 o'clock sector. The following nomenclature identified the air bag: P5206000-00E TXM010476255.

**Figure 11:** Driver air bag.

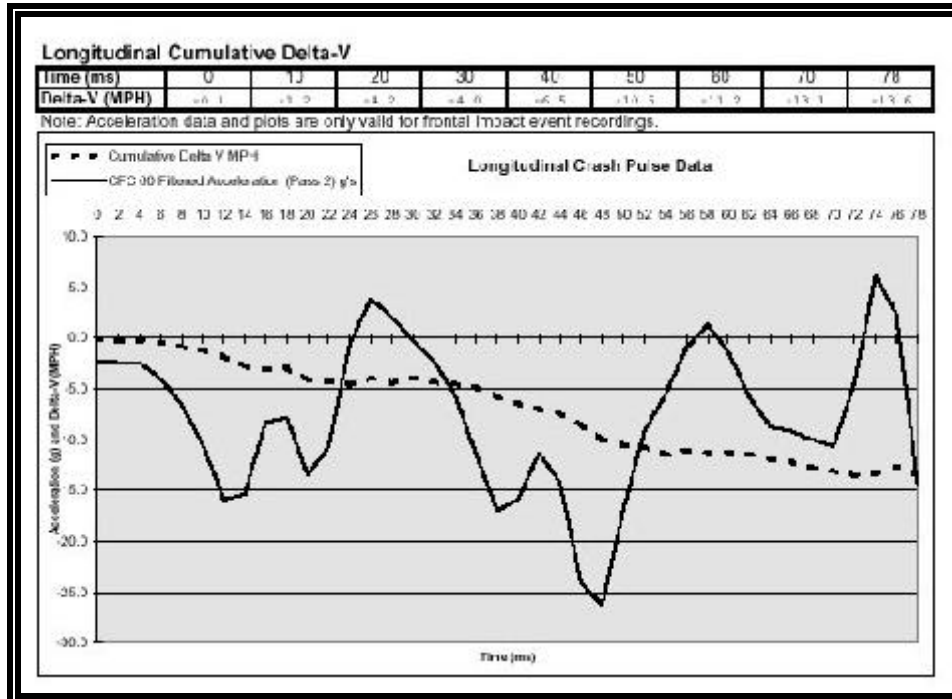
The RCM data indicated the front belt systems were unbuckled at the time of the crash and the buckle pretensioners did not fire. The driver seat was not adjusted to a forward position. A Stage 1 frontal air bag deployment was commanded 87 milliseconds after algorithm wakeup. The second stage of the dual-stage frontal bags was disposed of (deployed) approximately 100 milliseconds after Stage 1. The RCM continuously sensed and then recorded the crash acceleration pulse for a duration of 78 milliseconds. The 78 millisecond longitudinal delta V recorded by the RCM was approximately -21.9 km/h (-13.6 mph).

Figure 13: Longitudinal Delta V.

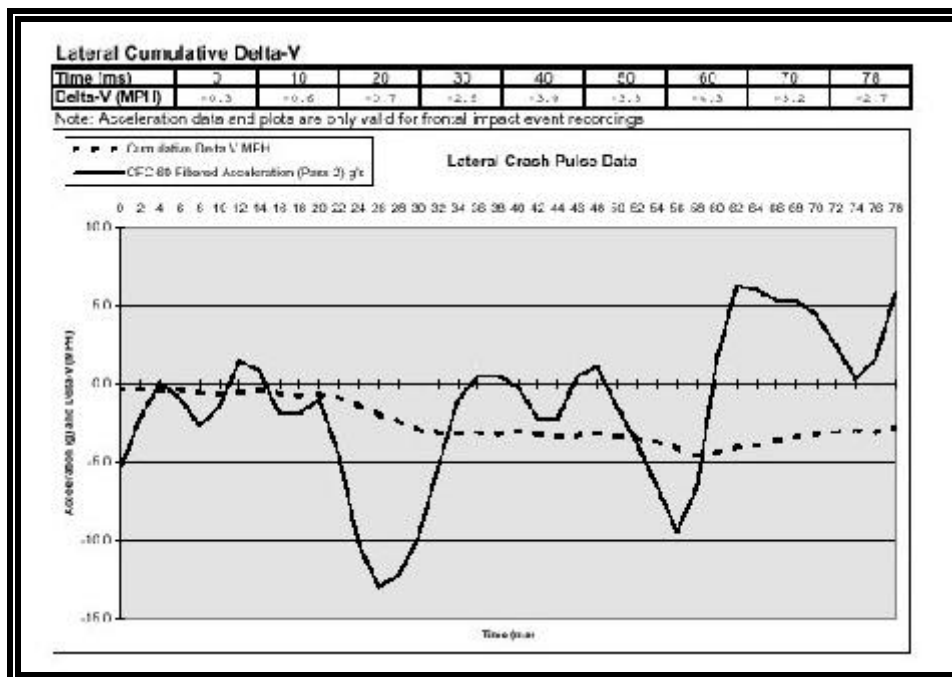
The 78 millisecond lateral delta V was approximately -4.3 km/h (-2.7 mph). Analysis of the acceleration pulse and velocity curves indicated that only a portion of this long duration crash event was recorded. The acceleration traces were still active and the velocity curves were still rising at the termination of the recording.

Figure 14: Lateral Delta V.
