**VERIDIAN REMOTE ADVANCED OCCUPANT PROTECTION SYSTEM CRASH
INVESTIGATION
SCI TECHNICAL SUMMARY REPORT**

NASS/SCI COMBO CASE NO. 02-45-039A

VEHICLE – 2001 PONTIAC BONNEVILLE

CRASH DATE – MARCH 2002

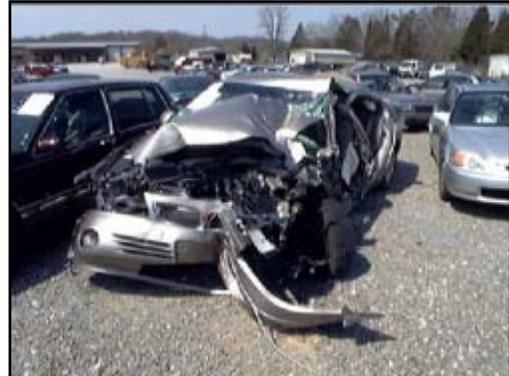
This remote investigation focused on the performance of the Advanced Occupant Protection System (AOPS) in a 2001 Pontiac Bonneville (**Figure 1**). The vehicle was equipped with side impact air bags, dual-stage frontal air bags, seat belt sensors, integrated manual 3-point lap and shoulder belts, and an Event Data Recorder (EDR). The Bonneville was involved in a run-off-road crash and sideswiped a number of trees, which resulted in the driver's side impact air bag deployment. The Bonneville subsequently sustained a frontal impact with two additional trees, which resulted in the deployment of the frontal air bag system. The vehicle was occupied by a 32-year-old female driver who was restrained by the 3-point lap and shoulder belt. She was probably out of position left due to the negative roadside slope. She initiated a forward trajectory in response to the multiple impacts, and loaded the manual restraint and intruded frontal components. She sustained forehead lacerations and a probable closed head injury from possible contact with the intruded with trees during the sideswipe event. The combination of her forward loading and frontal component intrusion resulted in a left humerus fracture, a left femur fracture, a right lower leg fracture and bilateral lower leg contusions and abrasions. She was pronounced dead at the scene prior to being removed from the vehicle.

Figure 1. Damaged Pontiac Bonneville

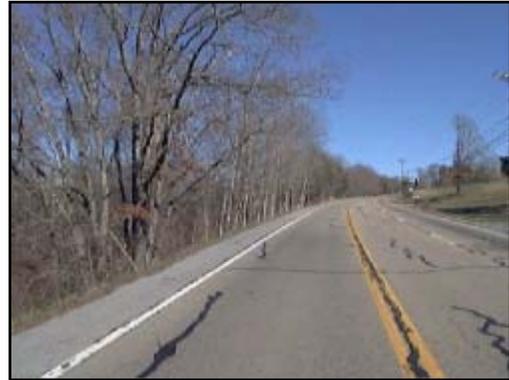
The 32-year-old female driver was operating the 2001 Pontiac Bonneville in an eastbound direction on the east/west roadway on approach to the gradual right curve (**Figure 2**). As the vehicle entered the curve and positive grade, the driver relinquished control for unknown reasons. The Bonneville drifted across the centerline and departed the left sloped roadside in a tracking mode. Due to the slope of the north roadside, the Bonneville was leaning to the left relative to the vehicle's longitudinal axis. The vehicle's EDR recorded the pre-crash vehicle speed five seconds prior to Algorithm Enable was 98 km/h (61 mph).

Figure 2. Eastbound approach for the Bonneville

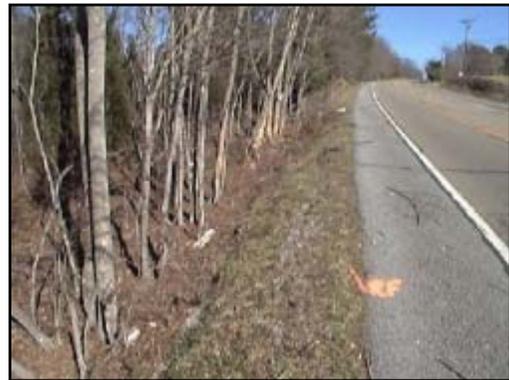
As the 2001 Pontiac Bonneville departed the roadside in a tracking mode, the left side aspect impacted five trees in a sideswipe configuration (**Figure 3**). The direction of force was in the 12 o'clock sector and the impact produced moderate left side damage. Although the force direction did not have a significant lateral component, the tree contact to the lower left B-pillar resulted in the deployment of the driver's side impact air bag. The vehicle's EDR recorded a "Near Deployment" event as a result of the sideswipe impact. The EDR recorded a 1.50 km/h (0.93 mph) velocity change for the left side impact with the trees. The Bonneville continued in a forward direction and impacted two additional trees with the front aspect. Impact resulted in moderate/severe damage to the Bonneville. The direction of force was in the 12 o'clock sector and the impact was sufficient to deploy the frontal air bag system in the vehicle. The maximum EDR recorded velocity change for the frontal impact was 38.8 km/h (24.1 mph). Due to the multiple impacts and masking damage, the WinSMASH program was not used to compute delta-V's for the impacts. The Bonneville rotated in a counterclockwise (CCW) direction around the trees and came to rest on the north shoulder and straddling the fog line.

Figure 3. View of crash site and struck trees

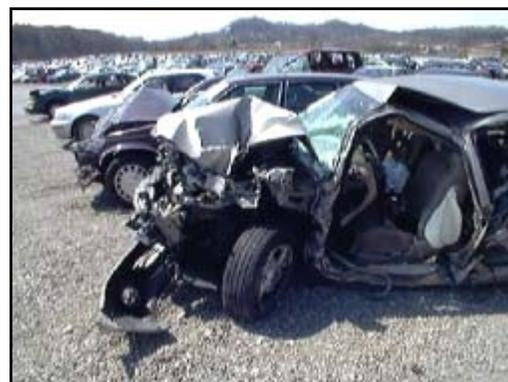
The 2001 Pontiac Bonneville sustained moderate damage as a result of the five left side sideswipe impacts with the trees (**Figure 4**). The second of the five impacts involved a tree less than 10.0 cm (3.9”) in diameter and was assigned as the impact for Collision Deformation Classification (CDC) and crush measurements, as the remaining left side impacts resulted in overlapping damage. The left side combined direct and induced damage began 68.0 cm (26.8”) aft of the rear axle and extended forward 415.0 cm (163.4”)

Figure 4. Left side damage to the Bonneville

along the left side plane. Both left side doors had been removed by rescue personnel, and the left front door was deformed as a result of extrication efforts. The left front fender was fractured and separated from the vehicle. The left front alloy/aluminum wheel was fractured and the left front tire was deflated. Longitudinal abrasions were present along the entire left side plane. The left front wheel was rotated CCW. One CDC was assigned to the second left side impact and was 12-LDAW-2. The remaining left side impacts were assigned CDC's of 12-L999-9.

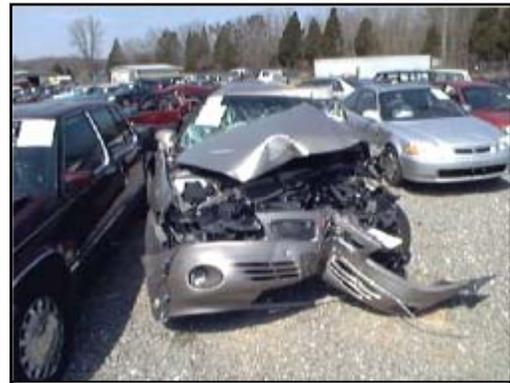
The Bonneville sustained moderate/severe frontal damage as a result of the frontal impact with the trees (**Figure 5**). The direct contact damage began 31.0 cm (12.2") to the right of the centerline and extended 73.0 cm (28.7") across the frontal plane. The combined direct and induced damage measured 95.0 cm (37.4") across the frontal plane. The bumper fascia was fractured, abraded, and partially separated on the left aspect. The hood sustained abrasions from the tree impact, and was buckled and displaced to the left. The front axle was crushed on the left aspect and displaced rearward and slightly CCW. The front axle displacement resulted in the shortening of the left wheelbase by 32.0 cm (12.6") and the elongation of the right wheelbase by 12.0 cm (4.7"). The left A-pillar was deformed rearward and the left roof side rail was deformed upward from induced buckling. Six crush measurements were taken along the frontal plane and were as follows: C1 = 50.0 cm (19.7"), C2 = 73.0 cm (28.7"), C3 = 85.0 cm (33.5"), C4 = 76.0 cm (29.9"), C5 = 60.0 cm (23.6"), C6 = 29.0 cm (11.4"). The maximum frontal crush was located between C2 and C3 and measured 91.0 cm (35.8"). The CDC for the frontal impact was 12-FDEW-4.

Figure 5. Frontal damage to the Bonneville

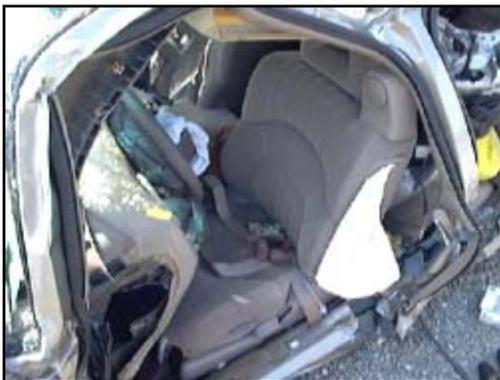
Interior damage to the 2001 Pontiac Bonneville was moderate and attributed to passenger compartment intrusion (**Figure 6**). The windshield laminate was fractured and holed vertically along the left A-pillar as a result of impact forces. The opening in the windshield laminate measured 50.0 cm (19.7") in height and 7.0 cm (2.8") in width (**Figure 7**). All left side glazing and the backlight were disintegrated from impact forces.

Figure 6. View of driver's seat area and intruded components

Position	Intruded Component	Magnitude of Intrusion	Direction
11	Left instrument panel	53.0 cm (20.9")	Longitudinal
11	Left A-pillar	45.0 cm (17.7")	Longitudinal
11	Windshield	40.0 cm (15.7")	Longitudinal
11	Windshield header	42.0 cm (16.5")	Longitudinal
11	Left floor pan	24.0 cm (9.4")	Longitudinal
12	Windshield header	8.0 cm (3.1")	Longitudinal
12	Center instrument panel	4.0 cm (1.6")	Longitudinal
21	Roof	28.0 cm (11.0")	Vertical
21	Left B-pillar	19.0 cm (7.5")	Longitudinal

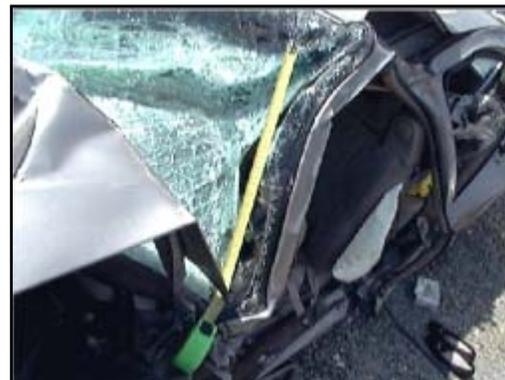
Figure 7. View of holed windshield

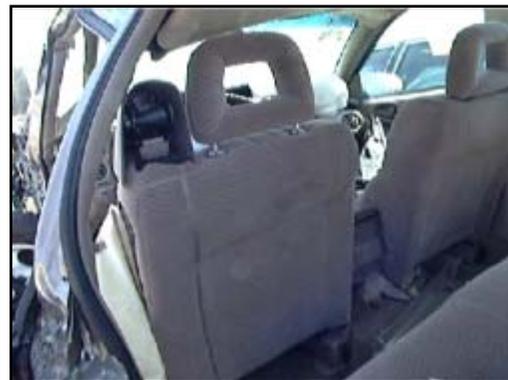
The driver and front right positions of the Pontiac Bonneville were configured with integrated manual 3-point lap and shoulder belts with sewn latch plates and Emergency Locking Retractors (ELR's). The shoulder belt retractors were located on the outboard upper aspects of the front seat backs (**Figure 8**) and the lap belt retractors were located on the outboard aspects near the lower B-pillars. The integrated shoulder belts did not have height adjustments. The driver's and front right passenger's manual restraints exhibited signs of historical usage. The driver's seat belt webbing was cut by rescue personnel to facilitate extrication of the driver, and loading evidence was present on the seat belt webbing in the NASS photographs. The EDR summary report indicated the driver's belt switch circuit status as "buckled." The front center position was configured with a lap belt that did not show any signs of historical usage.

Figure 8. View of the rear aspect of the integrated shoulder belt retractor

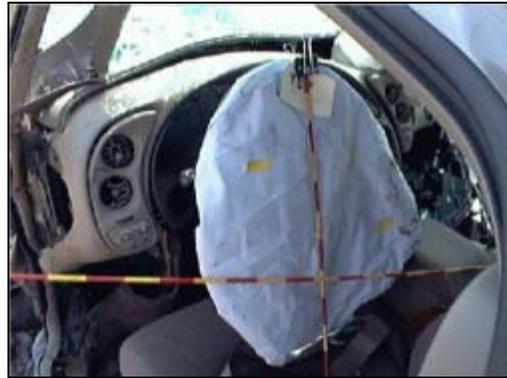
The 2001 Pontiac Bonneville was equipped with dual-stage frontal air bags for the driver and front right passenger positions that deployed as a result of the frontal impact with the trees. The EDR summary report indicated that only the first stage deployed in this crash. The driver's air bag (**Figure 9**) was housed in the center of the steering wheel hub with symmetrical I-configuration module cover flaps. Each cover flap measured 7.5 cm (3.0") in width and 11.0 cm (4.3") in height. The driver's air bag measured 55.9 cm (22.0") in diameter in its deflated state. The air bag was tethered by four internal straps and vented by two circular ports located on the rear aspect of the air bag at the 10 and 2 o'clock positions. Body fluid (blood) was present on the front and rear surfaces of the air bag from the driver.

Figure 9. Deployed driver's air bag

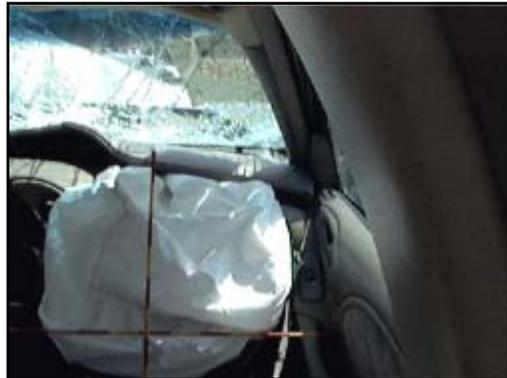
The front right passenger's air bag deployed from a top-mount module (**Figure 10**). The front right passenger's air bag measured 50.0 cm (19.7") in width and 50.0 cm (19.7") in height in its deflated state. The air bag was tethered by four internal straps and was vented internally through the instrument panel. There was no contact evidence present on the front right passenger's air bag.

Figure 10. Deployed front right passenger's air bag

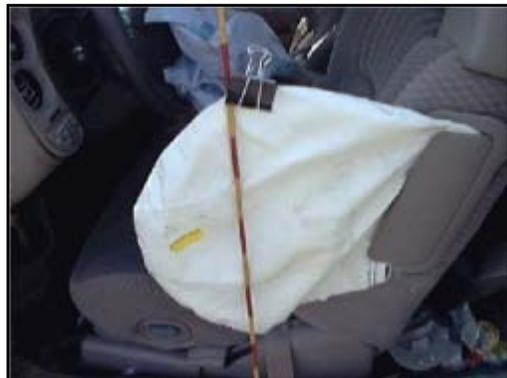
The 2001 Pontiac Bonneville was equipped with side impact air bags for the driver and front right passenger positions. The side impact air bags were located in the outboard aspects of the front seat backs. The driver's left side impact air bag (**Figure 11**) deployed as a result of the direct left side contact of the vehicle with the trees during the sideswipe event. The left side air bag impact sensor was located on the lower aspect of the left B-pillar. The driver's side impact air bag deployed forward from the outboard aspect of the driver's seat back. The plastic cover flap measured 8.0 cm (3.1") in width and 21.0 cm (8.3") in height and was hinged at the rear aspect. The driver's side impact air bag measured 37.0 cm (14.6") in height and deployed forward from the seat back approximately 38.0 cm (15.0"). A scuff was noted on the forward outboard aspect approximately 5.0 cm (2.0") aft of the forward seam. Body fluid (blood) was present on the inboard aspect of the driver's side impact air bag.

Figure 11. Left side view of driver's side impact air bag

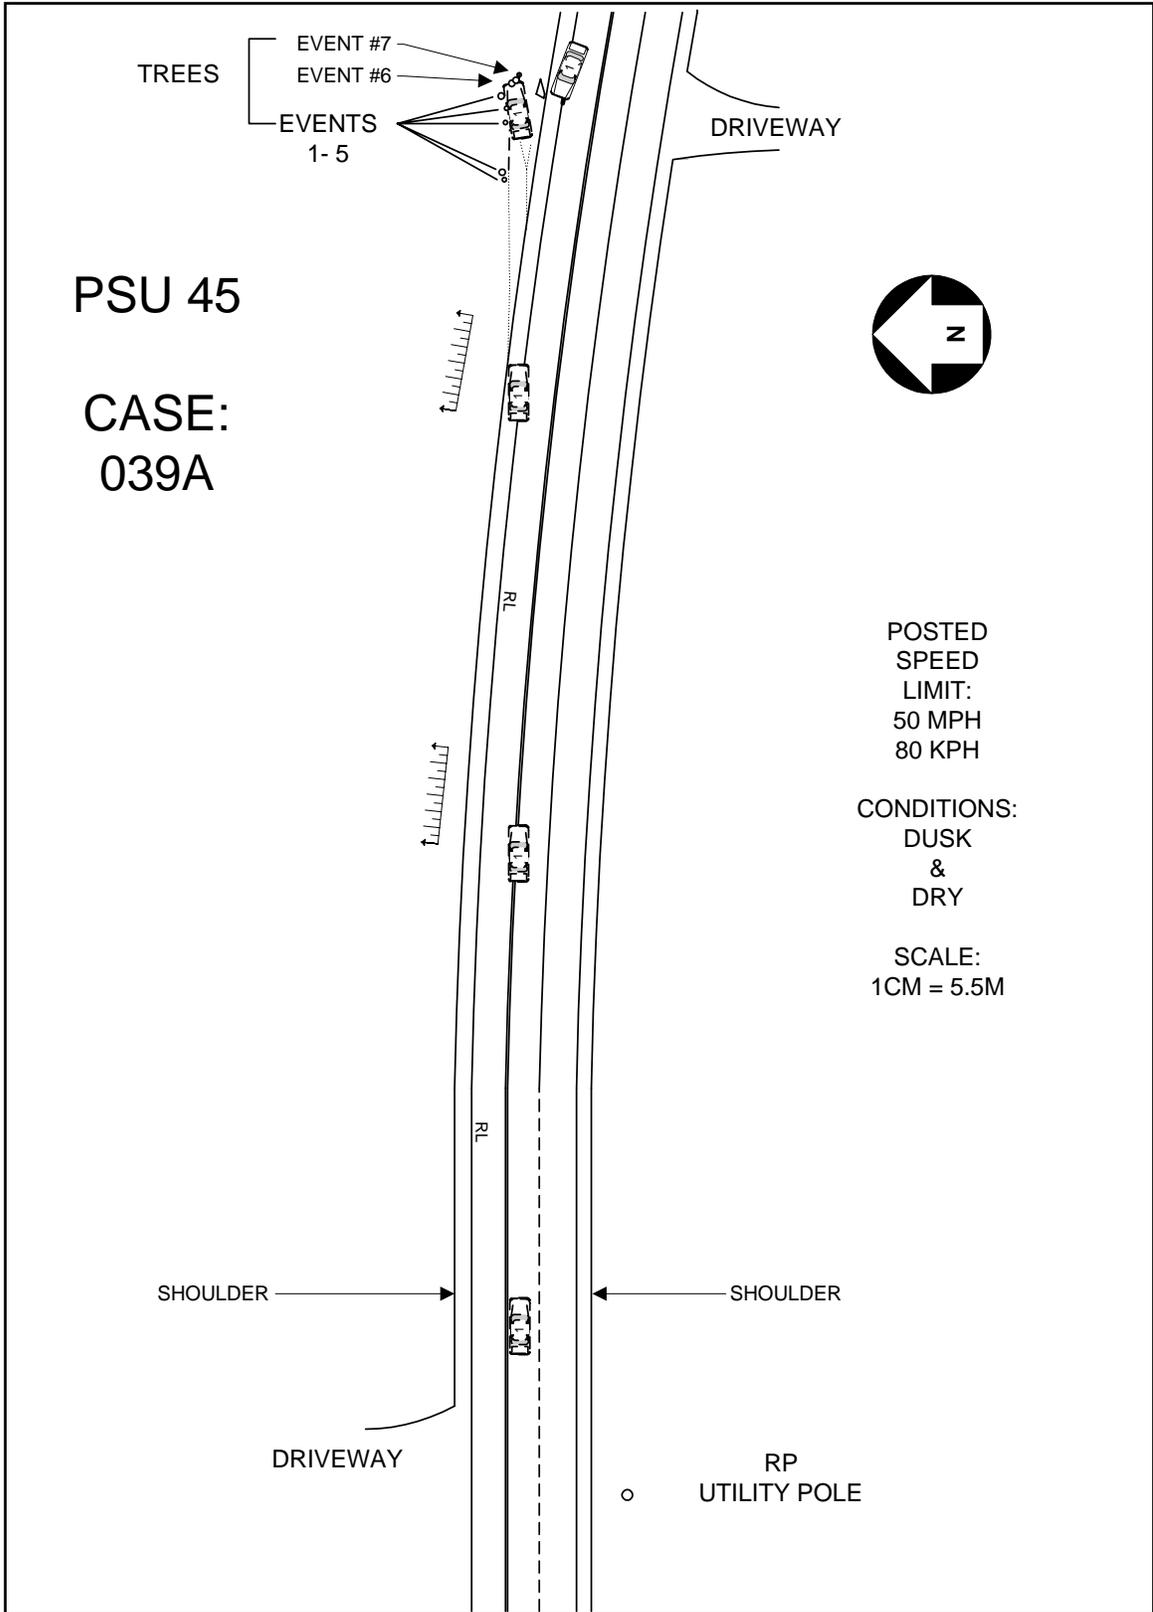
Figure 12. NASS scene schematic

roadside. The north roadside exhibited a negative slope from the north road edge. There were no traffic controls present at the crash site and the posted speed limit was 80 km/h (50 mph). The NASS scene schematic is included as **Figure 12**, Page 9 of this report.
