## ON-SITE ADVANCED OCCUPANT PROTECTION SYSTEM INVESTIGATION

CASE NUMBER - IN-02-007  
LOCATION - Texas  
VEHICLE - 2001 FORD CROWN VICTORIA  
CRASH DATE - September 2002

Submitted:  
August 8, 2003  
Revised:  
February 24, 2004

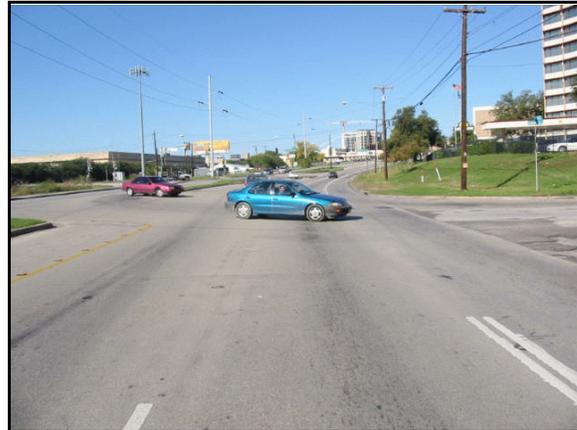
**Figure 1:** Case vehicle's northwestbound approach toward impact within the intersection; the other vehicle was approximately at the location of the vehicle in the center of this photograph (case photo #03)

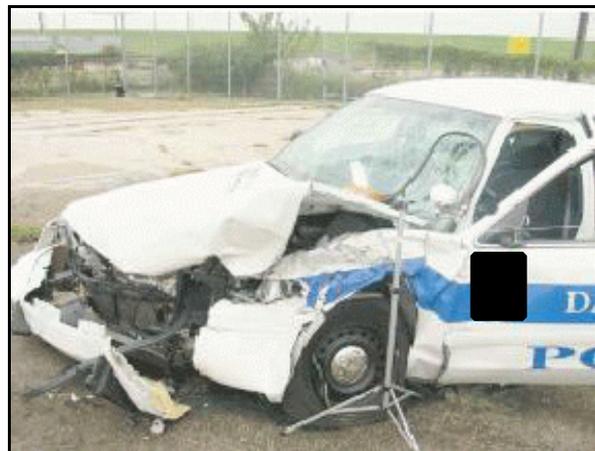
**Figure 2:** Case vehicle's front left damage from first (most severe) impact; note wheel damage from curb impact, front right wheel also damaged (case photo #18)

The case vehicle sustained direct contact damage across the left two-thirds of the front from the first impact, with induced damaged across the entire front and additional damage on the left fender resulting as the two vehicles rotated into each other (**Figures 2 and 3**). The front left corner area was crushed rearward and inward, with the radiator and other above-bumper front components displaced rearward. The grille and both headlamp assemblies were shattered and the front bumper cover was torn across the entire width with pieces missing. The steel bumper was separated from its mounting on the left. Maximum crush on the front plane was 69 centimeters [27.2 inches] at the front left corner. The left rear corner of the hood impacted the lower left corner of the windshield, causing heavy cracking of the laminated windshield. The left A-pillar was displaced rearward, the left front door opening was distorted and there was buckling of the left roof rail near the B-pillar. The driver's door came open, with the latch mechanism visibly damaged. The case vehicle's wheelbase was shortened by 30 centimeters [11.8 inches] on the left and 3 centimeters [1.2 inches] on the right. The CDC for the front impact was determined to be **11-FDEW-3 (340)**. The WinSMASH reconstruction program was used on the case vehicle's most severe impact, based on the measured crush profile for both vehicles. The results indicated Total, Longitudinal and Lateral Delta-V's, respectively: 23.0 km.p.h. [14.3 m.p.h.], -21.6 km.p.h. [-14.1 m.p.h.] and +7.9 km.p.h. [+4.9 m.p.h.]. These results appear somewhat low.

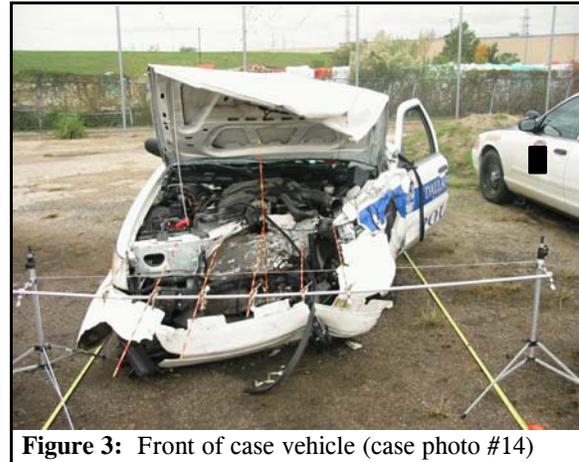
**Figure 3:** Front of case vehicle (case photo #14)

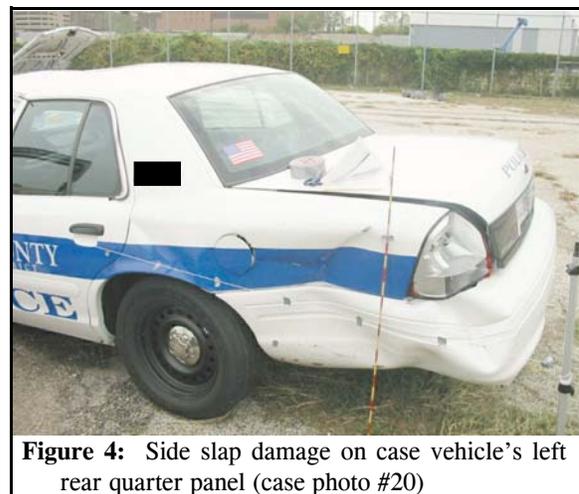
The case vehicle also sustained direct damage on the left rear quarter panel from the second (side slap) event (**Figure 4**). The case vehicle's high pre-crash speed and lock-up braking caused its front to be angled down and its rear wheels probably lifted up off the ground as the case vehicle pivoted clockwise into the side slap impact. Direct contact was measured as 65 centimeters [25.6 inches], centered on the rear overhang. The left tail light lens was broken out and the trunk lid was displaced. Maximum crush was 17 centimeters [6.7 inches]. The CDC was determined to be **09-LBEW-2 (270)**. The WinSMASH reconstruction program was used on this secondary impact, based on the measured crush profiles of both vehicles. The results indicated Total, Longitudinal and Lateral DeltaVs, respectively: 8.0 km.p.h. [5.0 m.p.h.], 0 km.p.h. [0 m.p.h.] and +8.0 km.p.h. [+5.0 m.p.h.]. These results appear reasonable. The case vehicle also sustained left and right front wheel impacts as it mounted the curb, with CDCs **12-FLWN-3** and **12-FRWN-3**.

**Figure 4:** Side slap damage on case vehicle's left rear quarter panel (case photo #20)

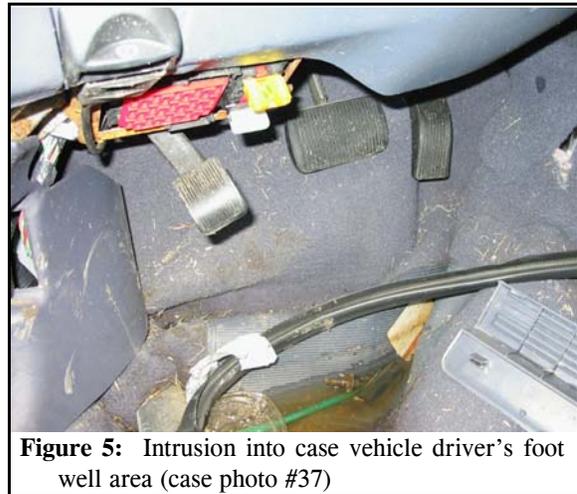
Inspection of the case vehicle's interior revealed several areas of intrusion and evidence of occupant contact. The toe pan in driver's foot well was moved 21 centimeters [8.3 inches] rearward (**Figure 5**). The left side instrument panel was moved 13 centimeters [5.1 inches] rearward, with the steering assembly displaced 6 centimeters [2.4 inches] upward and the upper half of the steering wheel rim bent 2 centimeters [0.8 inches] forward. The lower end of the left upper A-pillar was moved 4 centimeters [1.6 inches] rearward. There was an imprint and dent in the knee bolster below the steering column. There was also a skin transfer in the fractured windshield.

**Figure 5:** Intrusion into case vehicle driver's foot well area (case photo #37)

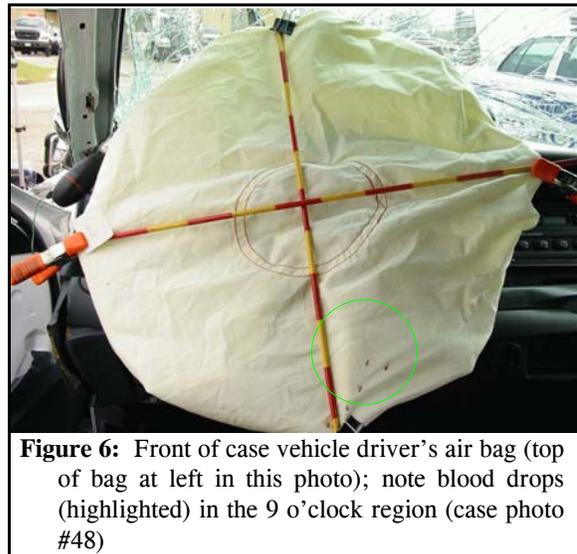
The case vehicle was equipped with driver and front right passenger front air bags. The driver's air bag (**Figure 6**) was mounted in the steering wheel hub, with a single module cover flap that measured 12 centimeters [4.7 inches] vertically and 15 centimeters [5.9 inches] horizontally, with the top edge tapering to a hinge that measured 9 centimeters [3.5 inches] horizontally. The cover flap opened at the tear points, with no evidence of damage to the flap, the adjacent structures or the air bag. The driver's air bag was round, with diameter 56 centimeters [22.0 inches]. It had four tethers that were 6 centimeters [2.4 inches] wide, and two vent ports each with a diameter of 3 centimeters [1.2 inches] at the 11:00 and 1:00 o'clock positions. There were droplets of blood in the 9:00 o'clock region on the front extending to the back of the air bag and no other evidence of contact.

**Figure 6:** Front of case vehicle driver's air bag (top of bag at left in this photo); note blood drops (highlighted) in the 9 o'clock region (case photo #48)

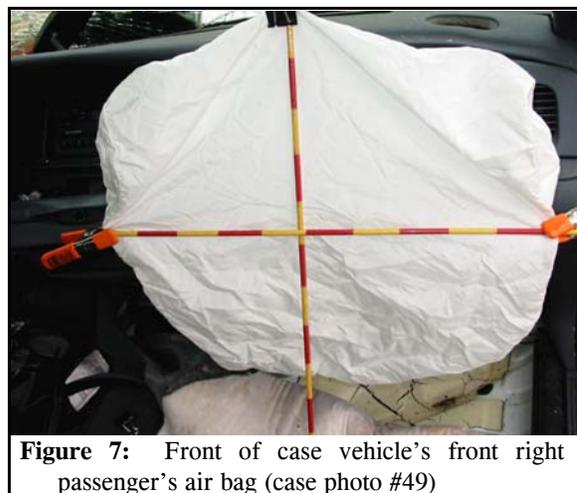
The front right passenger air bag was located in the mid-instrument panel position (**Figure 7**), with a single module cover flap that measured 40 centimeters [15.7 inches] horizontally and 15 centimeters [5.9 inches] vertically. The cover flap opened at the tear points, with no evidence of damage to the cover

**Figure 7:** Front of case vehicle's front right passenger's air bag (case photo #49)

flap, the adjacent structures or the air bag. The front right passenger's air bag was rectangular, measuring 51 centimeters [20.1 inches] vertically and 53 centimeters [20.9 inches] horizontally. It was designed with no tether strap and a single vent port with a diameter of 7 centimeters [2.8 inches] at the 8 o'clock position on the back. Inspection of the air bag revealed scuff marks from the deployment and no other evidence of contact.

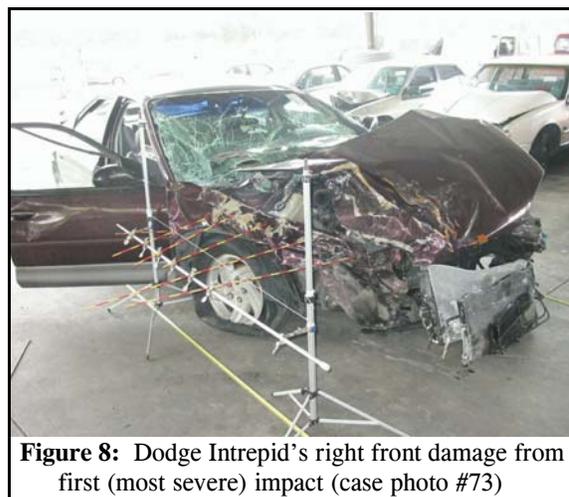
The Dodge sustained initial direct contact at the right front corner area that was measured as 91 centimeters [35.8 inches]. As the two vehicles rotated into each other, the entire right front fender sustained crushing and abrading (**Figure 8**). Maximum crush was measured as 61 centimeters [24.0 inches] at the right front corner. The CDC for the first impact was determined to be **02-RYEW-4 (80)**. The WinSMASH reconstruction program was used on the Dodge's most severe impact, based on the measured crush profile of both vehicles. The Total, Longitudinal and Lateral Delta-V's are for the Dodge's first impact are, respectively: 32.0 km.p.h. [19.9 m.p.h.], -10.9 km.p.h. [-6.8 m.p.h.] and -30.1 km.p.h. [-18.7 m.p.h.]. These results appear to be low.

**Figure 8:** Dodge Intrepid's right front damage from first (most severe) impact (case photo #73)

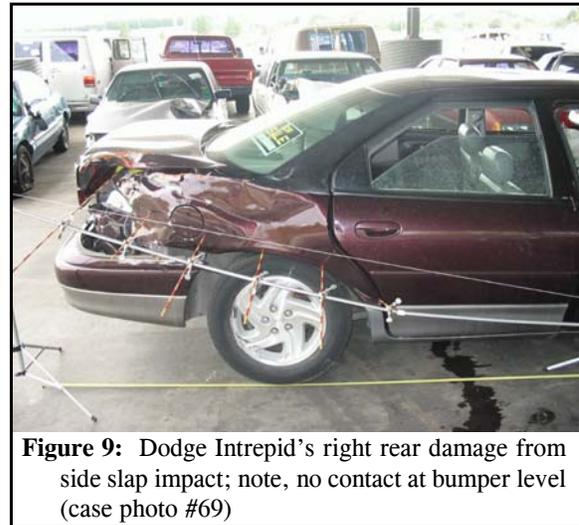
The Dodge also sustained direct contact on its right rear quarter panel from the side slap impact (event #2) with the case vehicle. Because of its high speed and configuration at the first impact, the case vehicle's rear wheels were probably raised up off the ground as the two vehicles pivoted into each other. As a result of the case vehicle being elevated, direct damage on the Dodge was restricted to the upper portion of the quarter panel and trunk lid (**Figure 9**). The CDC for the side slap impact was determined to be **03-RBMW-3 (90)**. The WinSMASH reconstruction for the Dodge's second impact indicated Total, Longitudinal and Lateral Delta-V's, respectively: 10.0 km.p.h. [6.2 m.p.h.], 0 km.p.h. [0 m.p.h.] and -10 km.p.h. [-6.2 m.p.h.].

**Figure 9:** Dodge Intrepid's right rear damage from side slap impact; note, no contact at bumper level (case photo #69)
