**CALSPAN ON-SITE ADVANCED OCCUPANT PROTECTION SYSTEM
CRASH INVESTIGATION**

CASE NO: CA02-045

VEHICLE: 2002 FORD TAURUS

CRASH DATE: OCTOBER 2002

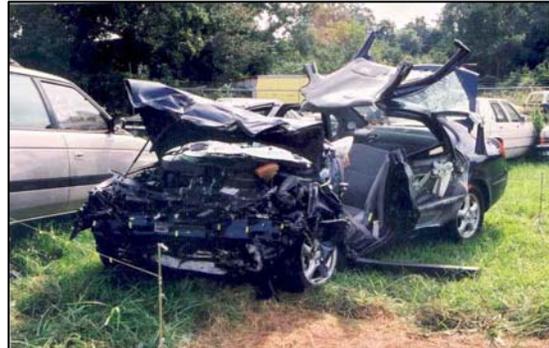
Figure 1 - Damaged 2002 Ford Taurus SE.

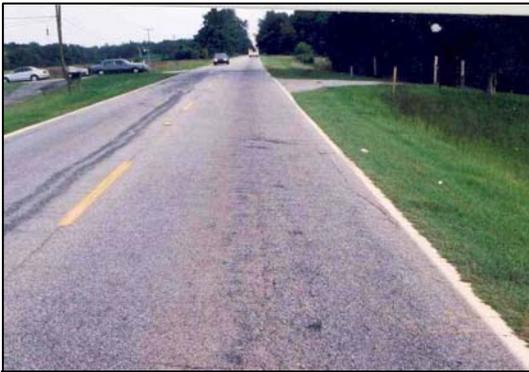
The 49-year old male driver of the 2002 Ford Taurus was traveling southbound on the unlit roadway and was initially negotiating a right curve (**Figure 2**). An unrelated vehicle was traveling in front of the Taurus. The driver of this vehicle reported seeing the Taurus's headlights in his rear view mirror for several miles while maintaining the same gap distance at a travel rate of 89 km/h (55 mph). The 1972 Dodge Challenger was traveling in the northbound direction (**Figure 3**) at a witness-reported speed of approximately 89 km/h (55 mph). The witness noticed that the Taurus left its lane of travel and entered the northbound lane after exiting a curve that was located 53 m (178') prior to the impending point of impact. The witness also reported that the Taurus swerved into the northbound lane on at least one other occasion prior to the impact. The witness tracked the vehicle's headlights for a few seconds further until he witnessed the crash. The crash scene revealed no evidence of pre-crash braking to either the on-scene investigative police agency or to the follow-up SCI investigator.

Figure 2 - Northbound approach of the 2002 Ford Taurus SE.

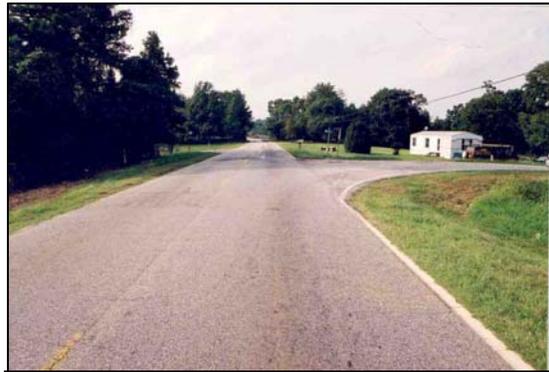
Figure 3 - Southbound approach of the 1972 Dodge Challenger.

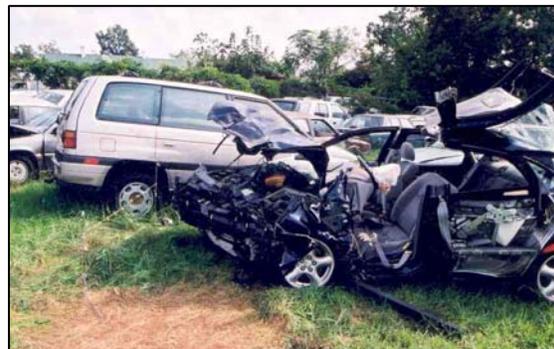
The 2002 Ford Taurus (**Figure 4**) sustained severe frontal damage as a result of the impact with the 1972 Dodge Challenger. The direct contact damage began at the left front corner and extended 135 cm (53.1") along the damage profile. The combined direct and induced damage was measured parallel to the original length of the reference line and was 88 cm (34.6) in width. The maximum crush was located at the left front bumper corner and measured 114 cm (44.9") in depth. The Collision Deformation Classification (CDC) for the impact with the Challenger was 12-FDEW-5. Six equidistant crush measurements were documented across the front bumper and were as follows: C1 = 114 cm (44.9"), C2 = 109 cm (42.9"), C3 = 104 cm (40.9"), C4 = 79 cm (31.1"), C5 = 48 cm (18.9"), C6 = 18 cm (7.9").

Figure 4 - Oblique view of damaged 2002 Ford Taurus SE.

The severe damage to the Taurus resulted in induced damage across the roof and down both side planes of the vehicle. Both left side doors were jammed closed and rescue personnel used extrication measures to mechanically remove the doors from the vehicle. The glazing in the left side windows was also shattered. The left wheelbase was compressed from its original length 64 cm (25.2"). The right side wheelbase expanded 2 cm (0.5") to 278 cm (109.4") between the axles. Due to the injuries sustained by the driver, rescue personnel used further extrication measures to cut the left and right side A- and B-pillars and then deflected the roof rearward.

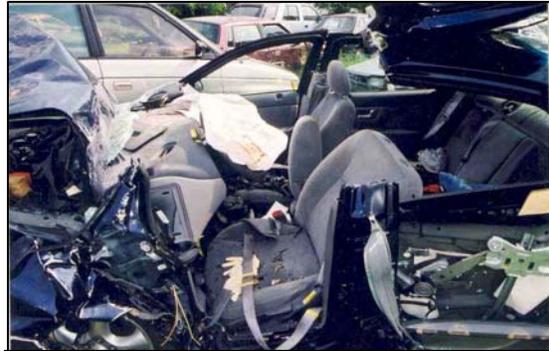
The 2002 Ford Taurus sustained moderate interior damage as a result of intrusion and occupant contact. **Figure 5** is an overall view of the first row interior of the Taurus. Longitudinal intrusions of the instrument panel, knee bolster, the right toe pan, and the steering assembly reduced occupant space. The maximum intrusion occurred to the left toe pan which intruded longitudinally 49 cm (19.3"). The windshield was cracked and it possibly intruded along with the windshield header and the left A-pillar; however, extrication measures by emergency personnel masked any definitive evidence of this.

Figure 5 - Post-crash view of the interior of the 2002 Ford Taurus.

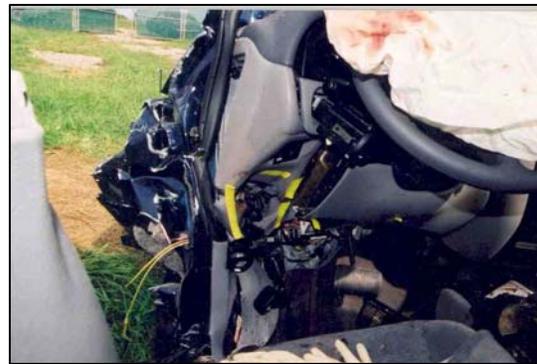
The driver of the vehicle loaded several components resulting in moderate interior damage and probable injuries. A large contact point was identified on the left instrument panel in the area of the driver's left knee (**Figure 6**). Horizontally, the contact point began 60 cm (23.5") left of the vehicle's centerline and extended to the left for 13 cm (5"). Vertically, it began 32 cm (12.5") below the top aspect of the brow and extended downward 18 cm (7.25"). The driver's left knee penetrated the instrument panel housing to a depth of 1 cm (0.25"). The component revealed hair, tissue, and blood transfers embedded within the cracked panel. The emergency brake pedal located on the left aspect of the floor pan was loaded and rotated clockwise approximately 90 degrees. This probably occurred as a result of the driver's left lower extremity being in close proximity to the component as intrusion directed the toe pan rearward into the occupant space. The emergency brake release lever was also contacted and cracked due to occupant loading.

Figure 6 - Area of knee contact on instrument panel/knee bolster.

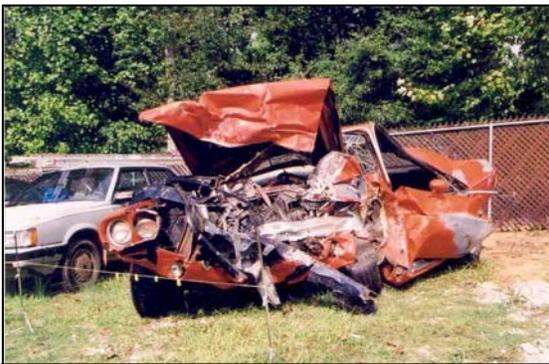
The 1972 Dodge Challenger sustained severe damage as a result of the impact with the 2002 Ford Taurus (**Figures 7 and 8**). The direct contact damage encompassed the entire front end of the vehicle and measured 131 cm (51.6”) in width. The combined direct and induced damage was documented along the compressed bumper beam and measured 51 cm in length. The maximum crush was located at the vehicle’s front left corner and measured 177 cm (69.7”) in depth. Both frontal frame rails shifted to the left and the incremented CDC for the impact with the Taurus was 92-FDEW-6. Due to the compressed bumper beam, only four equidistant measurements were documented and were as follows: C1 = 177 cm (69.7”), C2 = 158 cm (62.2”), C3 = 130 (51.1”), C4 = 54 cm (21.3”).

Figure 7 - Frontal view of the damaged 1972 Dodge Challenger.

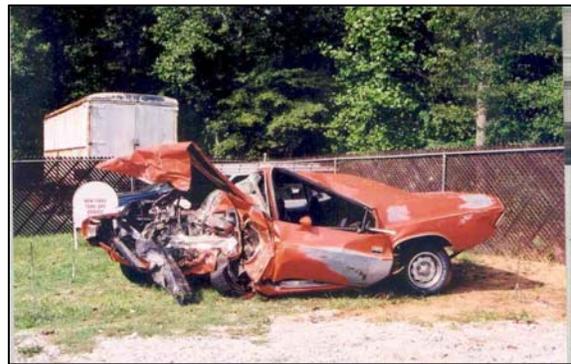
Figure 8 - Left side view of the damaged 1972 Dodge Challenger.

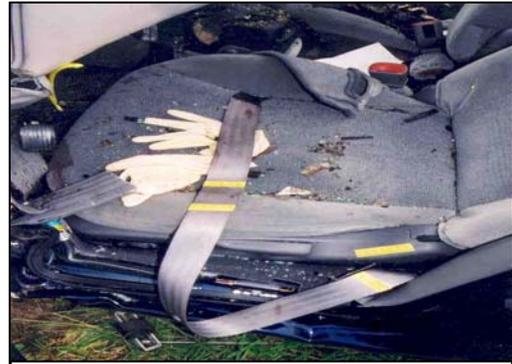
Loading evidence in the form of an abrasion was present on the driver's lap belt webbing with a correlative transfers present on the plastic trim at the left outboard aspect of the seat cushion trim. The full width belt abrasion was documented on the inside aspect of the lap belt and was located 4 – 6 cm (2 – 2.5") above the vinyl anchorage sleeve. The correlative abrasion on the seat cushion trim was 5 cm in length and 1 cm (0.4") in width. A separate 5 cm (2") abrasion consistent with latch plate loading was present on the shoulder belt

Figure 9 - Safety belt system in the 2002 Ford Taurus.

webbing. It began 65 cm (25.5") above the top of belt anchor. Additionally, vertical striations were present on the webbing just below the cut position of the shoulder belt. The cut position on the belt and striations were located 98 cm (38.5") above the seat belt anchor sleeve. **Figure 9** is an overall view of the damaged restraint system.

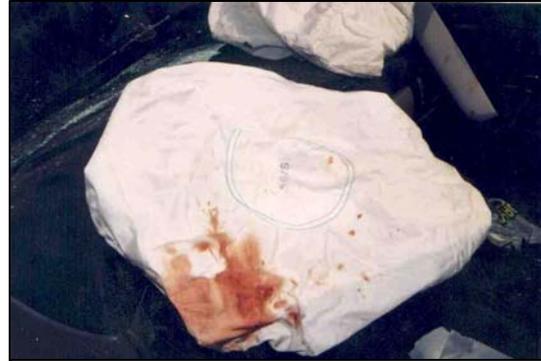
The driver's air bag (**Figure 10**) deployed from the center of the steering wheel hub through H-configuration trapezoidal cover flaps. The top flap measured 17 cm (6.7") horizontally and 8 cm (3.1") vertically. The upper aspect of the lower flap measured 17 cm (6.7") horizontally and the bottom aspect tapered in to a horizontal width of 11 cm (4.3"). The lower flap was 5 cm (2") in height. The air bag measured 56 cm (22") in diameter in its deflated state. The air bag contained two 11 cm (4.5") wide tether straps at the 12 and 6 o'clock positions of the air bag. The bag was vented by two 3 cm (1.125") diameter ports located at the 11:30 and 12:30 positions on the back of the bag. A blood transfer was concentrated on the lower left aspect of the deployed air bag at the 8 o'clock position. No additional occupant loading evidence was identified. The following nomenclature was stamped on the back of the air bag:

Figure 10 - Deployed driver's air bag.

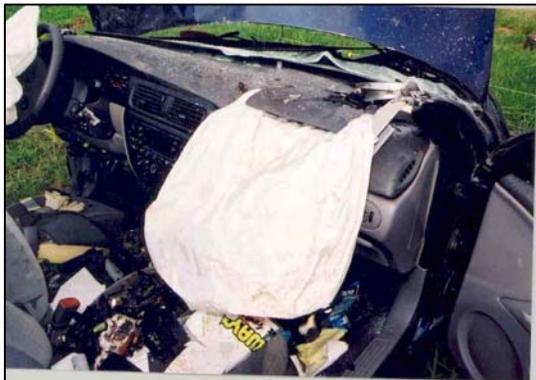
The front right passenger's air bag (**Figure 11**) deployed from a top-mount module located on the right instrument panel with a single cover flap design. The rectangular cover flap measured 27 cm (10.9") horizontally and 14 cm (5.5") vertically. The front right air bag measured 48 cm (18.9") horizontally and 56 cm (22") vertically in its deflated state. The air bag was not tethered and had no vent ports. There was no occupant contact evidence on the front right air bag.

Figure 11 - Deployed front right air bag.

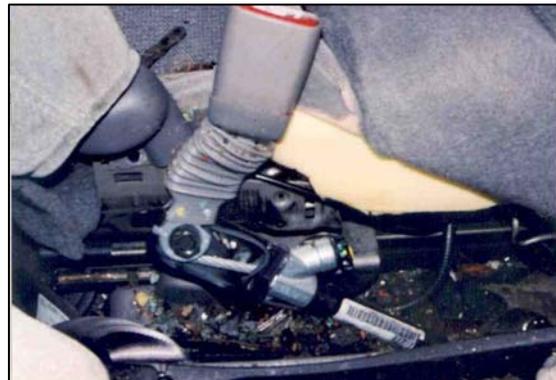
The front safety belts were equipped with buckle pretensioners designed to fire in conjunction with the frontal air bag system in frontal impacts. The driver's buckle pretensioner fired with the deployment of the air bag system (**Figure 12**). The stalk from the buckle's anchor point to the top aspect of the buckle compressed approximately 5 cm (2"). The driver's pretensioner rotated into the floor pan and prevented access to measure the barrel length. The front right seating position was not occupied during the crash; therefore, the front right buckle pretensioner did not fire.

Figure 12 - Driver's pretensioner post-crash.
