**TRANSPORTATION SCIENCES
CRASH DATA RESEARCH CENTER**

SCI TECHNICAL SUMMARY REPORT

NASS/SCI COMBO CASE NO. 03-12-136G

VEHICLE – 2003 CHEVROLET SILVERADO

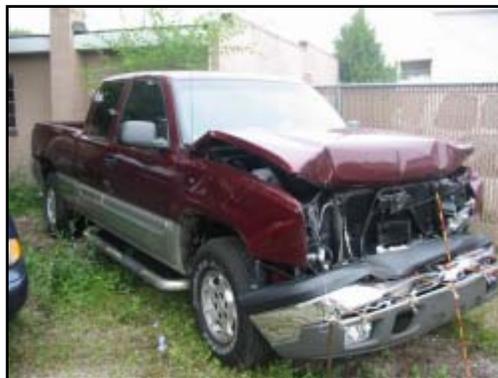
Figure 1. 2003 Chevrolet Silverado.

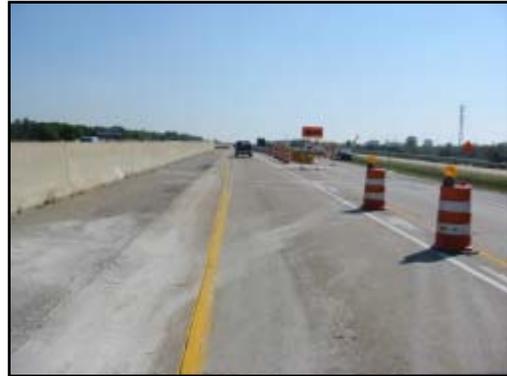
This three-vehicle front-to-rear type collision occurred during the morning hours of August 2003 in the state of Michigan. At the time of the crash, there were no adverse weather conditions and the concrete road surface was dry. The concrete roadway was under construction at the time of the collision (**Figure 2**). The crash occurred on the eastbound lane of an east/west interstate roadway that was divided by a concrete Jersey barrier. The eastbound roadway was configured with one lane for through traffic. The eastbound lane was bordered with a yellow fog line and a concrete shoulder on the north edge. A yellow fog line with construction cones marked the south edge of the roadway. The posted speed limit for the eastbound construction zone was 72 km/h (45 mph).

Figure 2. Crash site.

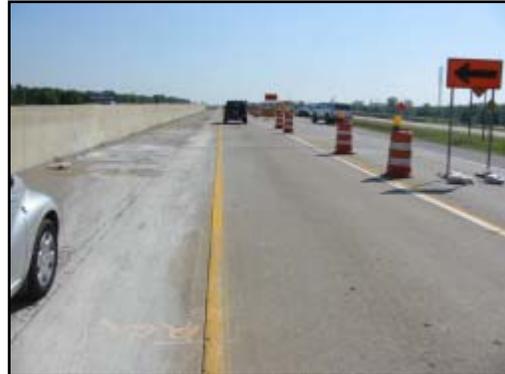
The full frontal aspect of the 2003 Chevrolet impacted (SV) the full rear aspect of the 2000 Chevrolet in a 12/6 o'clock impact configuration (**Figure 3**). The 2000 Chevrolet was subsequently displaced forward by the rear impact. The frontal aspect of the 2000 Chevrolet impacted the rear aspect of the stopped 2003 Chevrolet in a subsequent 12/6 o'clock impact configuration. The impact resulted in moderate severity damage to the front aspect of the 2003 Chevrolet (SV) and was sufficient to deploy the driver's frontal air bag. The WINSMASH program was used to calculate the delta V for this impact. The total delta V for the 2003 Chevrolet (SV) was 27.0 km/h (16.7 mph). The longitudinal and lateral components were -27.0 (16.7 mph) and 0.0 respectively. The total delta V for the 2000 Chevrolet was 25.0 km/h (15.5 mph). The longitudinal and lateral components were 25.0 (15.5 mph) and 0.0 respectively. The 2003 Chevrolet's (SV) EDR recorded a maximum delta V of -19.0 km/h (-11.8 mph) at 170 milliseconds.

Figure 3. Area of impact.

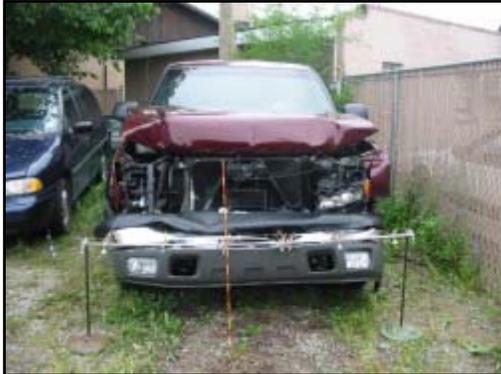
The 2003 Chevrolet Silverado sustained moderate severity frontal damage as a result of the rear-end collision with the 2000 Chevrolet (**Figure 4 and 5**). The direct contact damage width was 168.0 cm (66.1”) and extended from bumper corner-to-bumper corner. The damage consisted of a longitudinally displaced front bumper, hood, left and right front fenders. The damage also consisted of disintegrated front left and front right headlights and grille. The maximum crush was located 5.0 cm left of crush measurement three. Six crush measurements were documented along the front bumper using a combined direct and induced damage width of 168.0 cm (66.1”) and were as follows:

C1= 11.0 cm (4.3") C2= 21.0 cm (8.3") C3= 29.0 cm (11.4") C4= 20.0 cm (7.9") C5= 14.0 cm (5.5") C6= 5.0 cm (2.0"). The Collision Deformation Classification for the frontal impact with the 2000 Chevrolet was 12-FDEW-2. The four doors remained closed and operational. The windshield was fractured on the left edge at the A-pillar from contact with the hood edge. The remainder of the glazing was not damaged.

Figure 4. Damage profile of the 2003 Chevrolet Silverado (SV).

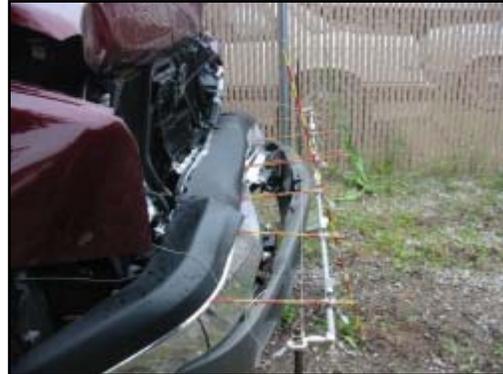
Figure 5. Lateral view of the rush profile of the SV.

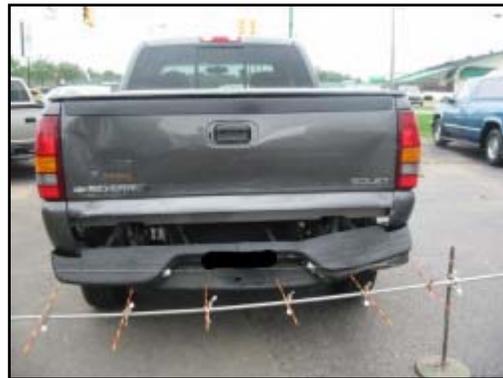
The 2000 Chevrolet Silverado sustained moderate severity rear damage (**Figure 6**) as result of the impact with the 2003 Chevrolet. The damage consisted of a longitudinally and vertically displaced bumper and deformed rear tailgate. The direct contact damage width was 169.0 cm (66.5") and extended from bumper corner-to-bumper corner. Maximum crush was located at crush measurement three. Six crush measurements were documented along the rear bumper using a combined direct and induced damage width of 178.0 cm (70.1") and were as follows: C1= 22.0 cm (8.6"), C2 =21.0 cm (8.3), C3= 29.0 cm (11.4"), C4= 27.0 cm (10.6"), C5= 17.0 cm (6.7"), C6= 21.0 cm (8.3"). The Collision Deformation Classification for this impact was 06-BDEW-2. The doors remained closed and operational and all glazing remained intact.

Figure 6. Rear damage to 2000 Chevrolet Silverado.

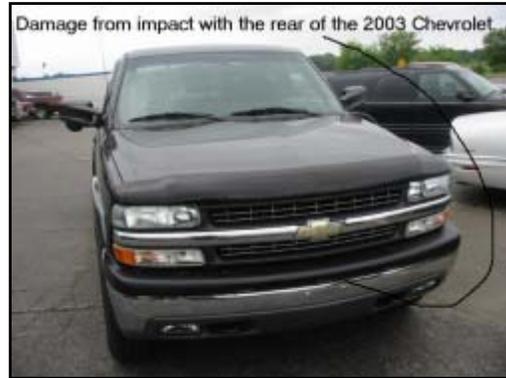
A secondary impact was documented to the front of the Chevrolet from the impact with the rear of the stopped 2003 Chevrolet. The damage consisted of a 3.0 cm gouge on the plastic molding (**Figure 7**) of the front bumper that was located 87.0 cm (34.3”) right of the front left bumper corner. The Collision Deformation Classification for this impact was 12-FCEN-1.

Figure 7. Damage to 2000 Chevrolet Silverado from 2nd event minor gouge on plastic bumper molding,

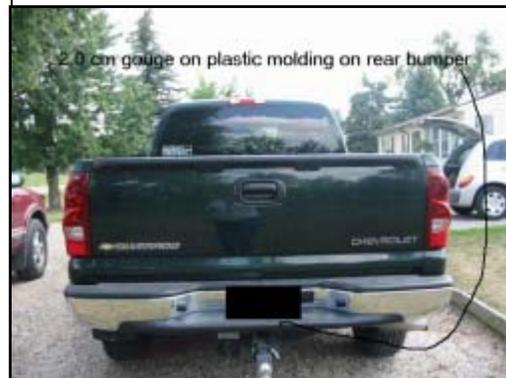
The 2003 Chevrolet Silverado sustained minor severity rear damage (**Figure 8**) as result of the impact with the 2000 Chevrolet. The damage consisted of a 2.0 cm (0.8”) gouge in plastic molding on the front bumper that was located 86.0 cm (33.8”) right of the rear left bumper corner. The Collision Deformation Classification for this impact was 06-BCLN-1.

Figure 8. Damage to rear of 2003 Chevrolet Silverado.

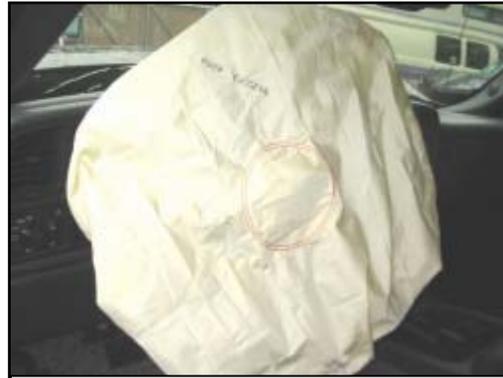
The driver's frontal air bag was located in the steering wheel hub. The air bag contained two symmetrical "I" configuration cover flaps that measured 11.0 cm (4.3") in height and 8.0 cm (3.1") in width. The air bag was 61.0 cm (24.0") in diameter (**Figure 8**) and contained four tethers and was vented by two vent ports on the rear aspect of the air bag at the 11 and 1 o'clock positions. The front right air bag was located on the center of the right front instrument panel. The front right air bag did not deploy in this crash.

Figure 4. Deployed driver's frontal air bag.
