SCI/NASS COMBINATION CERTIFIED ADVANCED 208-COMPLIANT VEHICLE INVESTIGATION

CASE NUMBER - NASS-2003-50-042C
LOCATION - Texas
VEHICLE - 2003 Chevrolet Silverado C1500
CRASH DATE - June 2003

Submitted:
March 17, 2004
Revised:
November 1, 2006

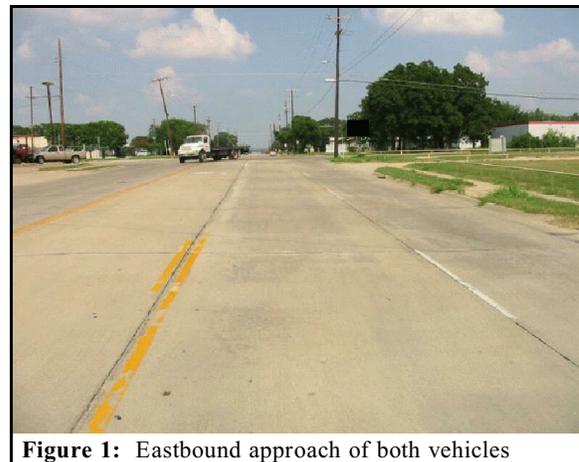
The case vehicle was traveling east in the inside eastbound through lane of a five-lane, undivided, city roadway, approaching a four-leg intersection with no controls for east-west traffic, and intended to continue east (i.e., there were two through lanes in each direction and a center left turn lane). The Peterbilt tractor-trailer rig was also traveling east, ahead of the case vehicle and at a slower speed, in the inside eastbound through lane of the same city roadway, approaching the same intersection, and intended to continue east. The weather was clear, it was dark but lighted and the straight, level concrete road surface was dry and without defects (**Figure 1**). The police crash report indicates that the case vehicle was traveling at high speed and that alcohol use by the case vehicle's driver was a contributing factor in this crash. The case vehicle driver did not attempt any avoidance maneuvers prior to the crash. The crash occurred in the inside, eastbound lane of the roadway.

Figure 1: Eastbound approach of both vehicles

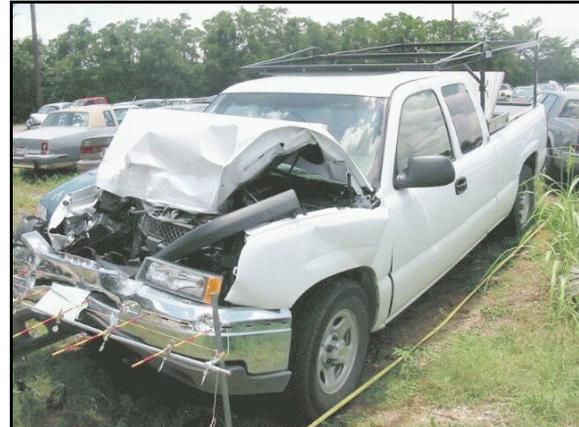
The case vehicle sustained heavy direct contact damage across the entire front (**Figures 2 and 3**). The residual damage exhibited the features of a classic heavy truck rear underride impact, with maximum bumper-level crush 12 centimeters [4.7 inches] and maximum above-bumper crush 39 centimeters [15.4 inches], both at the right headlight area. The tractor-trailer rig was not inspected and the configuration of the trailer's back surface is not known, but the imprint of an underride guard can be readily seen in the case vehicle's above-bumper crush pocket (**Figure 4**). It appears that the trailer's underride guard engaged the case vehicle's engine block and the rear of the case vehicle probably pitched upward during maximum penetration. The case vehicle's frame rails forward of the front axle were bent upward as a result of the pitching as the case vehicle's front was wedged under the back of the trailer's cargo bed (**Figures 2 and 3**). The bumper sustained direct contact across its entire width except the extreme left-most area and was crushed rearward, more heavily on the right. The grille and right headlamp assembly were shattered and broken away, with the left headlamp intact but displaced. The leading edge of the hood, the radiator support bracket and the top of the radiator were crushed rearward against the engine block. The hood was buckled nearly double and the trailing edge of the hood was forced rearward, causing heavy cracking of the windshield glazing across the entire width. There was no other glazing damage. The leading edge of the right fender

Figure 2: Case vehicle's front and left side; note, direct contact heavier on right

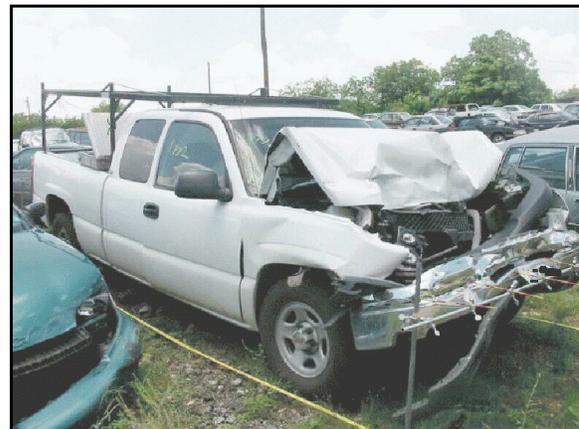
Figure 3: Case vehicle's front and right side; note, front frame rails shifted upward

The CDC for the case vehicle's single impact was determined to be **32-FDEW-2 (0)**, indicating a 12 o'clock direction of force incremented by + 20 to reflect upward shifting of the frame rail ends in the front. Maximum crush was 39 centimeters [15.4 inches] at C5 on the leading edge of the hood. This crash is out of scope for the WinSMASH reconstruction program (heavy truck impact). The case vehicle's barrier equivalent speed (BES) was calculated based on the case vehicle's crush profile using the crush averaging technique, indicating BES = 25 km.p.h. [15.5 m.p.h.], which seems reasonable but slightly low. This contractor judges that the crash severity for the case vehicle was moderate (24-40 km.p.h. [15-25 m.p.h.]).

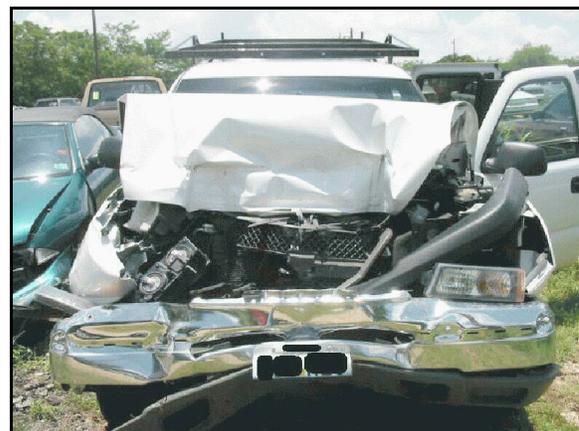
Figure 4: Case vehicle's front straight on; note imprint of underride guard in hood

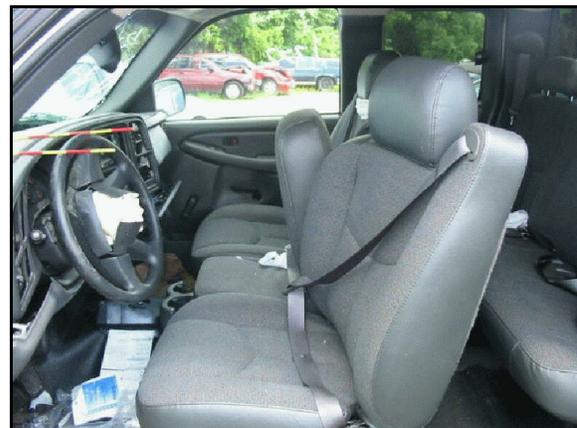
Inspection of the case vehicle's interior revealed numerous areas of intrusion and evidence of occupant contact. The driver's knee bolster intruded 16 centimeters [6.3 inches] longitudinally. The instrument panel intruded longitudinally 15 centimeters [6.0 inches] on the right, 7 centimeters [2.8 inches] in the center and 5 centimeters [2.0 inches] on the left. The right rear corner of the hood broke through the windshield and intruded 3 centimeters [1.2 inches] at the base of the right upper A-pillar. In addition, the rear seat occupant impacted the back of the front seat, causing deformation of the seat back and back-to-front intrusion by the front seat back into the front seat area (**Figure 5**), 15 centimeters [6.0 inches] at the center and 11 centimeters [4.3 inches] at the left. The top left

Figure 5: Case vehicle's front seat row viewed from left; note, seat back bent forward and steering wheel rim deformed

portion of the steering wheel rim was bent forward 13 centimeters [5.1 inches], due to contact by the driver's chest, and the steering column tilt mechanism was broken (**Figure 5**). The driver's head impacted the left sunvisor, leaving a skin and blood transfer. The front right passenger's knees impacted the glove box door, leaving scuff marks.

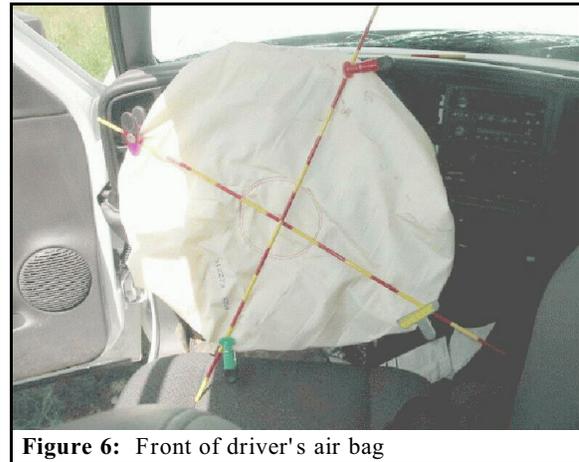
Figure 6: Front of driver's air bag

The driver's air bag was located in the steering wheel hub with the cover flaps in the I-configuration. Each cover flap measured 12 centimeters [4.7 inches] vertically and 7 centimeters [2.8 inches] horizontally. The cover flaps opened at the tear points and there was no evidence of damage to the cover flaps or the adjacent structures. The deployed driver's air bag was round with a diameter of 58 centimeters [22.8 inches] (**Figure 6**). There were two tether straps stitched near the center and two vent ports of unknown diameter on the back, at the 11 and 1 o'clock positions. There was mud smeared on the front of the air bag, but this probably occurred later when the case vehicle was being prepared for towing. There was a small amount of blood smeared on the back of the driver's air bag, near the top. There was no evidence of damage to the air bag.

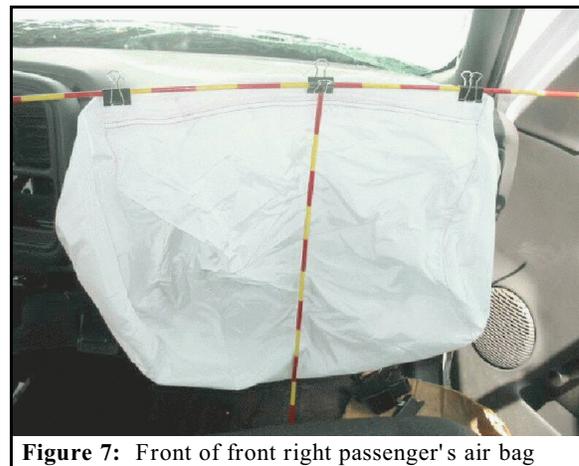
Figure 7: Front of front right passenger's air bag

The front right passenger's air bag was located in the mid-instrument panel position with a single cover flap hinged at the top. The cover flap measured 39 centimeters [15.3 inches] horizontally and 15 centimeters [5.9 inches] vertically. The cover flap opened at the tear points and there was no evidence of damage to the cover flap or the adjacent structures. The deployed passenger's air bag was rectangular, measuring 45 centimeters [17.7 inches] horizontally and 50 centimeters [19.7 inches] vertically (**Figure 7**). There was a single tether strap stitched across the entire width near the front-top, and two vent ports of unknown diameter near the center on the side panels. There was a single droplet of blood on the left side near the bottom edge and no other evidence of contact. There was no evidence of damage to the passenger's air bag.

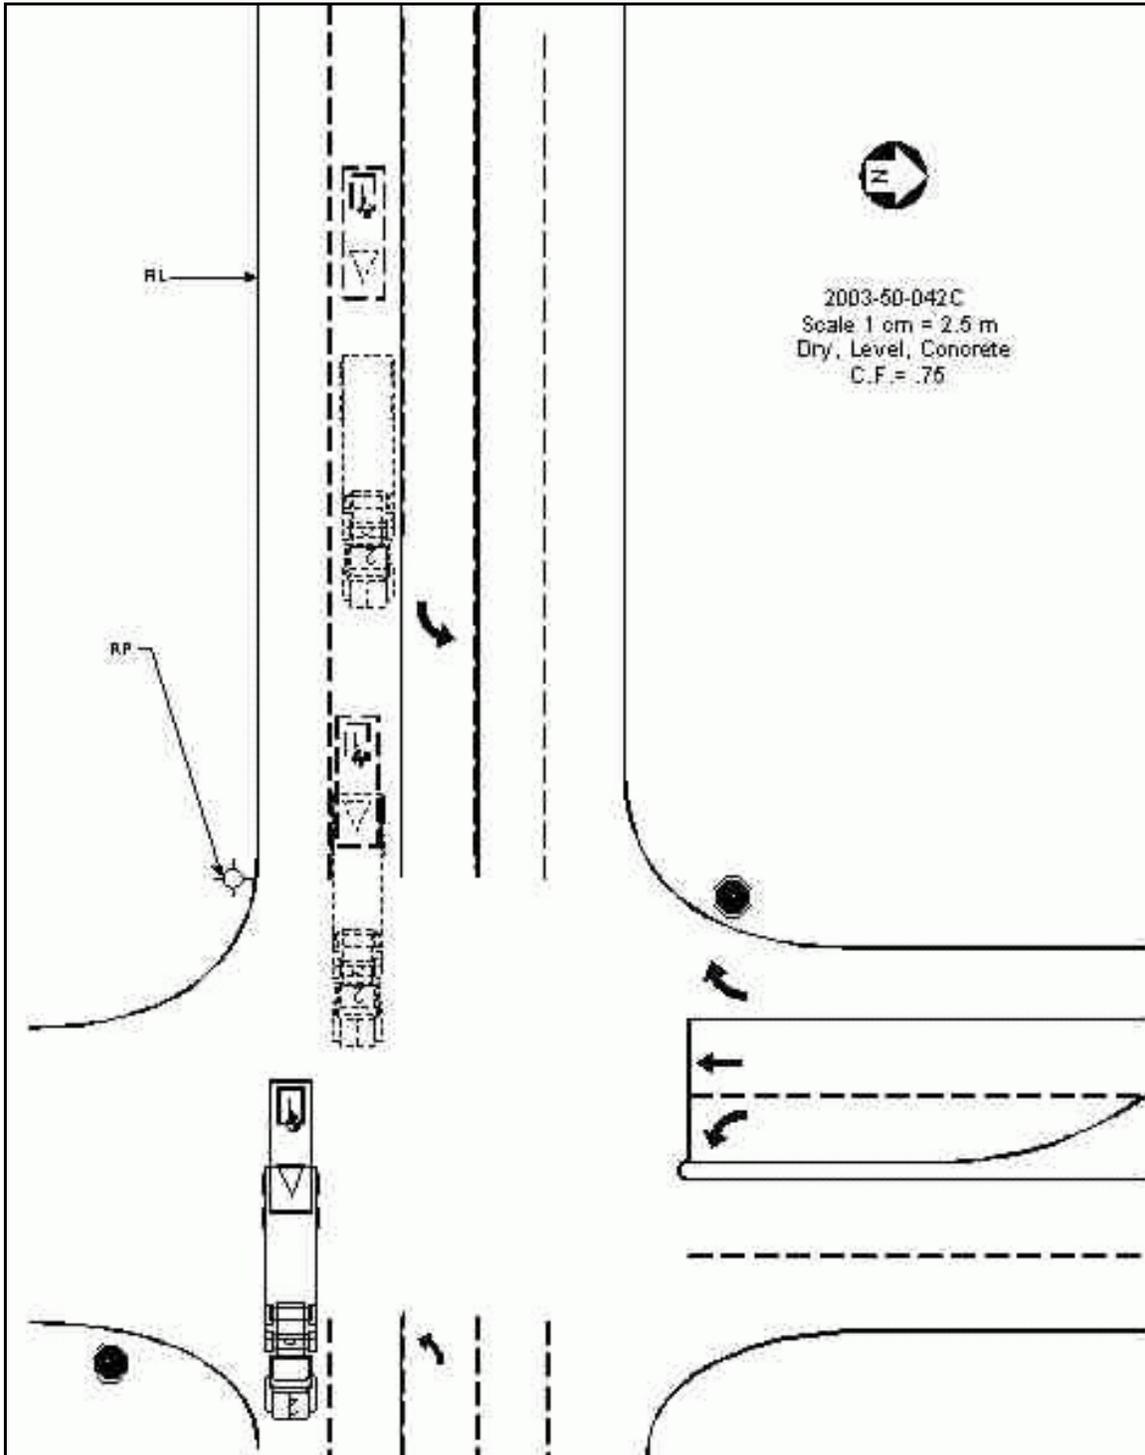
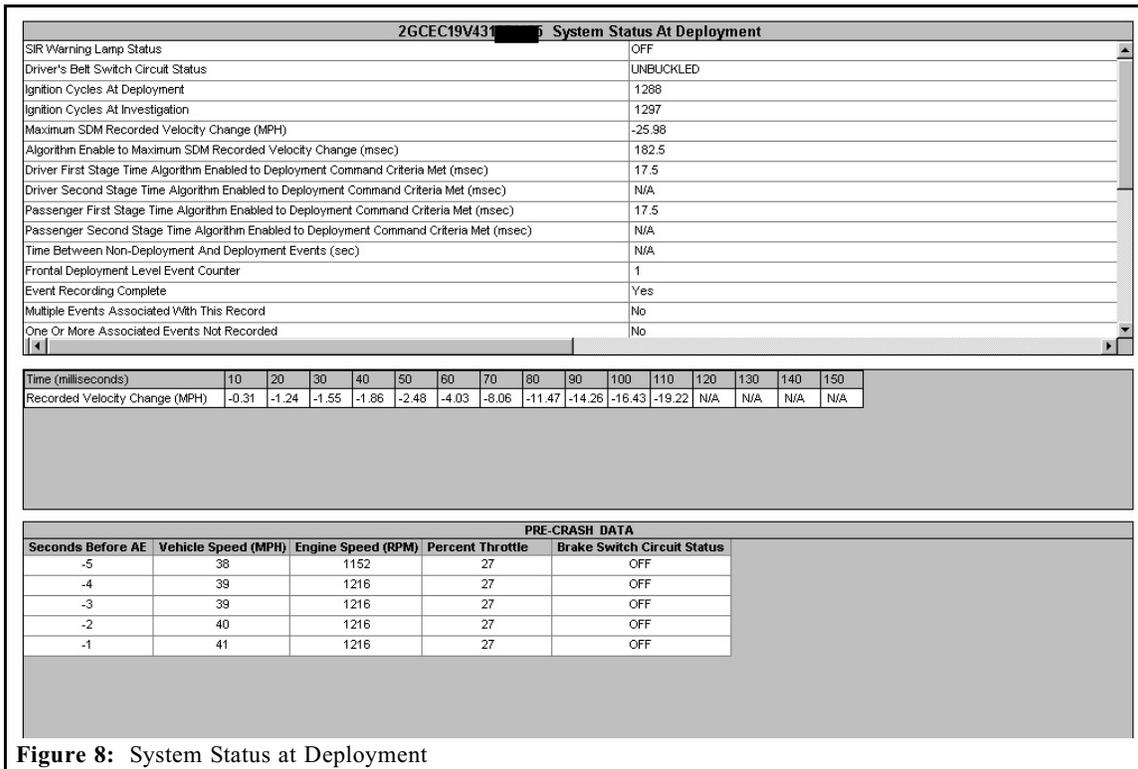
Figure 8: System Status at Deployment

The SDM System Status reports for the deployment (**Figure 8**) and the non-deployment (**Figure 11**) events show that the SIR Warning Lamp was OFF, indicating no faults in the air bag system, and the driver's seat belt was not buckled. The events were recorded during ignition cycle 1,288 and the download was accomplished on ignition cycle 1,297. The deployment event System Status report (**Figure 8**) shows that there was not a non-deployment event prior to the deployment event (Time Between Deployment and Non-Deployment Events = N/A), which indicates that the non-deployment event recording is an artifact of the single impact, probably reflecting the prolonged duration of the crash pulse as the case vehicle first impacted the underride guard and then penetrated beneath the semi-trailer. The non-deployment event is not discussed further.

The SDM System Status report for the deployment event (**Figure 8**) and the associated Pre-Crash Graph (**Figure 9**) show that the case vehicle was traveling 61 km.p.h. [38 m.p.h.] at five seconds prior to algorithm enable (AE) and its speed increased over the five second interval to 66 km.p.h. [41 m.p.h.] at one second prior to AE. The case vehicle driver did not apply the brakes during the recorded interval and the throttle remained constant at 27 percent. First stage deployment of the driver and front right passenger air bags was commanded at 17.5 milliseconds [0.0175 seconds] after AE. The threshold for second stage deployment was not reached. The maximum longitudinal velocity change was recorded as -41.8 km.p.h. [-25.98 m.p.h.] at 182.5 milliseconds [0.1825 seconds] after AE. The velocity change data (**Figure 8**) and the associated graph (**Figure 10**) show gradual deceleration to -4.0 km.p.h. [-2.48 m.p.h.] at 50 milliseconds [0.050 seconds] after AE, followed by rapid deceleration to -30.9 km.p.h. [-19.22 m.p.h.] at 110 milliseconds [0.110 seconds] after AE when the SDM stopped recording.

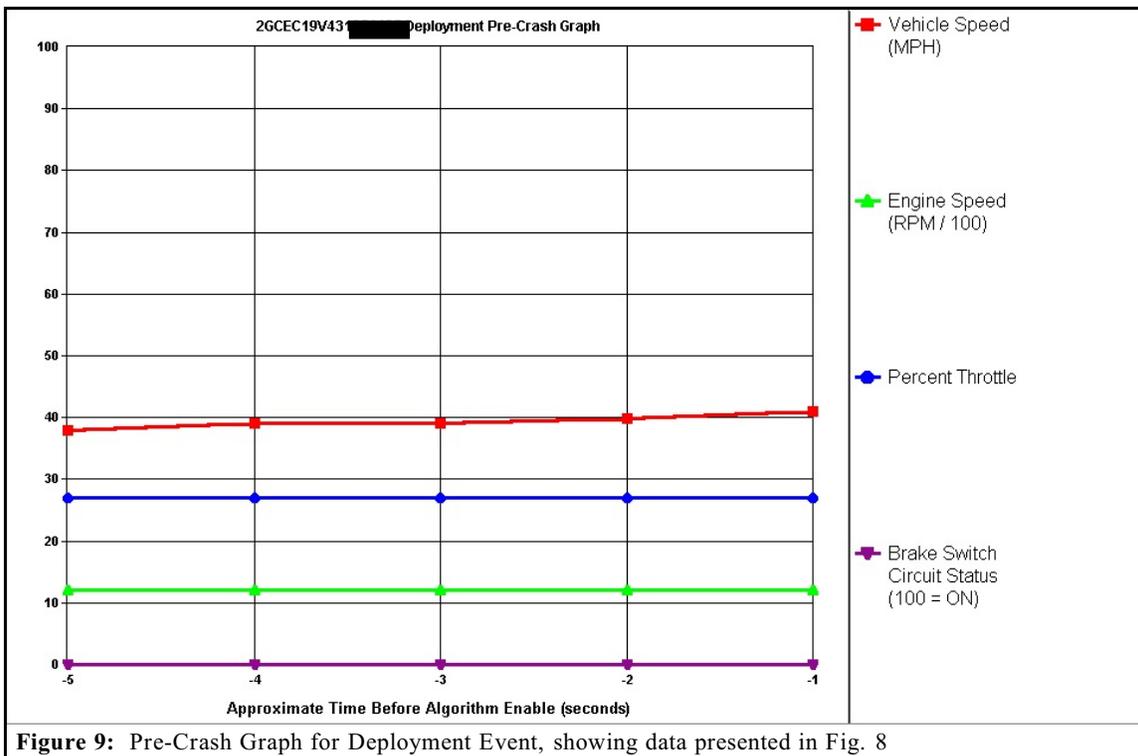
Figure 9: Pre-Crash Graph for Deployment Event, showing data presented in Fig. 8

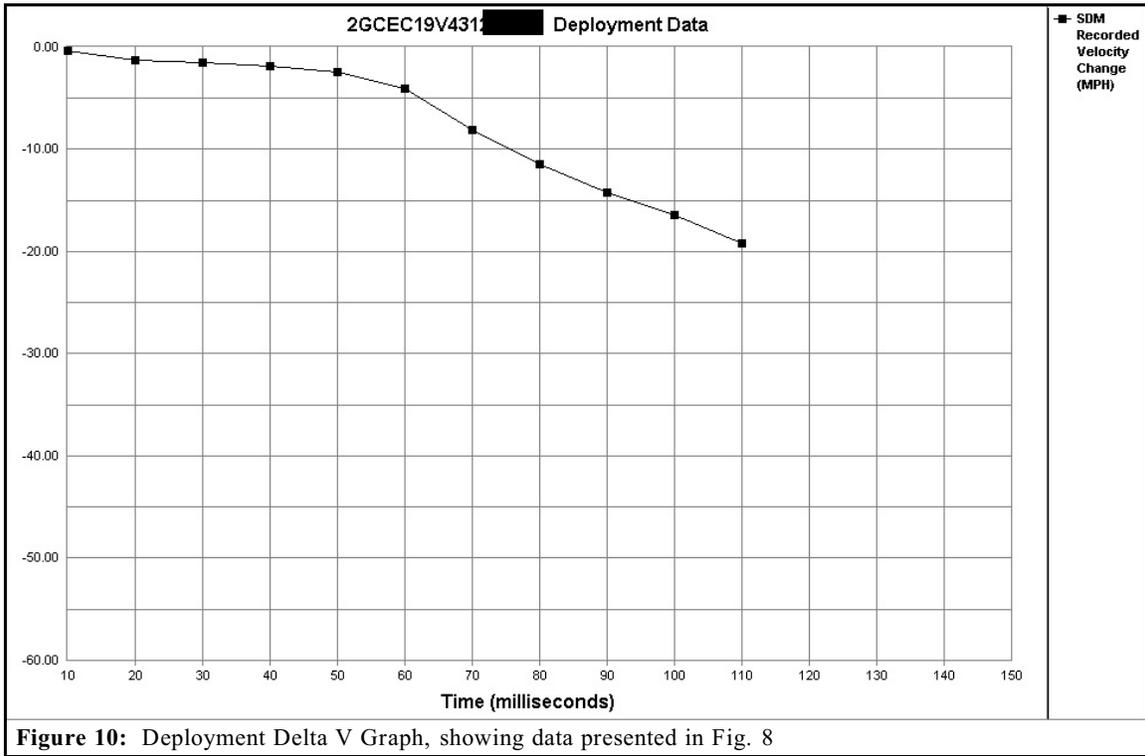
Figure 10: Deployment Delta V Graph, showing data presented in Fig. 8

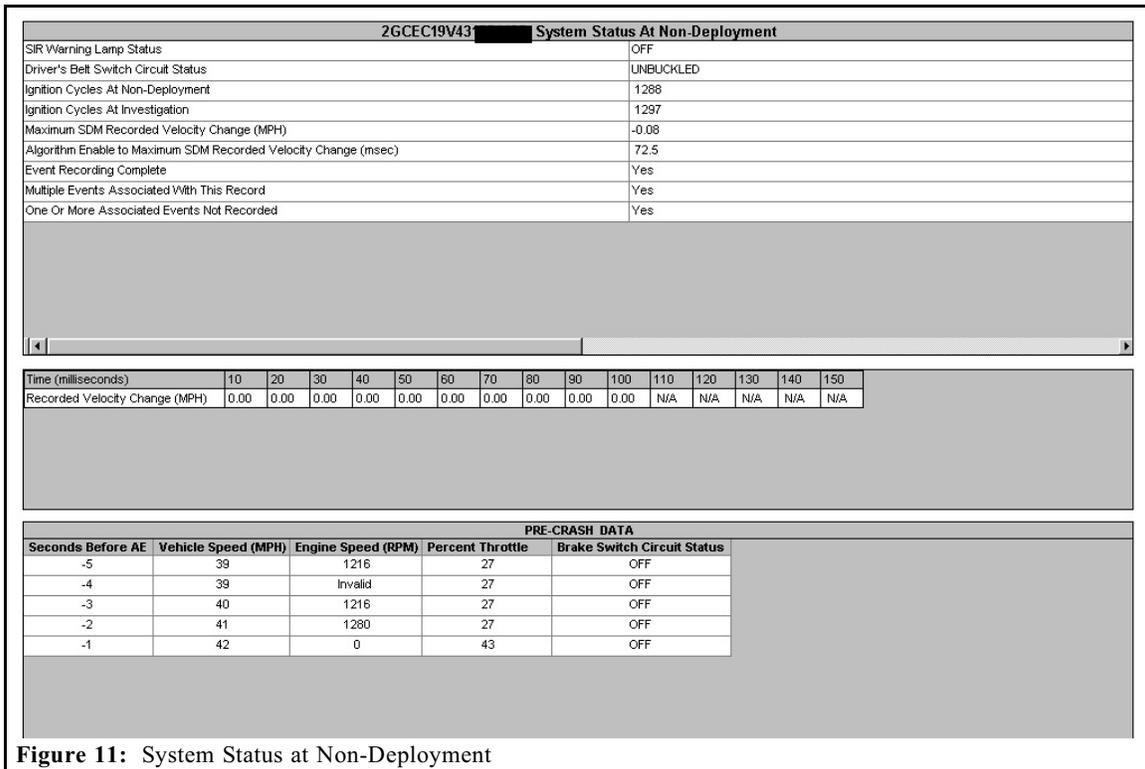
Figure 11: System Status at Non-Deployment
