Advanced Occupant Protection Systems Investigation / Single Vehicle Rollover
Dynamic Science, Inc. / Case Number: DS03003
2003 BMW M3
Washington
December 2002

1. Report No. DS03003		2. Government Accession No.		3. Recipient Catalog No.	
4. Title and Subtitle Advanced Occupant Protection Systems Investigation / Single Vehicle Rollover				5. Report Date

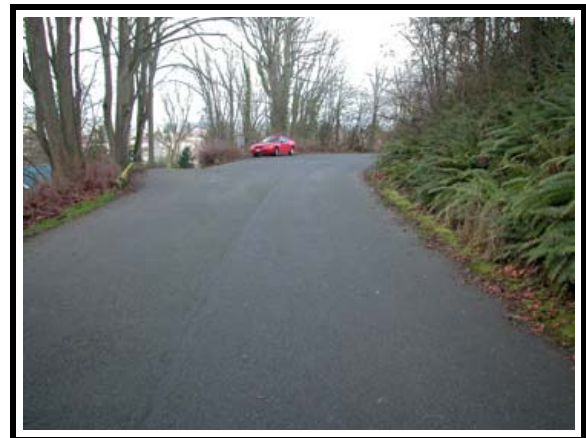
Figure 1. Initial travel path and approach to curve (east)

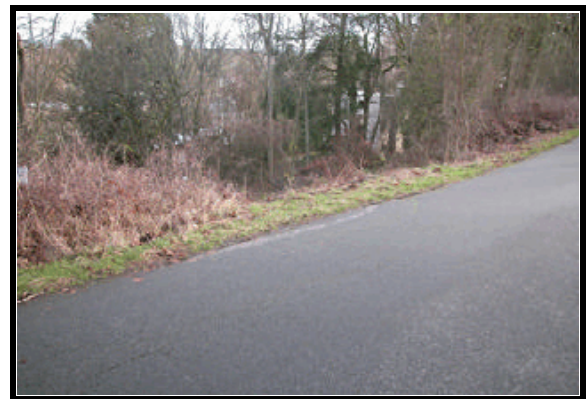
Figure 2. View showing area of case vehicle east roadside departure

The front right seated occupant is a car sales person and the vehicle was being test driven for the purpose of a potential sale. The driver of the case vehicle was initially traveling east at a reported speed of 32-40 km/h (20-25 mph) and was negotiating a series of curves. The case vehicle entered a hairpin, right curve with a radius of 24 m (72 ft) and a critical speed of 35.35 km/h (21.97 mph). The driver applied the brakes which initiated a driver loss of control. In an effort to correct the loss of control, the driver probably applied several counter-steering applications. The case vehicle traversed the opposing travel lane while rotating in counterclockwise fashion before departing the east roadside.

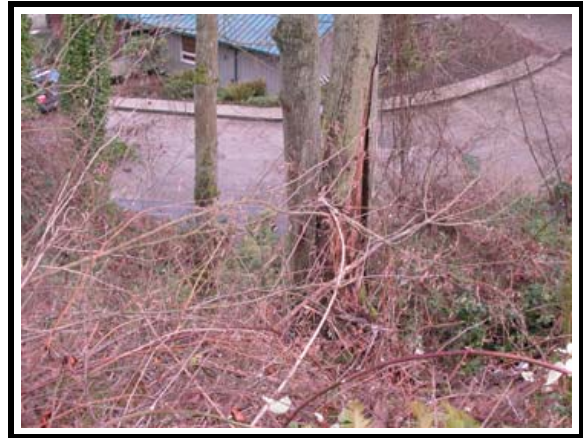
Figure 3. Area of final rest (east)

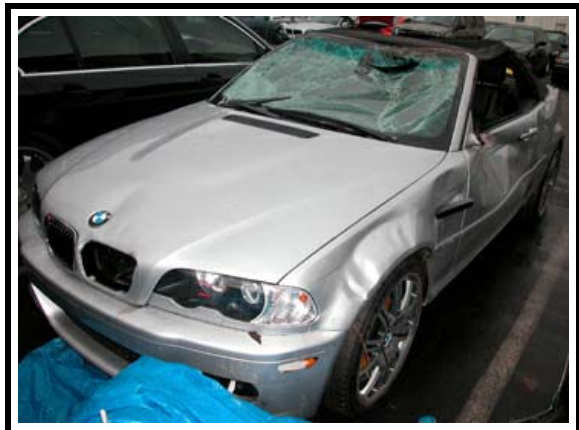
Figure 4. Exterior left side damage to case vehicle

Damage Description: Moderate/ Primary Rollover Collision (Highest delta V):
 Pocket sheet metal deformation noted to the right quarter panel area, hood top surface and entire left side plane. Rollover damage associated to the windshield resulting in a hole to the laminated glazing. Vertical displacement to the windshield header, and convertible top cover. Tempered side glazing and backlight glazing disintegrated due to the impact forces. Rear fascia completely separated exposing underlying rear bumper bar.

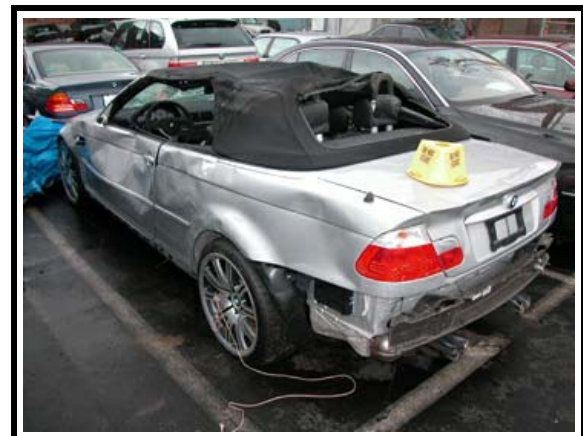
The case vehicle was leading with its right side as it traveled a short distance down the -45% embankment grade before initiating a rollover sequence. The case vehicle rolled six quarter turns coming to rest on its soft, convertible roof top (00TDDO3). Upon the initial leading right side rollover sequence, the rollover protection system activated, and the dual rear roll bars which were integrated into the head restraints, deployed. The case vehicle slid down the -45% embankment for approximately 24 m (80 ft) while on its roof. The case vehicle slid into a tree with its frontal plane (00FDEW1) as it came to rest on its top and facing east. The case vehicle sustained significant rollover related deformation with damage documented to all of its planes. The integrity of the case vehicle was greatly compromised as the front windshield was holed, and the side glazing and backlight disintegrated due to the impact forces. There were numerous intrusions with the leading intruding component involving 11 cm (4 in) of vertical intrusion to the roof top immediately behind the front seats. The front A-pillars were not vertically displaced, but there was damage noted to the windshield header area. The vehicle was towed from the crash location, however, the engine would start and technically was driveable. The case vehicle was subsequently declared a total loss by the insurance company.

Figure 5. Exterior damage to case vehicle

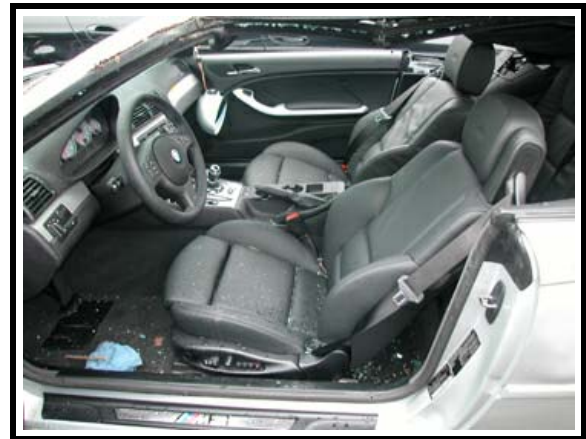
The integrity of the case vehicle was greatly compromised as all side glazing disintegrated, the laminated windshield glazing was holed and the tempered backlight glazing disintegrated due to the rollover impact forces. The left and right doors remained closed and operational and the restrained driver and front right passenger remained inside of the vehicle as the case vehicle came to rest. The convertible soft top roof crushed vertically downward and intruded into the greenhouse area approximately 11.0 cm (4.3 in). The interior was void of occupant contacts which is consistent with no reported injuries. Both advanced, dual stage/dual threshold frontal air bag units were non-deployed as a result of the non-horizontal rollover force and the minor (non-horizontal) frontal tree impact. The front bucket seats were undamaged in the crash sequence.

Figure 6. Case vehicle-driver's area

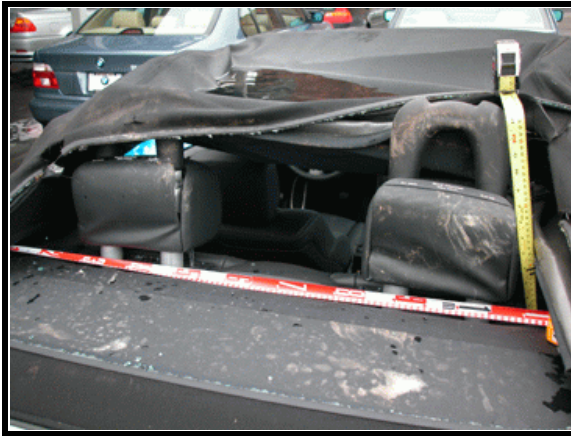
The second row consists of a split bench seat with separate seatback cushions. The rear seat accommodates two passengers at the outboard positions. There was obvious contact evidence noted to both roll bars of the Rollover Protection System.

- The BMW Rollover Protection System deployed both roll bars in the rear head restraints. The system is comprised of *“two recessed aluminum bars fitted behind the rear-seat headrests and pre-tensioned by powerful springs. When the angle of the vehicle changes and exceeds a certain point, the bars instantaneously move up by a maximum of 27 cm (11 in) and then are held back by a dampened mechanism just in front of the soft roof or hardtop. The pop-up roll-bars fully deploy in 110 milliseconds. They remain securely in position for optimal safety. The windscreen columns are strong enough to support the entire weight of the car”*².

Figure 7. Deployed roll bars

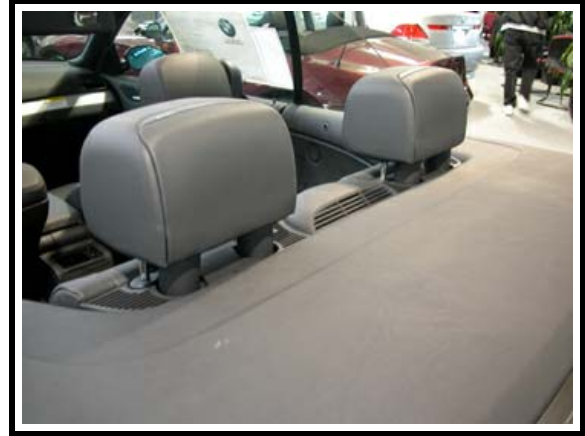
Figure 8. Exemplar non-deployed roll bars
