**GENERAL DYNAMICS ON-SITE CHILD SAFETY SEAT CRASH INVESTIGATION  
SCI TECHNICAL SUMMARY REPORT**

**CASE NO. CA03-007**

**VEHICLES – 1993 DODGE CARAVAN / 1997 FORD F-150 PICKUP TRUCK**

**CRASH DATE – JANUARY 2003**

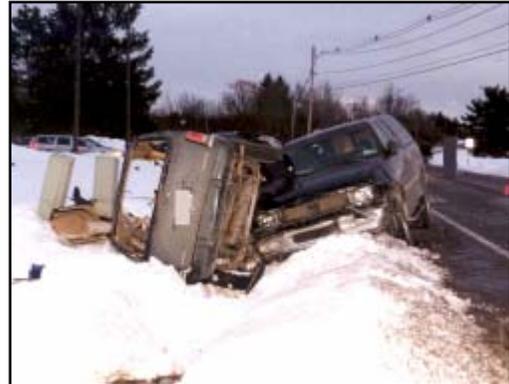
**Figure 1. On-scene photo of vehicles at final rest**

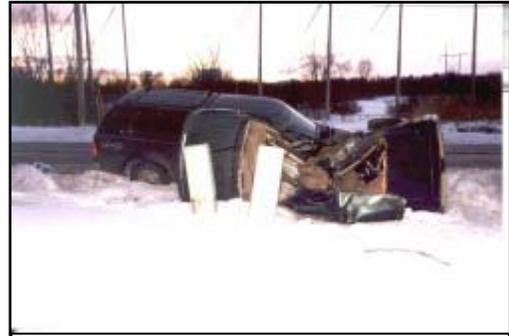
**Figure 4. View of final rest positions**

(-28.0 mph), respectively. The longitudinal and lateral components for the F-150 were -37.4 km/h (-23.3 mph) and 6.6 km/h (4.1 mph), respectively. At impact, the CCW yaw of the Caravan was arrested as the van was redirected in a clockwise (CW) rotation onto the roadside. Based on the final rest positions and vehicle damage, it appeared that there was sustained contact between the vehicles as they traveled to final rest. The Caravan was redirected onto the east roadside in a CW rotation and as it traveled into the drainage ditch, the high center of gravity combined with its CW rotation resulted in a tip over onto the left side. The Caravan came to rest on its left side facing north. The Ford F-150 came to rest against the undercarriage of the Caravan, facing north and straddling the east roadside (**Figure 4**).

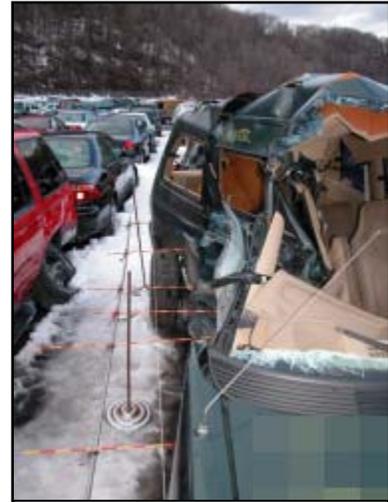
The 1993 Dodge Caravan sustained severe right side damage as a result of the impact with the Ford F-150 pickup truck (**Figure 5**). The direct contact damage on the right side began at the leading edge of the right front door and extended rearward 175.3 cm (69.0") to the aft edge of the sliding side door. Abrasions from the F-150 pickup truck were present along the entire length of the direct contact area and were present on the entire vertical height of the doors. The combined direct and induced damage began 66.0 cm (26.0") forward of the leading edge of the right front door and measured 351.8 cm (138.5") in length. The maximum crush was vertically located 45.7 cm (18.0") below the beltline, 109.9 cm (43.3") rear of the leading edge of the right front door, and measured 82.7 cm (32.6"). The contour of the F-150's bumper was visible on the Caravan's right side door panels. Induced damage was also noted on the roof and right roof side rail, which were buckled laterally. The exterior panel of the right front door was displaced outward, away from the door structure. The mid-door trim pieces were separated from both doors. The rear aspect of the right front fender and the front aspect of the right rear quarter panel were pulled inward. The right sill was abraded, crushed, and displaced upward 20.3 cm (8.0") at the B-pillar. The sill's sheet metal sustained lateral tears at the B-pillar and the B-pillar was crushed laterally at the bottom aspect. The right side sliding door was completely removed by rescue personnel. The hood and the rear hatch were displaced slightly. The Collision Deformation Classification (CDC) for the impact with the Ford F-150 pickup truck was 02-RPEW-5. Six crush measurements were documented at the sill and mid-door across the damaged right side (**Figure 6**). The crush measurements along the mid-door were: C1 = 0.0 cm, C2 = 29.2 cm (11.5"), C3 = 82.6 cm (32.5"), C4 = 62.2 cm (24.5"), C5 = 17.8 cm (7.0"), C6 = 0.0 cm. The crush measurements along the sill were as follows: C1 = 0.0 cm, C2 = 20.3 cm (8.0"), C3 = 36.8 cm (14.5"), C4 = 39.4 cm (15.5"), C5 = 8.9 cm (3.5"), C6 = 0.0 cm.

**Figure 5. View of down the right side plane**

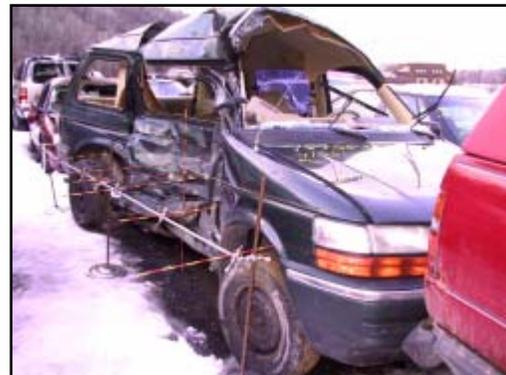
**Figure 6. View of right side damage**

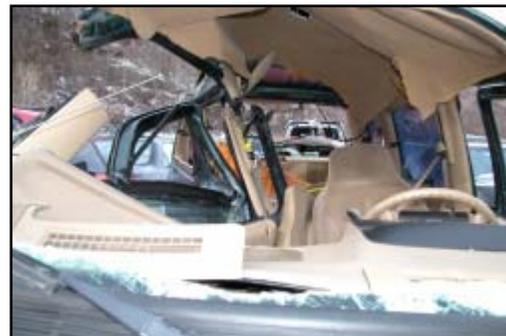
**Figure 7. View of interior damage and lateral intrusion**

Interior damage to the Dodge Caravan was severe and attributed to passenger compartment intrusion (**Figure 7**) and occupant contact. The windshield was completely removed by rescue personnel. The left front window glazing, all right side glazing, and the backlight glazing were disintegrated. The right front door was jammed shut, the right side door was removed completely by rescue personnel, and the rear hatch was jammed shut. Crackers were present in the window frames of the intact left rear window and a piece of a fractured head lamp from the Ford F-150 was wedged in the bottom aspect of the left side center window frame.

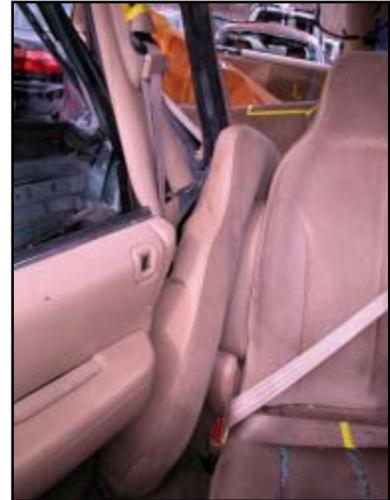
Intrusion into the passenger compartment was severe (**Figure 8**). Lateral intrusions included the right door, right A-pillar, right B-pillar, right roof side rail, right sill, right rear sliding door, right C-pillar, and the right rear side panel. The front right seat was crushed and displaced downward and laterally to the left. The inboard aspect of the front right seat cushion was wedged under the inboard aspect of the driver's seat cushion. The front right seat back was rotated approximately 80 degrees in a CCW direction and was crushed against the inboard aspect of the driver's seat back. The lateral distance between the forward edge of the right side sliding door and the left side interior panel measured 73.7 cm (29.0"). The specific intrusions were documented as follows:

**Figure 8. View of deformed front right seat back and intrusion of right front door and right B-pillar**

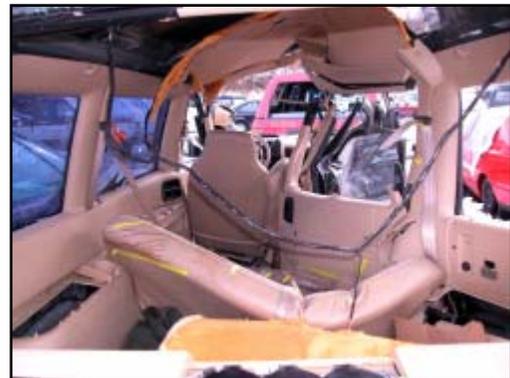
**Figure 9. View from the backlight showing intrusion and contacts**

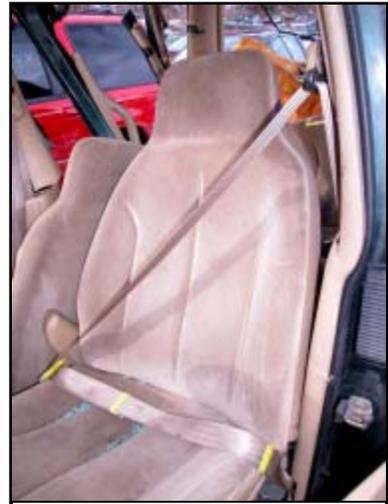
The 1993 Dodge Caravan was configured with manual 3-point lap and shoulder belts for all outboard seating positions and a lap belt with a locking latch plate for the second seat center position. The vehicle was not equipped with the Lower Anchors and Tethers for Children (LATCH) system. Both front safety belts were designed with Emergency Locking Retractors (ELR's) and adjustable D-rings that were in the full-down positions. The driver's restraint was configured with a sliding latch plate and remaining outboard restraints were configured with cinching latch plates. The driver's safety belt exhibited minor stretching along the lap and shoulder webbing consistent with occupant loading (**Figure 10**). Both sides of the lap belt webbing sustained multiple minor abrasions and black transfers over a distance of 29.8 cm (11.8"). The driver's plastic latch plate cover exhibited minor abrasions along the entire width of the belt path. Faint abrasions were noted on the driver's plastic D-ring.

**Figure 10. View of driver's safety belt**

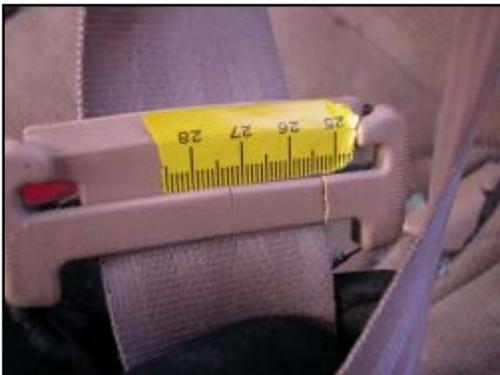
The second seat left restraint was used to restrain the 4-year-old child passenger in the belt-positioning booster CSS. There was no loading evidence present on the D-ring, but the webbing exhibited 31.1 cm (12.3") section of stretching that began 47.0 cm (18.5") above the anchor and minor stretching on the lap belt portion. The rear aspect of the plastic latch plate cover sustained two linear vertical fractures on the rear aspect (**Figure 11**), and the top plastic aspect of the cinch bar was fractured on the front aspect. The second seat right safety belt was severed at the time of the vehicle inspection. The section of webbing between the retractor and the severed edge measured 78.7 cm (31.0") in length and the section between the anchor and the severed edge (**Figure 12**) measured 97.8 cm (38.5") in length. It appeared that the webbing had been cut, evidenced by the lack of CSS displacement. In addition, there were no interior components that appeared to have contacted the safety belt in that area. The safety belt webbing exhibited stretching that began 29.8 cm (11.8") and measured 9.5 cm (3.5") in length from engagement with the edge of the CSS belt path.

**Figure 11. View of fractured rear left latch plate**

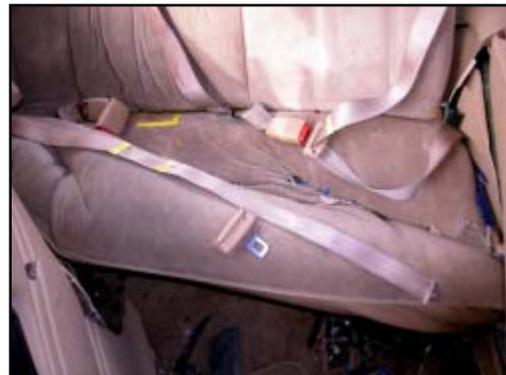
**Figure 12. View of rear right safety belt webbing (cut) and latch plate**

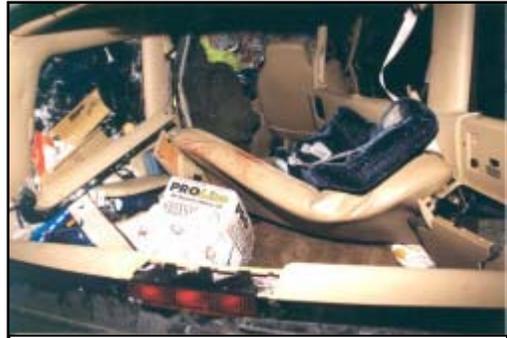
The Century Encore Convertible CSS was positioned on the second row bench seat on the right position (**Figure 13**). The CSS could not be located for an inspection. Therefore, information regarding the CSS has been obtained from on-scene police photographs and police documentation.

**Figure 13. View of post-crash convertible CSS position**

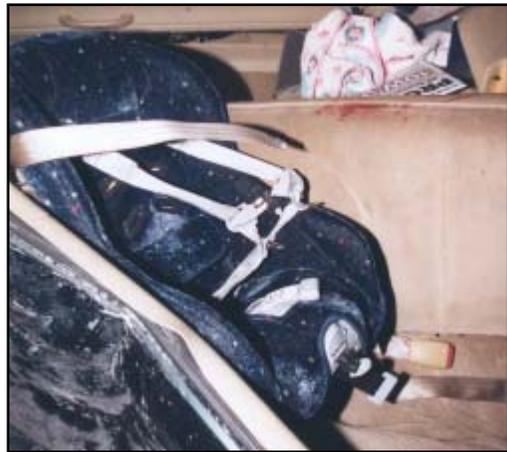
**Figure 14. Close-up of post-crash convertible CSS**

The harness straps were routed through the top slots of the CSS. Both shoulder harness straps exhibited vertical creases between the harness slots and the harness retainer clip, and both were folded through the respective latch plate slots. The amount of slack in the harness system could not be determined.

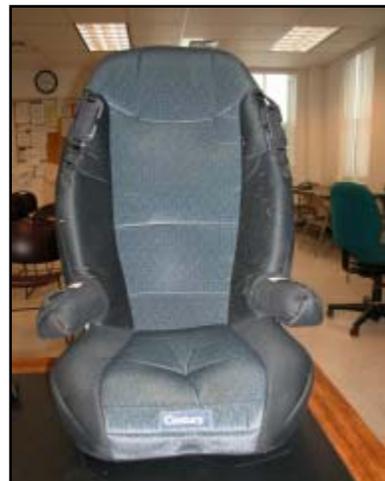
The Century Breverra Ascend BPB (**Figure 15**) was installed on the second row bench seat on the left position. The model number was 4895SBY, the manufacture date was May 20, 2002, and the BPB was not on the NHTSA recall list. The BPB was not configured with a harness system, and was designed strictly as a high-back belt-positioning booster BPB. The BPB was configured with a plastic shoulder belt positioner on each top outboard aspect. The positioners were configured with three vertical positions. The left positioner was in the mid-position and the right was in the top position. The BPB was designed for use

**Figure 15. Century Breverra Ascend Belt-Positioning-Booster**

The BPB sustained minor damage as a result of the crash. An area of fabric on the left side aspect of the seat cushion that measured 5.1 cm (2.0”) in width was abraded from engagement against the safety belt webbing. A similar area on the right side aspect that measured 8.9 cm (3.5”) in width was also abraded as a result of the safety belt loading. The left plastic shoulder belt positioner was abraded on the inboard and outboard aspects from loading against the shoulder belt. It also sustained minor lacerations on then inboard lower aspect. Minor lacerations were also noted on the outboard aspect of the right armrest.

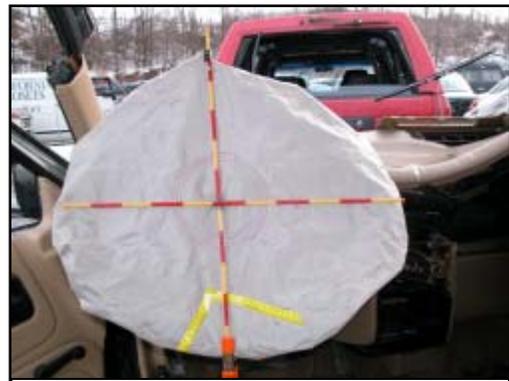
The 1993 Dodge Caravan was equipped with a frontal air bag for the driver that deployed as a result of the lateral impact with the Ford F-150 pickup truck (**Figure 16**). The driver’s air bag was housed in the center of the steering wheel. The air bag was circular in shape and measured 61.0 cm (24.0”) in diameter in its deflated state. The H-configuration vinyl cover flaps were symmetrical in shape and measured 16.5 cm (6.5”) in width at the top and bottom aspects, 6.7 cm (2.6”) in height, and 17.1 cm (6.8”) in width at the tear seam. The air bag was tethered by two internal straps that were located at the 3 and 9 o’clock positions and measured 7.6 cm (3.0”) in width. The air bag was vented by two external ports that measured 3.2 cm (1.3”) in diameter and were located at the 12 o’clock position on the rear aspect of the air bag.

**Figure 16. Driver's air bag in the Dodge Caravan**

The face of the air bag exhibited an area of faint body fluid transfers in the upper aspect, over an area that measured 15.2 x 16.5 cm (6.0 x 6.5”).

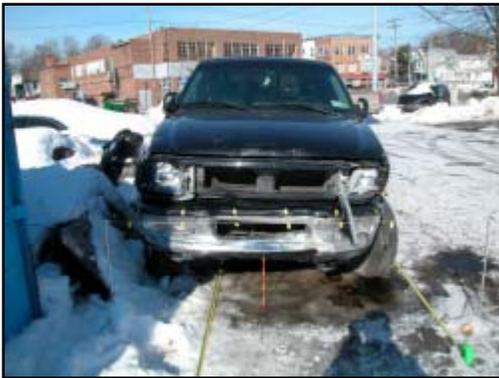
The 1997 Ford F-150 pickup truck sustained moderate frontal damage (**Figure 17**) as a result of the impact with the Dodge Caravan. The direct contact damage extended across the entire frontal width of the vehicle and measured 154.9 cm (61.0”). The penetration depth of the pickup truck and contact with the Caravan’s undercarriage resulted in abrasions on the front aspects of the left and right front fenders which extended rearward to 26.0 cm (10.2”) forward of the front axle (**Figure 18**). Both head lamps were fractured, the grille was separated, the bumper was crushed, and the hood was slightly displaced. The front bumper was displaced 3.2 cm (1.3”) to the right. Contact abrasions were also noted on the center aspect of the leading edge of the hood. The left wheelbase was shortened by 4 cm (1.5”). The right front fender was displaced rearward and overlapped the leading edge of the right front door, which prevented the door from opening fully. The CDC for the frontal impact with the Dodge Caravan was 12-FDEW-1. Six crush measurements were taken along the front bumper and were as follows: C1 = 11.0 cm (4.3”), C2 = 10.2 cm (4.0”), C3 = 12 cm (4.7”), C4 = 11 cm (4.3”), C5 = 9.2 cm (3.6”), C6 = 7.0 cm (2.8”).

**Figure 17. View of frontal damage to the Ford F-150**

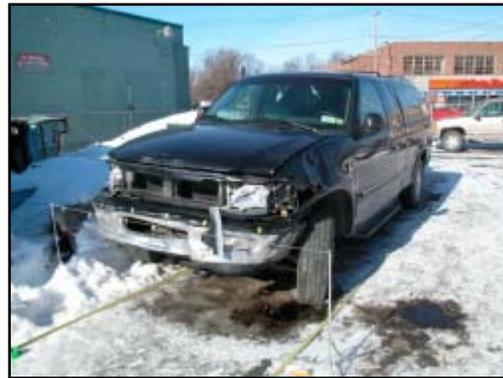
**Figure 18. View of front and left side damage on the Ford F-150**

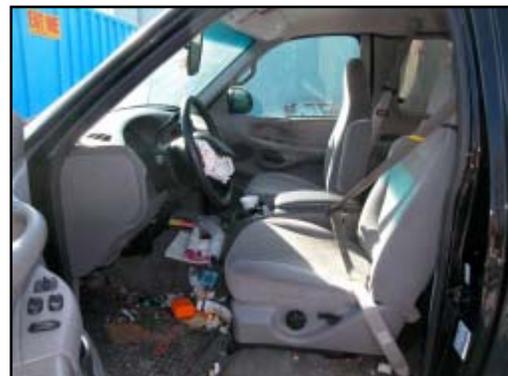
Interior damage to the 1997 Ford F-150 pickup truck was minor and attributed to occupant contact (**Figure 19**). The windshield was fractured on the right aspect from crash forces. The remaining vehicle glazing was undamaged. The left side of the rearview mirror was displaced upward from probable contact with the driver’s right hand. A faint scuff was present on the knee bolster that was located 10.2 cm (4.0”) left of the center of the steering column and measured 3.8 cm (1.5”) in width and 3.4 cm (2.5”) in height. The top rear aspect of the driver’s integral head restraint and seat back exhibited very minor body fluid spatter.

**Figure 19. Interior view of front seat positions**

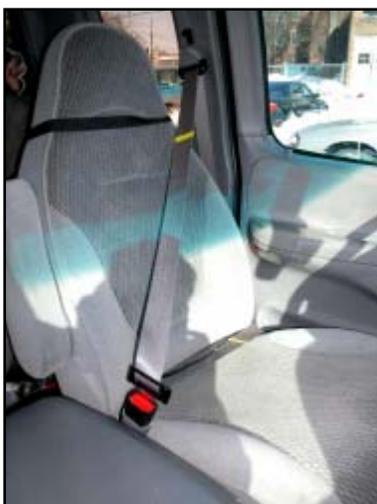
The driver's safety belt (**Figure 20**) exhibited minor stretch marks on the webbing that began 39.4 cm (15.5") from the anchor and extended 90.8 cm (35.5") on the safety belt webbing. Minor abrasions were noted on the driver's D-ring and plastic latch plate cover was abraded from occupant loading.

**Figure 20. View of Ford F-150's driver's safety belt**

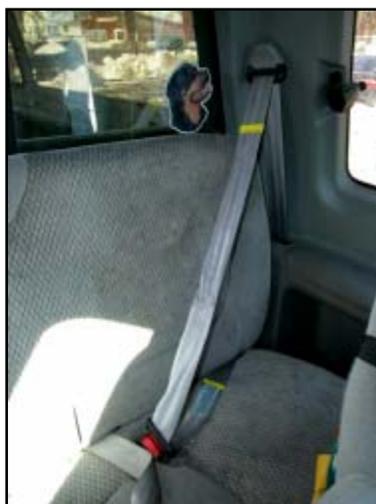
The rear left safety belt (**Figure 21**) was used to secure the forward-facing CSS in the Ford F-150. It was not known what mode the switchable retractor was in at the time of the crash, as the CSS was removed from the vehicle post-crash. A label was present on the webbing indicating the presence of the switchable retractor for use with CSS's. The webbing exhibited stretching that began 31.8 cm (12.5") from the anchor and extended 83.8 cm (33.0") along the webbing from CSS loading. The plastic latch plate cover was abraded and faint D-ring abrasions were present. When installed in the rear left position, the safety belt webbing had a tendency to gather in the rear aspect of the latch plate, due to the rearward orientation of the CSS belt path combined with the more forward position and angle of the safety belt buckle.

**Figure 21. Rear left safety belt**

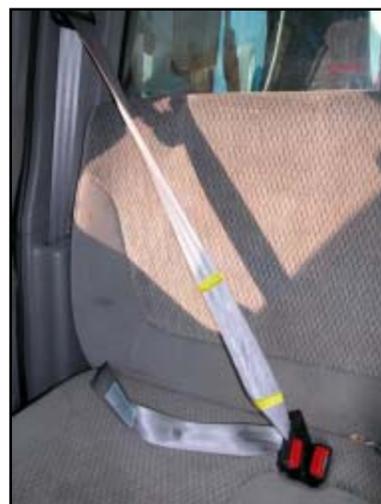
The rear right safety belt (**Figure 22**) was used to secure a forward-facing convertible CSS in the rear right position. Although the CSS was installed in the vehicle, it was unoccupied at the time

**Figure 22. Rear right safety belt**

of the crash. The webbing was distorted from the routing through the CSS belt path. The distortion on the webbing was located 24.1 cm (9.5”) from the stop button and extended 17.1 cm (6.8”) in length. The webbing was also folded in half through the latch plate. The fold began 16.5 cm (6.5”) from the stop button and extended to the leading edge of the stretched area of the webbing.

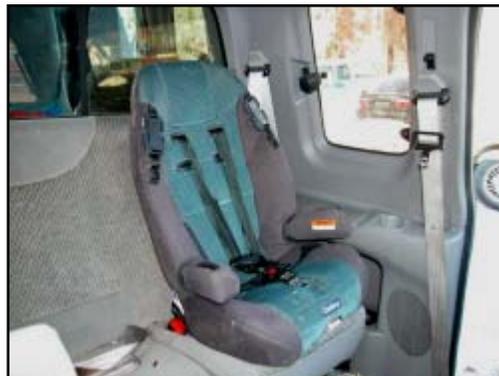
The Century Ascend SE forward-facing CSS was installed with the manual 3-point lap and shoulder belt on the left side of the rear bench seat (**Figure 23**). The model number was 44892UVT, the manufacture date was March 21, 2001, and the CSS was not on the NHTSA recall list. One of the investigating officers stated that the CSS was not tight within the vehicle’s restraint system after the crash. The CSS was equipped with a tether strap, but it was not used to install the CSS in the F-150. The CSS was designed for use with the harness system for children that weighed between 14 – 18 kg (30 – 40 lb) and measured between 89 – 127 cm (35 – 43”) in height. It was designed to be used without the harness system as a belt positioning booster for children who weight between 14 – 36 kg (30 – 80 lb) and who measured 89 – 127 cm (35 – 50”) in height. Based on the manufacturer’s recommendations, the 4-year-old child’s weight of 22 kg (48 lb) exceeded the recommended weight parameters for use of the CSS with the harness system.

**Figure 23. Century Ascend SE Forward-facing CSS in the Ford F-150**

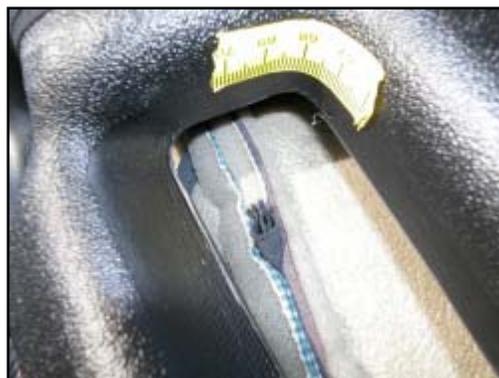
The CSS was configured with a 5-point harness system that was routed through the top slots of the CSS seat back. At the time of the vehicle inspection, the harness system was fully extended. The rear aspects of the plastic sleeves in the upper harness slots exhibited minor abrasions from occupant loading. Minor stretching was noted on the left shoulder harness that was gathered in the latch plate. The right harness strap was folded once through the upper harness slot, and exhibited a second fold through the latch plate. The distance from the harness slots to the harness retainer clip measured 39.4 cm (15.5”) in length. The distance from the retainer clip to the outboard cushion slots measured 24.1 cm (9.5”). The right and left upper rear corners of the plastic belt path on the CSS sustained abrasions from loading the vehicle’s safety belt (**Figure 24**).

**Figure 24. Close-up of abraded left side belt path corner**

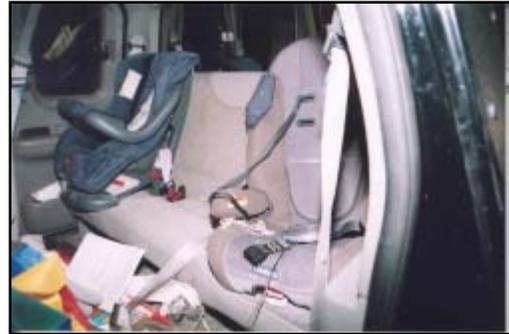
A Cosco Olympian Convertible CSS was positioned in the rear right position of the Ford F-150 pickup truck (**Figure 25**). The CSS was not available for inspection and information was obtained from police reports and police photographs.

**Figure 25. Post-crash photograph showing both CSS in the Ford F-150**

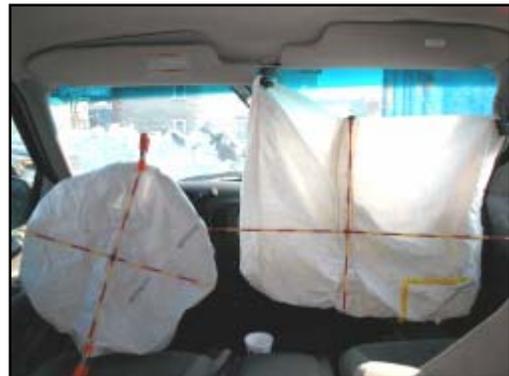
The 1997 Ford F-150 pickup truck was equipped with frontal air bags for the driver and front right passenger positions (**Figure 26**). The air bags deployed as a result of the frontal crash with the Dodge Caravan. The driver's air bag was housed in the center of the steering wheel that was configured with asymmetrical H-configuration cover flaps. The top flap measured 19.4 cm (7.6") in height, the bottom flap measured 8.9 cm (3.5") in height, and both measured 19.1 cm (7.5") in width at the tear seam. The driver's air bag measured 61.0 cm (24.0") in diameter and was vented back through the module. The air bag was tethered by two internal straps at the 12 and 6 o'clock positions. There was no contact evidence present on the air bag surface.

**Figure 26. Deployed frontal air bags in the Ford F-150**

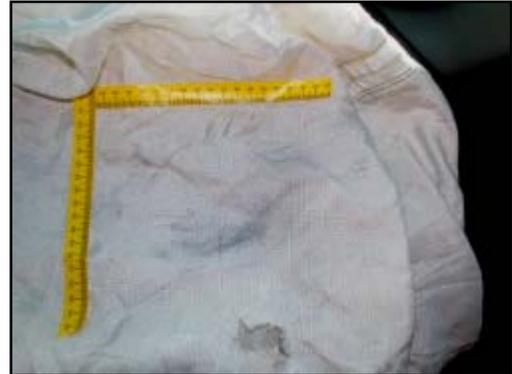
The front right passenger’s air bag measured 71.1 cm (28.0”) in width and 61.0 cm (24.0”) in height. The air bag extended laterally across the center instrument panel area in addition to the right aspect. Black vinyl transfers were present on the bottom right corner of the air bag membrane, and a 3.2 cm (1.3”) diameter hole was present 8.9 cm (3.5”) inboard of the outer right seam on the bottom edge of the air bag (**Figure 27**). The hole was most likely a result of interaction against the jagged edge of the fractured bottom aspect of the module during the deployment.

**Figure 27. Vinyl transfers and hole on the bottom right aspect of the front right passenger's air bag**
