INDIANA UNIVERSITY

TRANSPORTATION RESEARCH CENTER

ON-SITE CHILD SAFETY SEAT INVESTIGATION

CASE NUMBER - IN-03-009
LOCATION - MARYLAND
VEHICLE - 2003 FORD EXPLORER EDDIE BAUER
CRASH DATE - January 2003

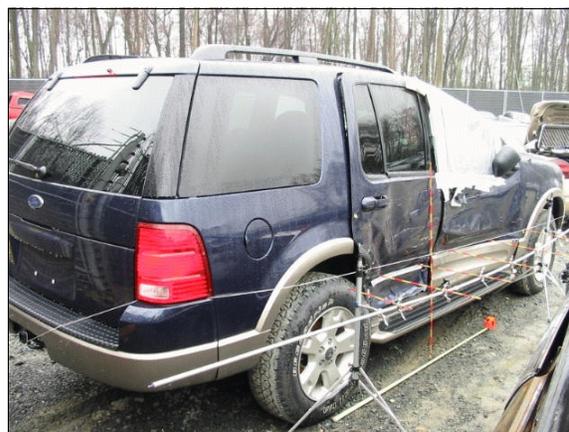
Figure 5: Case vehicle's right side damage viewed from right of back with contour gauge present (case photo #23)

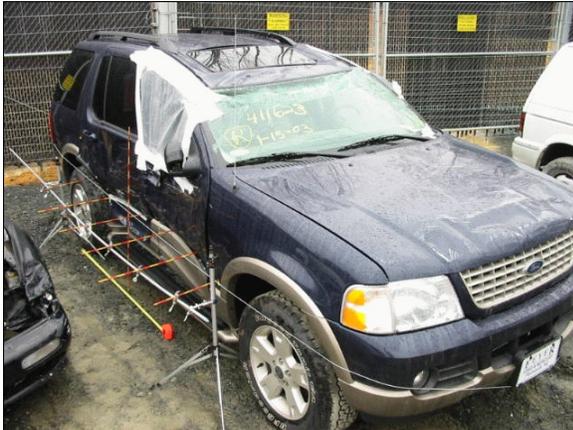
Figure 6: Elevated view of damage to case vehicle's left side from impact with Chevrolet and rollover damage to hood and roof (case photo #26)

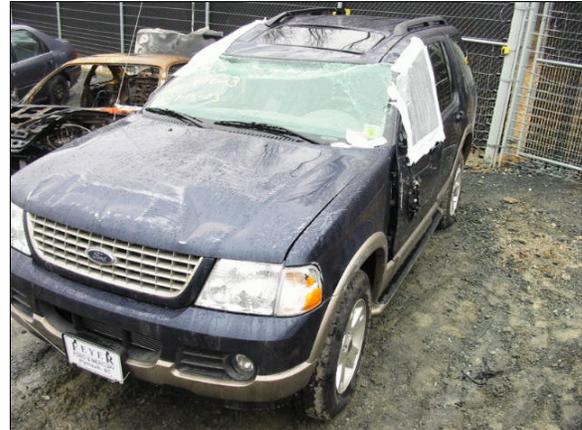
Figure 7: Elevated view from left of front showing rollover damage to case vehicle's hood, roof, and left front door areas (case photo #19)

Post-Crash: The Chevrolet's impact with the case vehicle caused the case vehicle to roll about its longitudinal axis, landing on its left side (**Figure 7**) as the case vehicle continued in its westerly travel path. The case vehicle continued to roll, one more quarter turn, landing on its top, across the centerline in the easterly lane, heading in a westerly direction (**Figure 8**).

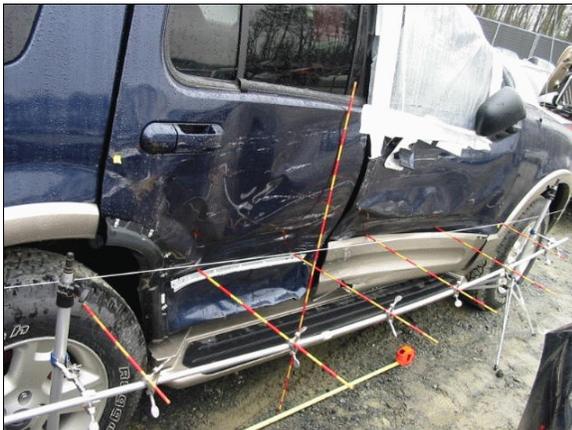
Figure 9: Closer-in view of case vehicle’s right side damage with contour gauge present (case photo #24)

Exterior Damage: The case vehicle’s contact with the Chevrolet involved primarily its right passenger area (**Figures 9 and 10**). Direct damage began 17 centimeters (6.7 inches) forward of the right rear axle (**Figure 9**) and extended 219 centimeters (86.2 inches), along the right side mid-door level toward the front of the vehicle. Maximum crush was measured as 19 centimeters (7.5 inches) at C₄ (**Figures 10 and 11**). The table below shows the case vehicle’s crush profile.

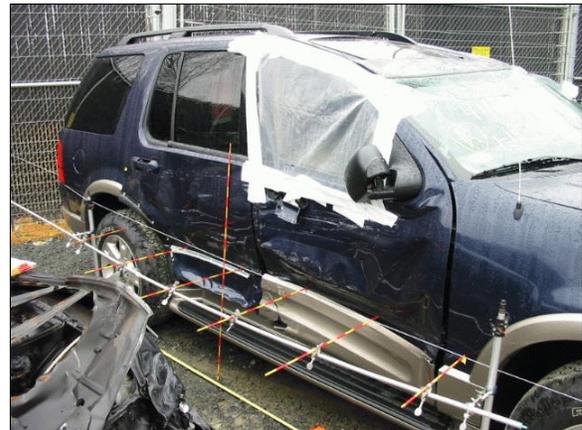
Figure 10: Case vehicle’s right side damage viewed from left of front with contour gauge present (case photo #25)

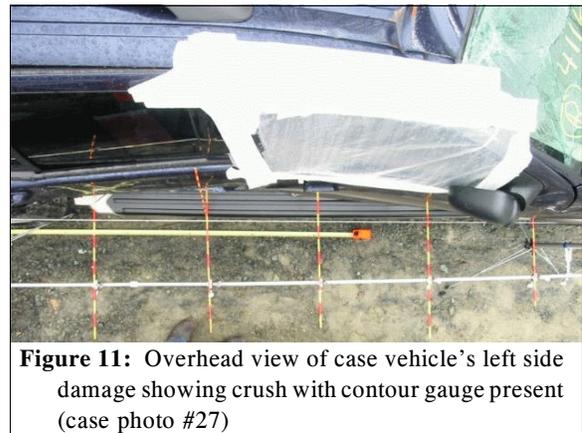
Figure 11: Overhead view of case vehicle’s left side damage showing crush with contour gauge present (case photo #27)

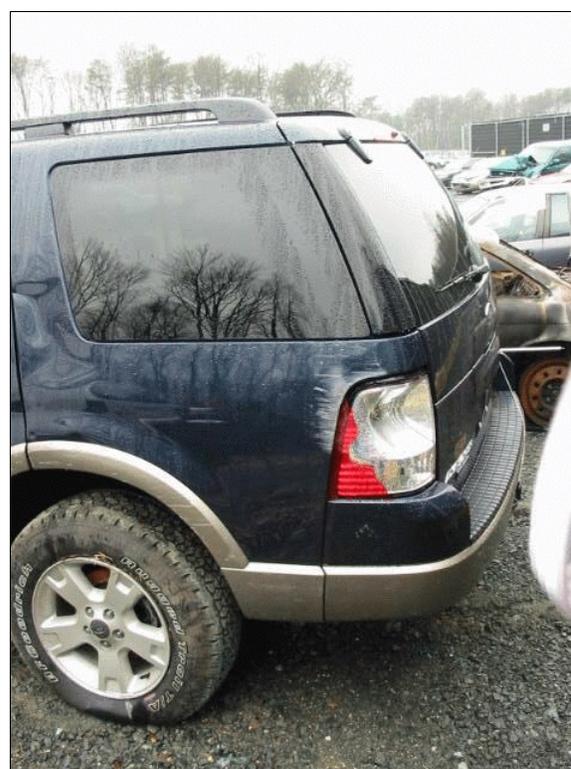
Figure 12: Rollover damage to case vehicle’s left quarter panel and tail/brake/stop light assembly (case photo #20)

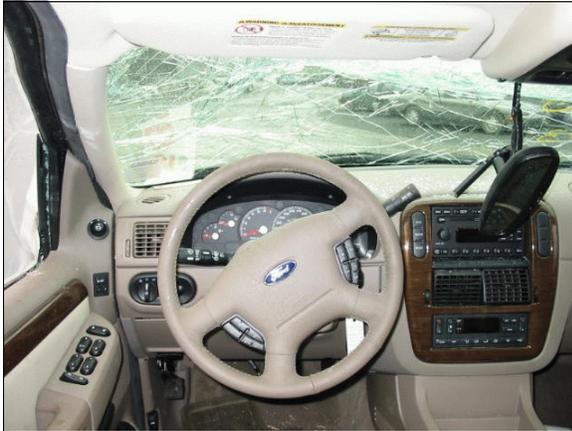
“A”-pillars, the windshield and roof over the front seating area (**Figures 13 and 14**), and both right and left front roof side rails (**Figure 15**). There was a hair on the roof over the driver’s seating position (**Figure 16**), and an extensive smear of blood over the left and center second seating area (**Figures 17 and 18** below). Finally, there was no evidence of compression of the energy absorbing shear capsules in the base of the steering column and no deformation to the steering wheel rim.

Figure 13: Case vehicle’s driver seating area showing non-deployed driver air bag, roof and left “A”-pillar intrusions, and no apparent evidence of occupant contact (case photo #34)

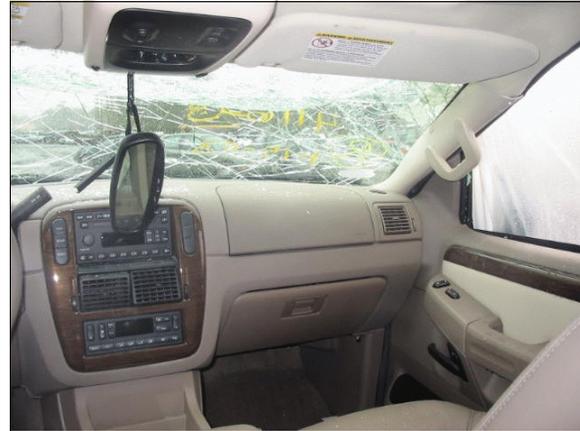
Figure 14: Case vehicle’s front right seating area showing non-deployed front right air bag, dislodged rearview mirror, right “A”-pillar and door intrusions, and no occupant contact evidence (case photo #36)

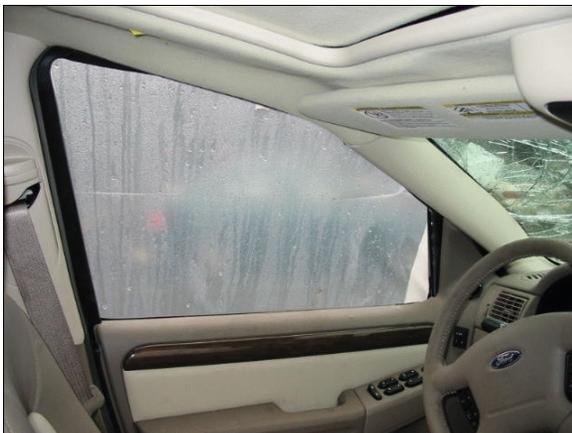
Figure 15: Case vehicle’s driver seating area showing non-deployed driver air bag and intrusion into occupant’s space from roof, roof side rail, left “A”-pillar, and windshield (case photo #33)

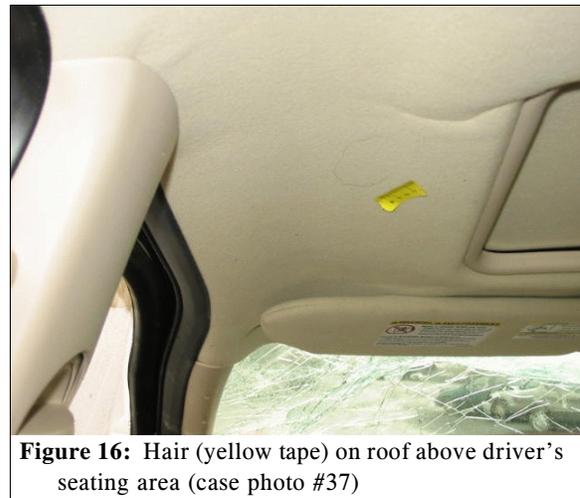
Figure 16: Hair (yellow tape) on roof above driver’s seating area (case photo #37)

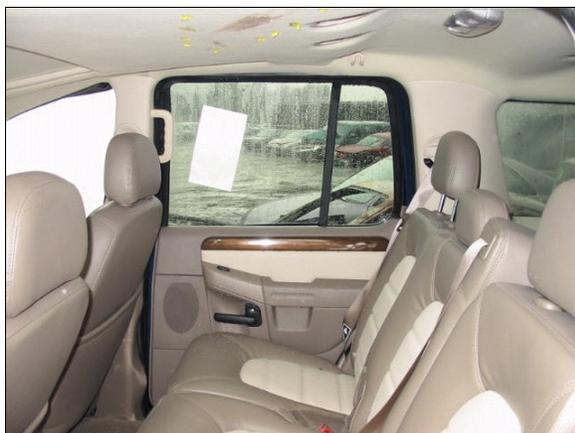
Figure 17: Case vehicle's second seating area viewed from left rear door showing blood stained area on interior roof surface, diagonally oriented above and leftward of second center seating position (case photo #51)

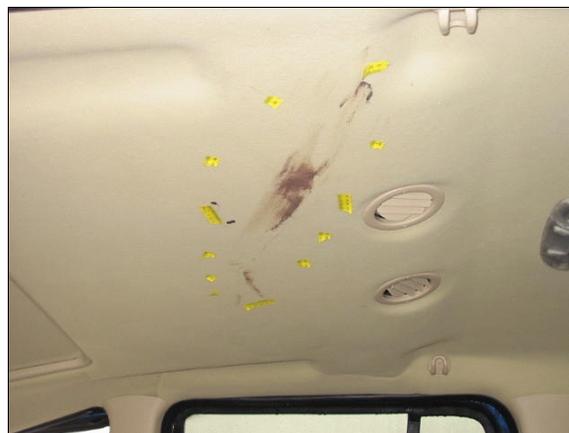
Figure 18: Closer-up view of diagonally oriented blood stained area above and to the left of case vehicle's second center seating position (case photo #52)

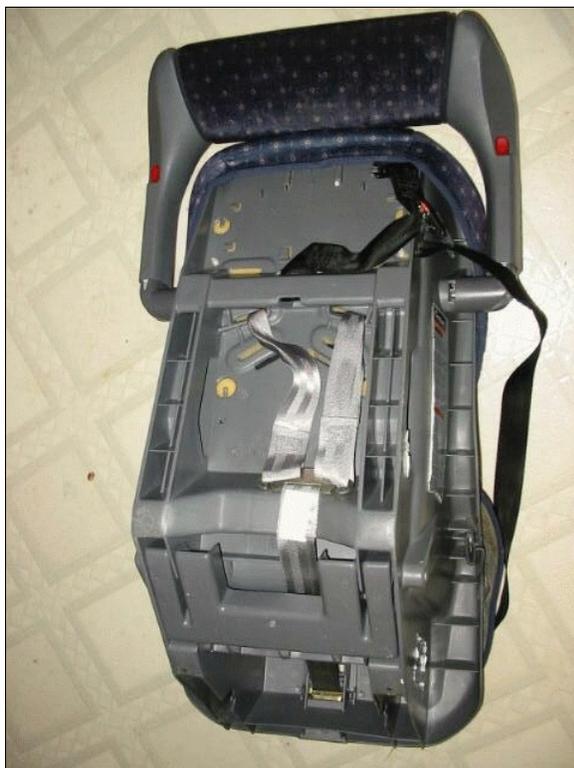
A close inspection of the child safety seat revealed no apparent damage or fractures to the base, shell, or shield (**Figure 20**). In addition, no damage or fractures were noted along the seat's path for the vehicle's safety belt (**Figure 21**). There was a manufacturer's label affixed to the left side (i.e., inboard side when used in the forward facing configuration) giving the child seat's weight limitations [i.e., up to 9-10 kilograms (20-22 pounds) for rear facing and 9-18 kilograms (20-40 pounds) for forward facing].

Figure 20: Back surface of Century convertible child safety seat used by case vehicle's second seat center passenger showing tray shield, top tether, and no apparent evidence of damage to back surface (case photo #70)

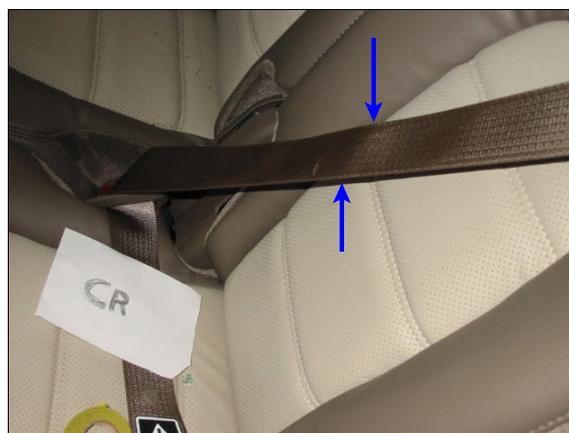
Figure 23: Safety belt for case vehicle's second center seating position showing crease mark on webbing between arrows (case photo #58)

(Figure 23 above) and latch plate (Figure 24) showed trace evidence of loading on the webbing (i.e., a crease).

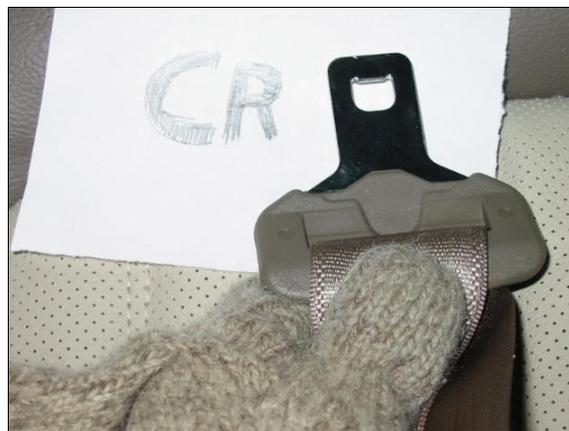
Figure 24: Latch plate for case vehicle's second seat center position showing no obvious evidence of loading (case photo #60)

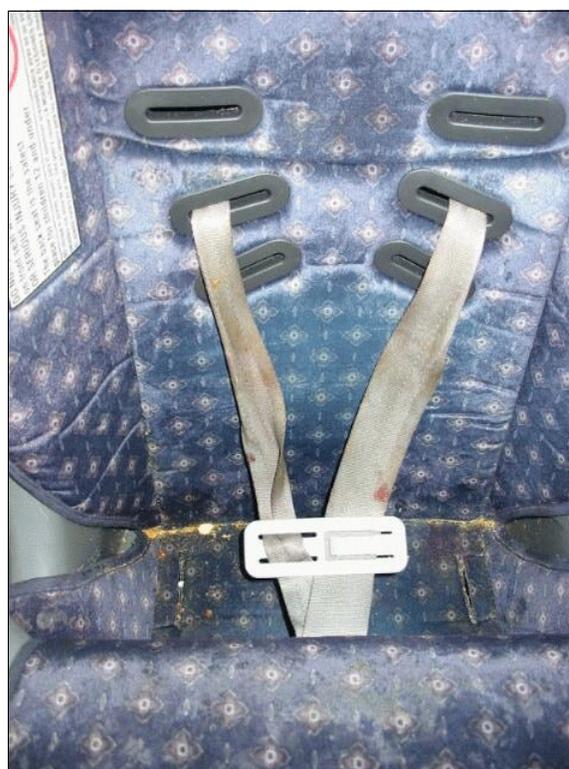
Figure 25: Close-up of blood stains on harness straps of case vehicle's Century child safety seat used by second seat center passenger (case photo #64)

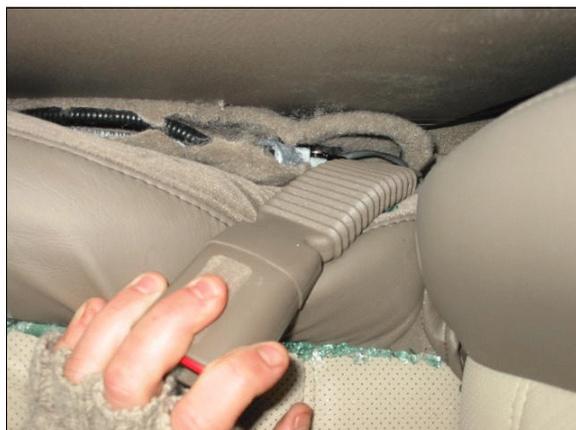
Figure 26: Buckle-mounted pretensioner for case vehicle's driver showing pretensioner not actuated (case photo #45)

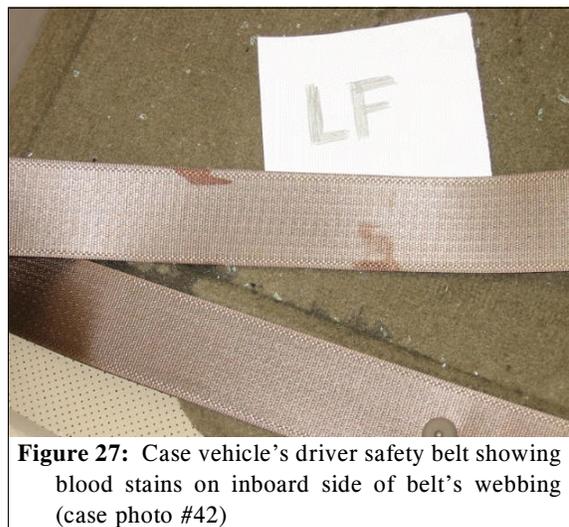
Figure 27: Case vehicle's driver safety belt showing blood stains on inboard side of belt's webbing (case photo #42)
