**VERIDIAN ON-SITE SIDE IMPACT INFLATABLE OCCUPANT PROTECTION
INVESTIGATION
SCI TECHNICAL SUMMARY REPORT**

CASE NO. CA03-011

VEHICLE – 2002 GMC ENVOY

CRASH DATE – JANUARY 2003

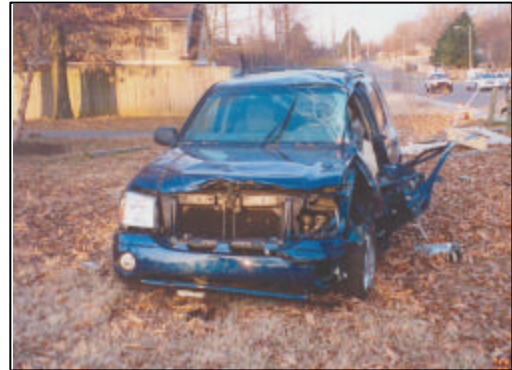
Figure 1. On-scene photograph of damaged 2002 GMC Envoy

The impact resulted in moderate damage to the Envoy (**Figure 1**), a dual-stage deployment of the frontal air bag system, and the deployment of the driver's side impact air bag. The driver's right arm was displaced as a result of the driver's frontal air bag deployment, which resulted in a right ulna fracture. The pole fractured in multiple locations as the Envoy was redirected in a counterclockwise (CCW) motion around the pole. Warning signs present on the pole and concrete fragments intruded into the driver's space, which resulted in a severe open forehead laceration with penetrating head trauma, right side neck and scalp lacerations, and abrasions and contusions on the right aspect of head and neck. The driver was pronounced dead at the scene and did not receive medical treatment. The 17-year-old front right passenger sustained a possible injury and was transported by ambulance to a local hospital. His admission status was not reported.

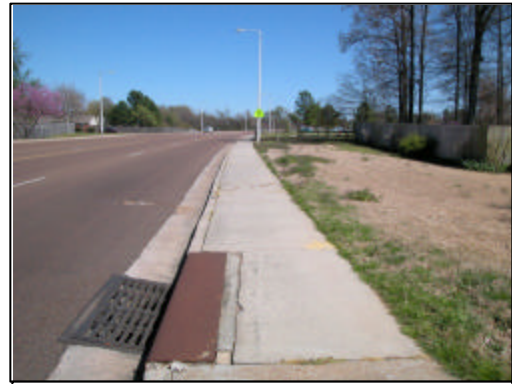
Figure 2. Eastbound view of crash site

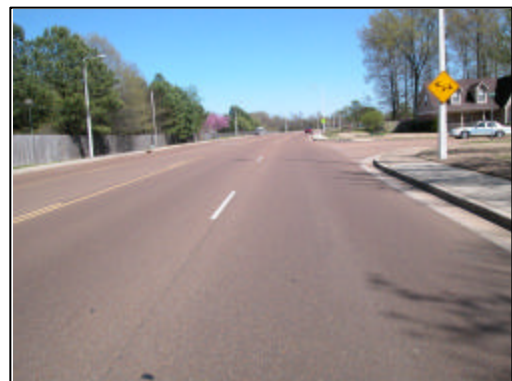
The 54-year-old male driver of the 2002 GMC Envoy was operating the vehicle eastbound on the four-lane roadway during nighttime hours (**Figure 3**). The driver may have fallen asleep or experienced a medical episode, although neither could be confirmed. He relinquished control of the vehicle as the roadway curved to the right. The vehicle drifted to the right and crossed the intersecting roadway in the T-intersection located west of the crash site. The EDR summary indicated the vehicle's speed five seconds prior to a recorded near event was 89 km/h (55 mph) and 90 km/h (56 mph) five seconds prior to a recorded deployment event. Given an EDR-stated 0.5-second interval between the near-event and deployment event, a total of 6 seconds of pre-impact data was collected prior to the deployment event (impact with the pole). Per the EDR output, the vehicle exhibited an increased throttle percentage over the entire six-second pre-impact interval from 25 percent to 53 percent. There was no scene evidence to suggest pre-crash braking and the EDR output shows the brake switch as "off" for the entire pre-crash duration.

Figure 3. Eastbound approach for the 2002 GMC Envoy

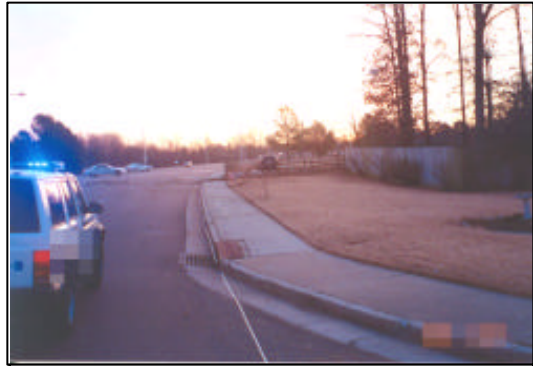
The Envoy struck the southeast curb edge at the intersection corner with the front right wheel and traveled onto the concrete sidewalk (**Figure 4**). Based on EDR-recorded vehicle pre-crash speed and distance traveled, the curb impact occurred approximately 1.5 seconds prior to impact with the pole and the Envoy was traveling approximately 97 km/h (60 mph). The curb impact was located 40.1 m (131.6') west of the pole. Given the stated EDR speed of the Envoy was 92 km/h (57 mph) one second prior to algorithm enable and the stated time of 0.5 seconds between the event and near event, the near event would have been located approximately 13m (42') west of the pole impact where the left rear wheel ramped up the curb. At 92 km/h (57 mph), the vehicle was traveling at 25.5 m (83.8') per second ($57 \text{ mph} \times 1.47 = 83.8' \text{ per second}$). There was no damage to the left rear tire or wheel suggestive of an impact. However, based solely on vehicle damage, it would appear that the near event was the initial curb impact with the right front wheel, evidenced by moderate deformation to the alloy wheel and sidewall tears. Given the Envoy's EDR-stated pre-impact speed, the initial curb impact occurred approximately 1.5 seconds prior to the pole impact, which was not consistent with the EDR output.

Figure 4. On-scene police photograph showing southeast curb impact

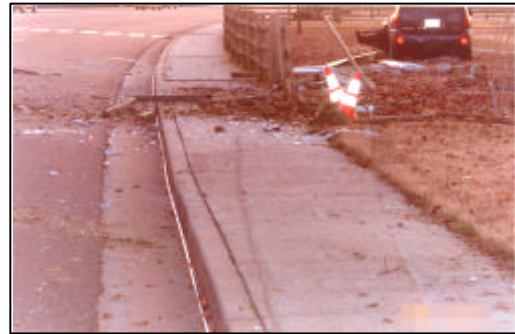
The Envoy continued in a CW yaw and struck the concrete light pole with the left front aspect forward of the left A-pillar (**Figure 5**). Simultaneously, the front aspect of the Envoy impacted the wood fence and 10.2 cm (4.0") square fence post (**Figure 6**). The fence post fractured and the fence shattered at impact, which provided little resistance relative to the pole impact and resulted in minor damage to the frontal plane of the Envoy. The approximate sideslip angle at the point of impact was 30 degrees and the direction of force was in the 11 o'clock sector. The pole impact resulted in the deployment of the driver's side impact air bag, and also resulted in sufficient longitudinal deceleration to deploy both stages of the frontal air bag system 20 milliseconds into the crash. The EDR reported delta-V for the impact was 18.04 km/h (11.21 mph). The concrete pole fractured in multiple locations, however, provided sufficient resistance to redirect the Envoy in a counterclockwise (CCW) direction as it engaged the pole. The square nature of the pole allowed sustained left side engagement against the Envoy, which caused significant rearward displacement of the left front door skin as the vehicle continued around the pole.

Figure 5. View of pre-impact tire marks

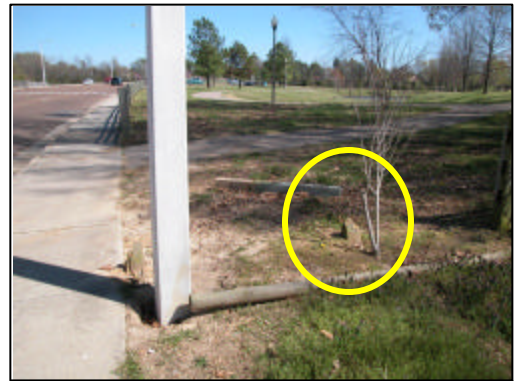
Figure 6. Close-up of replaced concrete pole and fractured fence post

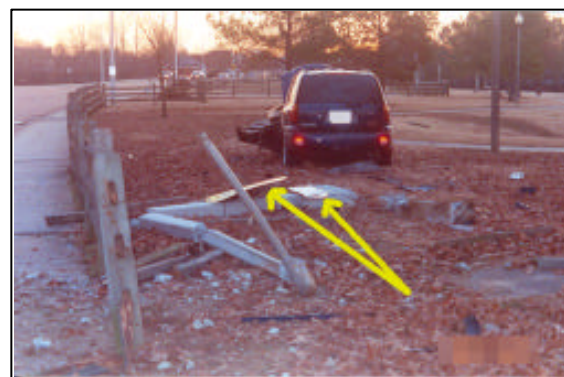
The top aspect of the left front door frame and left roof side rail also sustained contact with the "No Parking" sign which intruded into the driver's window as the pole fractured (**Figure 7**). The Envoy traveled east 23 m (75') in a tracking mode to final rest on the roadside, parallel to the roadway. The total rotation from impact to final rest was 30 degrees in a CCW direction. The EDR summary is included as **Appendix A** of this report.

Figure 7. Post-impact view of fractured pole showing position of metal signs

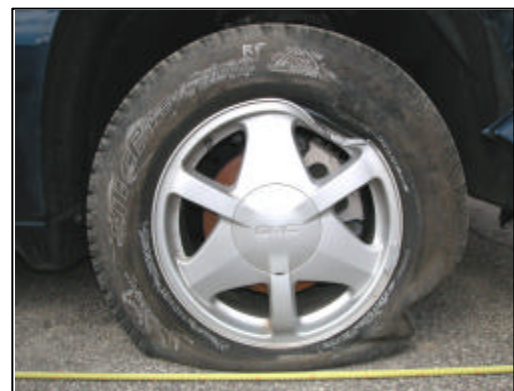
The 2002 GMC Envoy sustained minor right front wheel damage as a result of the first curb impact. The right front wheel exhibited a 12.7 cm (5.0") area of outward deformation that was located on the outboard aspect of the alloy wheel (**Figure 8**). Two tears in the outboard sidewall were present adjacent to the wheel damage. The Collision Deformation Classification (CDC) for the right front wheel impact with the curb was 12-FRWN-3.

Figure 8. Damaged right front wheel and tire

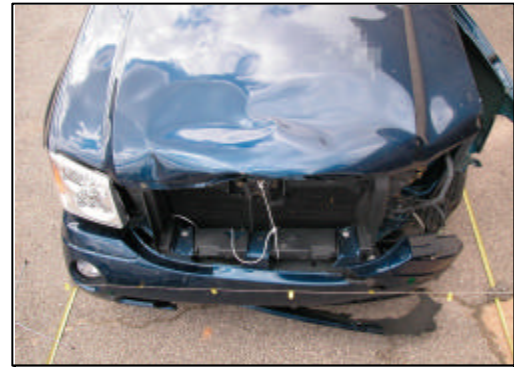
The Envoy sustained minor frontal damage (**Figure 9**) as a result of the simultaneous fence and fence post impact while the left aspect struck the pole. The direct damage on the bumper fascia included contact abrasions that began 69.9 cm (27.5") right of the centerline and extended 141.6 cm (55.8") across the fascia to the front left corner. The combined direct and induced damage involved the entire frontal width and measured 143.5 cm (56.5"). Direct contact damage on the hood included rearward buckling, and abrasions on the leading edge that began 38.7 cm (15.3") right of center and extended laterally to the front left corner. The front bumper fascia was partially separated and fractured in multiple places along the entire width. The front left corner of the bumper beam was deformed rearward, outboard of the frame rail. The maximum crush that resulted from the fence post was located on the bumper beam 16.5 cm (6.5") right of the centerline and measured 8.9 cm (3.5"). The grille and left headlamp were separated. The CDC for the frontal impact with the wood fence was 11-FDEW-1. Six crush measurements were documented along the front bumper beam and were as follows: C1 = 7.0 cm (2.3"), C2 = 0.6 cm (0.3), C3 = 2.7 cm (1.1"), C4 = 7.3 cm (2.9"), C5 = 1.9 cm (0.8"), C6 = 0.0 cm.

Figure 9. Overall view of frontal damage

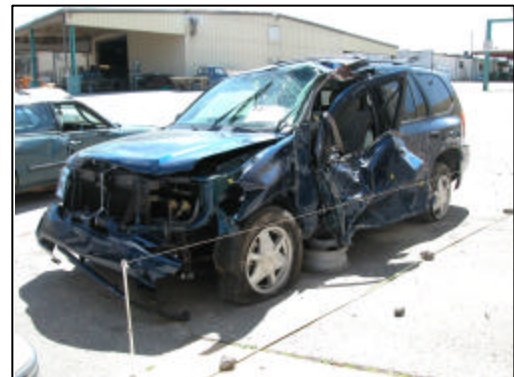
The Envoy sustained moderate left side damage as a result of the concrete pole impact (**Figure 10**). The direct contact from the pole began on the left front fender 26.7 cm (10.5") aft of the left front axle. The direct contact continued along the left side plane to the left rear bumper corner. The direct contact aft of the left front door consisted only of abrasions along the lower rear door and left rear quarter panel. The maximum crush on the left front fender was located 52.1 cm (20.5") aft of the left front axle and measured 20.3 cm (8.0"). The direct contact longitudinal abrasions from the pole extended the entire vertical height of the left front fender. The lateral displacement at the rear aspect caused the forward aspect of the fender to be displaced 22.9 cm (9.0") outward. A 3.8 cm (1.5") longitudinal tear in the sheet metal of the fender was located 20.3 cm (8.0") forward of the rear edge. The left A-pillar exterior trim was separated and the left aspect of the windshield was fractured. Bond separation was noted along the top left corner and measured 17.8 cm (7.0") across the top aspect and 40.6 cm (16.0") downward from the top along the left A-pillar.

Figure 10. View of left side damage

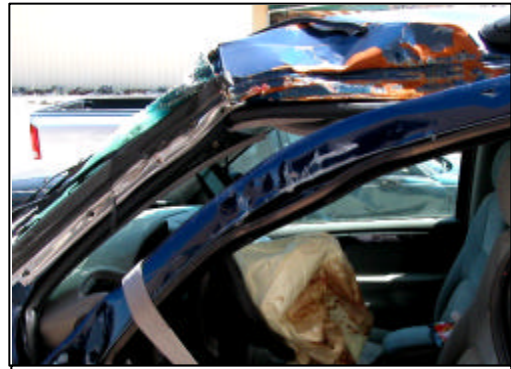
The left roof side rail sustained heavy abrasions and lateral deformation located 34.3 cm (13.5") forward of the center of the left B-pillar as a result of the impact (**Figure 11**). Red paint transfers were also present from direct contact with the "No Parking" sign that was present on the pole. The lateral crush on the left roof side rail measured 8.8 cm (3.5"). Abrasions were also present on the top aspect of the left front door.

Figure 11. Damage on the left roof side rail, left A-pillar, and left front door

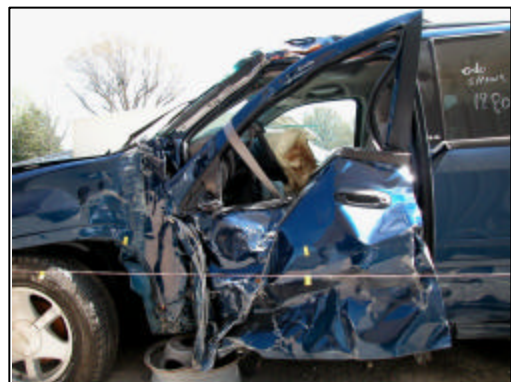
Due to the lateral crush on the left front fender and sustained engagement with the concrete pole, the leading edge of the left front door snagged on the pole (**Figure 12**). The leading edge of the left front door was deformed and displaced rearward. The forward aspect of the door was crushed laterally and the rear aspect was deformed and buckled outward. The outer door skin was separated 21.6 cm (8.5") outward at the rear aspect of the door.

Figure 12. Left front door damage

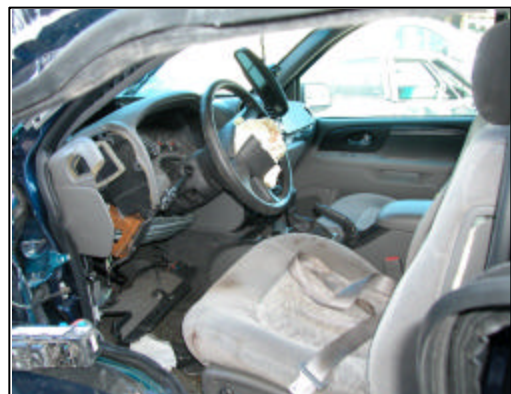
Interior damage to the 2002 GMC Envoy was moderate and attributed to passenger compartment intrusion (**Figure 13**). The left front door was jammed shut as a result of the damage. However, the door was removed at the hinge to facilitate extrication of the driver. The windshield was fractured and the bond was partially separated on the upper left corner. The left front window disintegrated as a result of impact forces. The remaining glazing was undamaged. The tilt steering wheel was jammed in the mid position. Inspection of the shear capsules confirmed no steering column compression. The knee bolster was fractured to the left of the steering column from impact forces and separated from the vehicle. There was no occupant contact evidence on the knee bolster. The metal backing plate remained in place, but was

Figure 13. Interior view through left front door

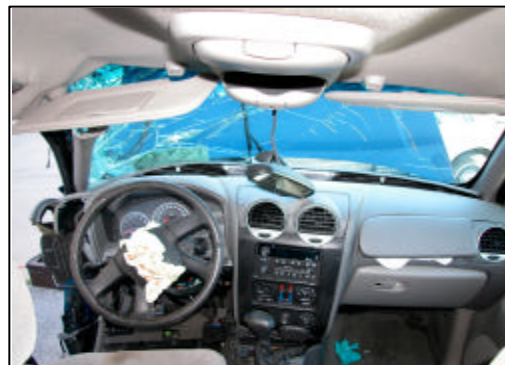
deformed laterally and bowed outward at the center aspect as a result of intrusion. The outboard aspect of the left instrument panel was fractured and partially separated. Due to the instrument panel damage, the instrument cluster was not functional even though power was applied to the vehicle during the inspection. The rear view mirror was separated at the time of the vehicle inspection, although it was in place in the on-scene police photographs. The driver's sun visor was displaced and the left A-pillar trim was partially separated (**Figure 14**). The plastic interior panel of the left front door was separated at the time of the vehicle inspection. The plastic door trim exhibited numerous stress marks from occupant loading and intrusion and was fractured at the armrest. The bottom aspect exhibited numerous abrasions and blue paint transfers from engagement against the sill. Concrete fragments were present throughout the floor pan and left sill areas of the interior.

Figure 14. Overall view of instrument panel and displaced components

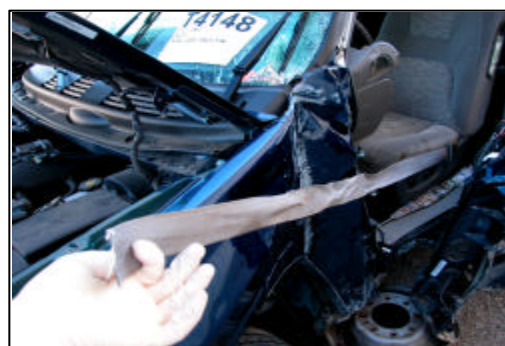
The 2002 GMC Envoy was configured with integrated manual 3-point lap and shoulder belts with sliding latch plates for the front seat positions. The driver's safety belt was configured with a belt-sensitive Emergency Locking Retractor (ELR) and the front right passenger's safety belt was configured with a belt-sensitive switchable/Automatic Locking Retractor (ALR). At the time of the vehicle inspection, the driver's safety belt was wrapped around the left front door frame and steering wheel to anchor the left front door in place, which masked signs of driver loading. Body fluid was also noted on the webbing. The driver's safety belt had been cut 174.0 cm (68.5") above the lower anchor (**Figure 15**). The latch plate

Figure 15. View of driver's safety belt

was still present on the webbing and exhibited a small amount of abrasion on the left aspect from loading against the safety belt webbing. The latch plate also had abrasions consistent with regular usage. There was no visible webbing left in the retractor located on the top outboard aspect of the seat back. The plastic cover and steel bracket were deformed vertically and laterally toward the left as a result of the driver loading the safety belt (**Figures 16 and 17**). The vertical displacement measured 3.2 cm (1.3") on the inboard aspect of the cover and the outboard aspect contacted the left B-pillar.

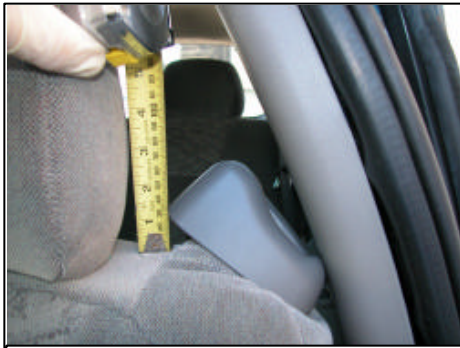
Figure 16. Frontal view of displaced plastic cover

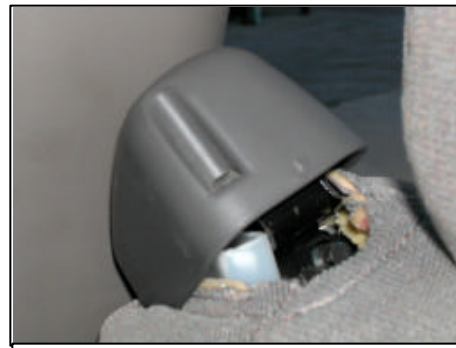
Figure 17. Rear view of displaced plastic cover and steel bracket

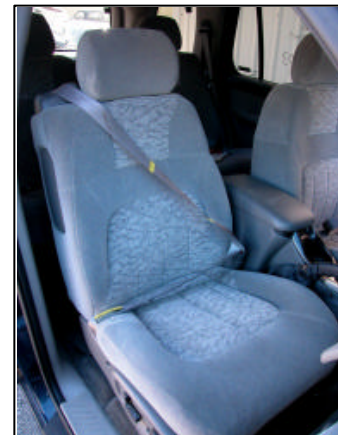
The front right safety belt exhibited minor stretching over an area that measured 22.2 cm (8.8") in length and began 67.3 cm (26.5") above the lower anchor (**Figure 18**). Small amounts of body fluid were present on the webbing, most likely from the driver.

Figure 18. Front right passenger's safety belt

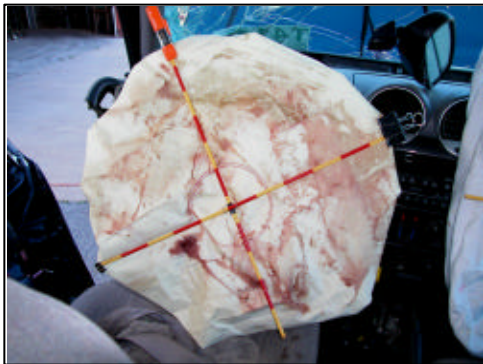
Heavy body fluid transfers were present on the face of the driver's air bag (**Figure 19**). There was no additional contact evidence on the air bag; however, the bottom rear aspect of the air bag exhibited numerous linear abrasion-like body fluid transfers (**Figure 20**).

Figure 19. Body fluid transfers on the face of the driver's air bag

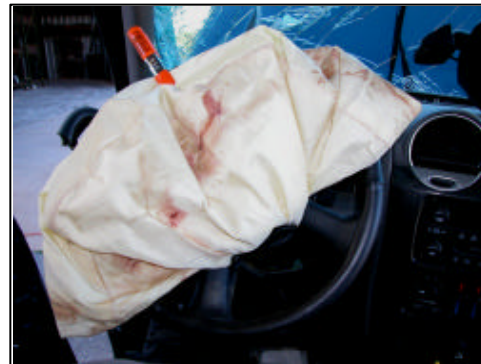
Figure 20. Abrasion-like transfers on the bottom rear aspect of the driver's air bag

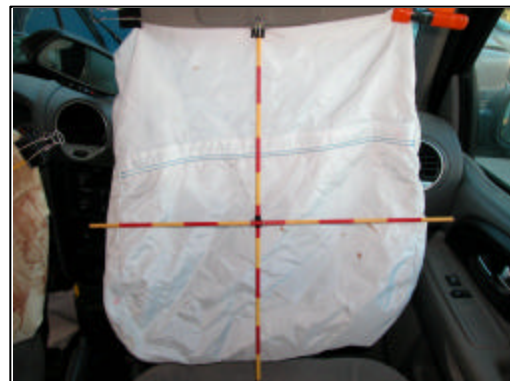
The front right passenger's air bag (**Figure 21**) deployed from a mid-mount module with a rectangular cover flap hinged at the forward aspect. The vinyl cover flap measured 33.0 cm (13.0") in width and 14.0 cm (5.5") in height. The front right passenger's air bag measured 49.5 cm (19.5") in width and 55.9 cm (22.0") in height. The air bag was tethered by a wide-band tether located at the center of the air bag that measured 30.5 cm (12.0") in width. The air bag was vented by two circular ports located at the 2 and 10 o'clock positions on the side panels of the air bag. The vent ports measured 3.8 cm (1.5") in diameter and were located 11.4 cm (4.5") rear of the face of the air bag. Trace amounts of body fluid spatter were present on the face of the air bag, most likely from the driver.

Figure 21. View of front right passenger's air bag

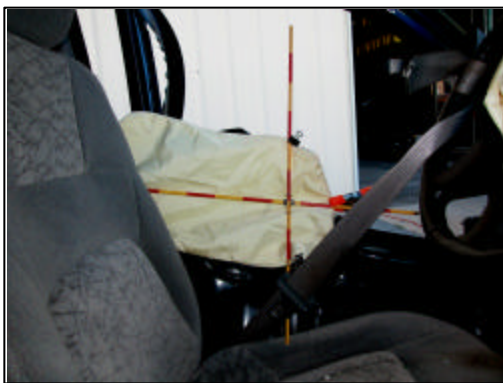
The 2002 GMC Envoy was equipped with seat back-mounted side impact air bags for the driver and front right passenger positions. The driver's side impact air bag deployed as a result of the impact with the concrete pole. The air bag deployed from the outboard aspect of the driver's seat back (**Figures 22 and 23**). The module was configured with a rectangular module cover flap that measured 7.6 cm (3.0") in width and 19.1 cm (7.5") in height. The air bag measured 40.6 cm (16.0") in length and 22.9 cm (9.0") in height. The side impact air bag provided abdominal/torso protection only, and did not offer protection for the occupant's head. The air bag was vented by a single circular port located on the top rear corner of the outboard aspect. The vent port measured 3.8 cm (1.5") in diameter and was located 7.6 cm (3.0") forward of the rear aspect of the air bag and 1.3 cm (0.5") below the top aspect. The side impact air bag deployed 30.5 cm (12.0") forward of the front aspect of the driver's seat back and 15.2 cm (6.0") above the seat cushion. There was no contact evidence, damage, or evidence of an impeded deployment on either side of the side impact air bag.

Figure 22. Inboard aspect of driver's side impact air bag

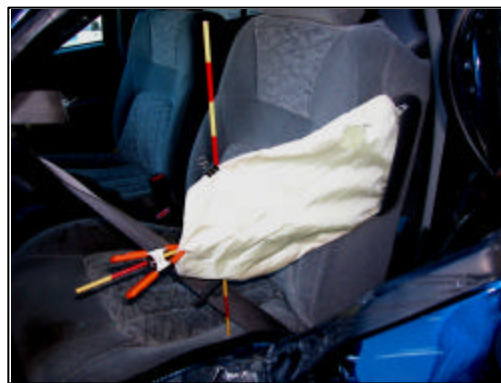
Figure 23. Outboard aspect of driver's side impact air bag
