Certified Advanced 208 Compliant Investigation / Vehicle to Object
Dynamic Science, Inc. / Case Number: DS03020
2003 GMC Yukon K1500
Texas
April, 2003

Dynamic Science, Inc.
Crash Investigation
Case Number: DS03020

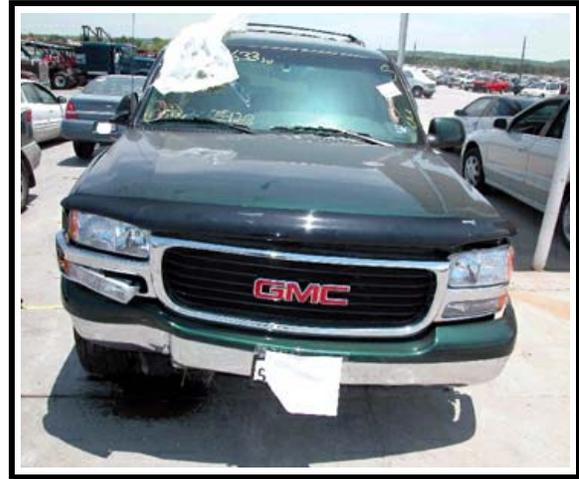
Figure 1. Front damage (Impact 1)

The 2003 GMC Yukon sustained moderate front damage as a result of the impact with the guardrail. The case vehicle sustained direct damage across the entire front bumper that began at the front right bumper corner. Maximum crush was 16.8 cm (6.6 in) located at C5. For the second impact versus the concrete bridge support pillar, the case vehicle sustained direct damage of 269.0 cm (105.9 in) that began at the right rear bumper corner and extended forward to the front right passenger's door area. Maximum crush was 18.0 cm (7.1 in) located at C1. For the third impact versus the ground, the ground impact separated the front left tire, wheel and brake assembly from the vehicle.

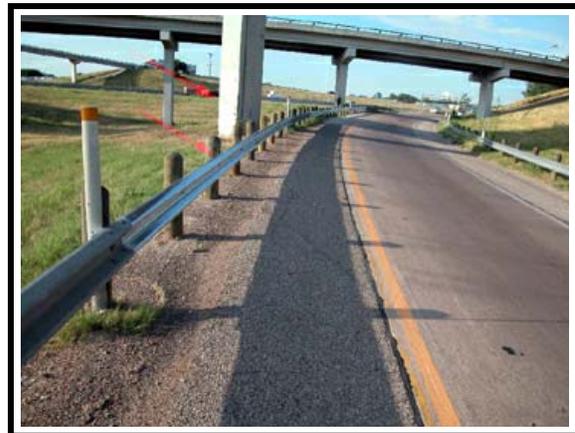
The case vehicle crashed into the metal/wood guardrail (approximately 15.0 meters [50.0 ft] of the guardrail was newly replaced) on the left shoulder area with its lower front end and undercarriage areas (12FDLW1). The total velocity change for the case vehicle as calculated by the Barrier algorithm of the WinSmash collision model was 13.0 km/h (8.1 mph)¹. The longitudinal and lateral delta V components were -13.0 km/h (-8.1 mph) and 0 km/h (0 mph), respectively. This is a borderline reconstruction given the yielding object-guardrail.

Figure 3. Impact 1 with guardrail

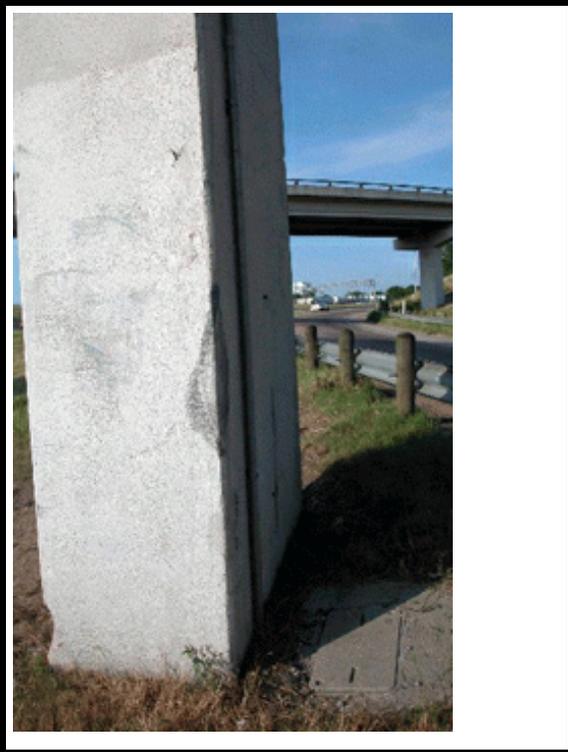
The case vehicle vaulted over the guardrail and continued airborne for approximately 2.0 meters (7.0 ft) while rotating counterclockwise and subsequently collided with a concrete bridge support pillar with the vehicle's right side (02RZAW2). There was what appeared to be black tire transfer on the concrete bridge support pillar that began 100.0 cm (39.0 in) from the ground. The total velocity change for the case vehicle as calculated by the Barrier algorithm of the WinSmash collision model was 14.0 km/h (8.7 mph). The longitudinal and lateral delta V components were -4.8 km/h (-3.0 mph) and -13.2 km/h (-8.2 mph), respectively. The result fit the collision model and appear reasonable.

Figure 4. Impact 2 with concrete bridge support pillar

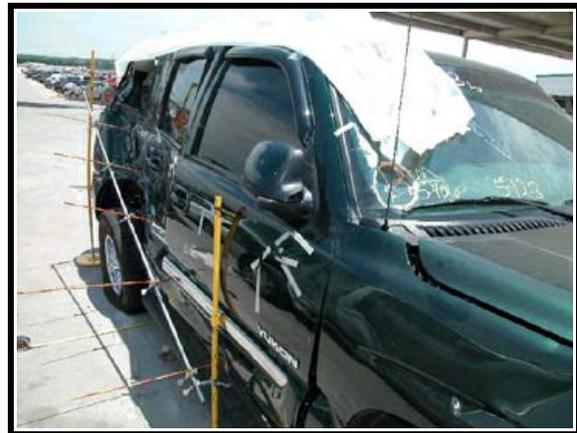
Figure 5. Exterior right side damage (Impact 2)

The 2003 GMC Yukon sustained minor interior damage as a result of passenger compartment intrusion. The right door panel, right side panel, and right C pillar sustained lateral intrusion. The two right doors were jammed shut. The third row side glass was disintegrated as a result of the pillar impact.

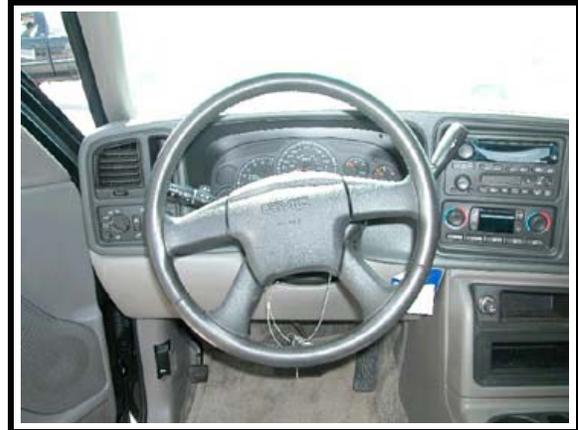
The case vehicle was equipped with advanced dual stage frontal air bags. The driver's air bag module was located in the center hub of the steering wheel rim and did not deploy during the crash because the forces generated during the crash events were below the air bag deployment threshold of the restrained driver. The front right passenger air bag was a mid-mount design located in the right aspect of the instrument panel. The front right passenger air bag did not deploy due to case vehicle being equipped with a Passenger Sensing System, and the absence of a front right occupant. The Passenger Sensing System is designed to automatically switch the air bag on or off based on a passenger's weight. The system also uses a sensor in the passenger-side seat belt to measure how much tension is exerted by the seat belt when it is being cinched down, another means of determining what may be on the seat. There is an indicator on the rear-view mirror that alerts vehicle occupants to the status of the system at all times. If the light reads "Passenger Air Bag ON," the air bag is programmed to deploy in a frontal crash of sufficient severity. If it reads "Passenger Air Bag OFF," the system has turned off the air bag because it determined either that there is no occupant on the front passenger seat, or that a rear-facing infant seat, a forward-facing child restraint, a booster seat or a smaller person, such as a child who has outgrown child restraints, is present.

Figure 6. Non-deployment of driver's air bag

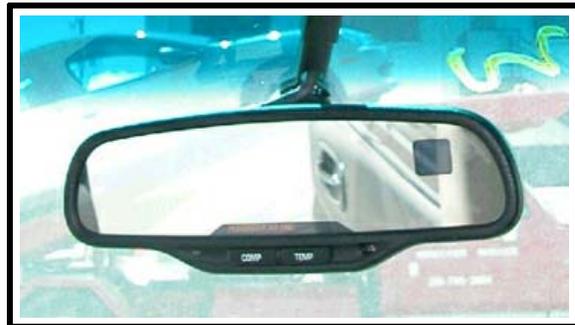
Figure 7. Front right Passenger Sensing System, monitored on rear view mirror

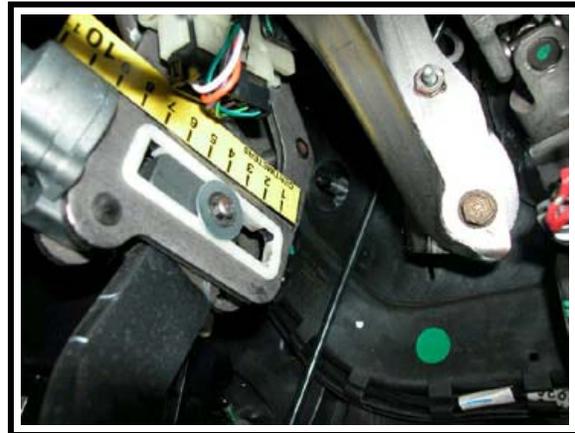
Figure 8. Adjustable pedals—location
