Certified Advanced 208 Compliant Investigation/ Vehicle to Vehicle  
Dynamic Science, Inc. / Case Number: DS03021  
2003 Chevrolet Silverado pickup  
Texas  
May, 2003

| 4. Title and Subtitle<br><br>On Site Certified Advanced 208 Compliant Investigation | | 5. Report Date<br>March 7, 2006 | |

**Dynamic Science, Inc.  
Crash Investigation  
Case Number:DS03021**

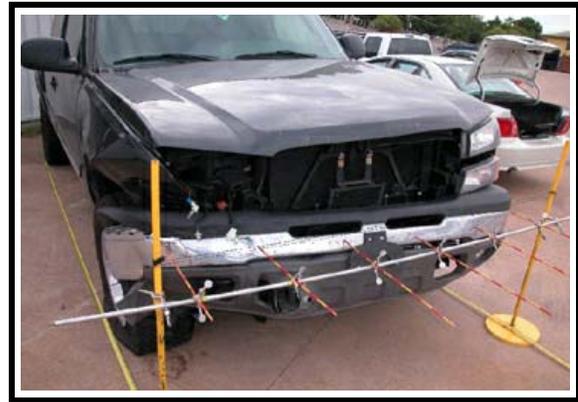
**Figure 1.** Case vehicle frontal damage

The 2003 Chevrolet Silverado pickup sustained moderate front end damage. The direct contact damage that began at the front right bumper corner and extended laterally 60.0 cm (23.6 in) to the left. Maximum crush measured 20.5 cm (8.1 in) at C6.

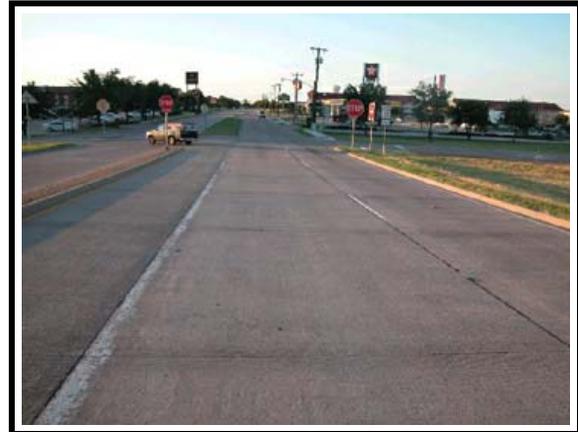
**Figure 2.** Case vehicle—approach to impact (north)

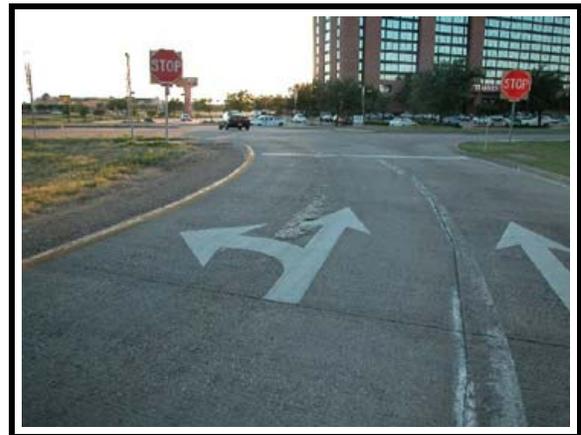
**Figure 3.** Other vehicle—approach to impact (west)

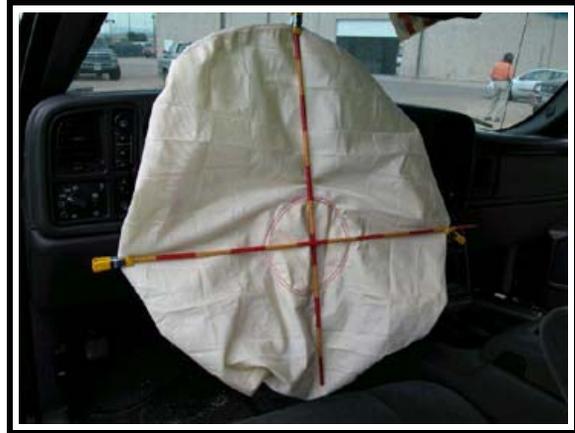
The driver's air bag deployed at impact with the other vehicle. The driver's air bag module was located in the center hub of the steering wheel rim and had two module cover flaps. The flaps opened in a designed I-configuration. Both module cover flaps measured 6.0 cm (2.4 in) by 12.0 cm (4.7 in). There was no contact evidence on the cover flaps. The diameter of the driver's air bag measured 66.0 cm (26.0 in) in its deflated state. The driver's air bag had a maximum excursion of 25.0 cm (9.8 in). It had two vent ports at the 11 and 1 o'clock positions and two tethers. There were 12 vertical folds and 9 horizontal folds on the face of the air bag. There were no indications of occupant contact. The front right passenger air bag was a mid-mount design located in the right aspect of the instrument panel. The front right passenger air bag includes a "Passenger Sensing System". The system is designed to automatically switch the air bag on or off based on a passenger's weight. The system also uses a sensor in the passenger-side seat belt to measure how much tension is exerted by the seat belt when it is being cinched down, to assist in determining what may be on the seat.

**Figure 5.** Case vehicle driver's air bag

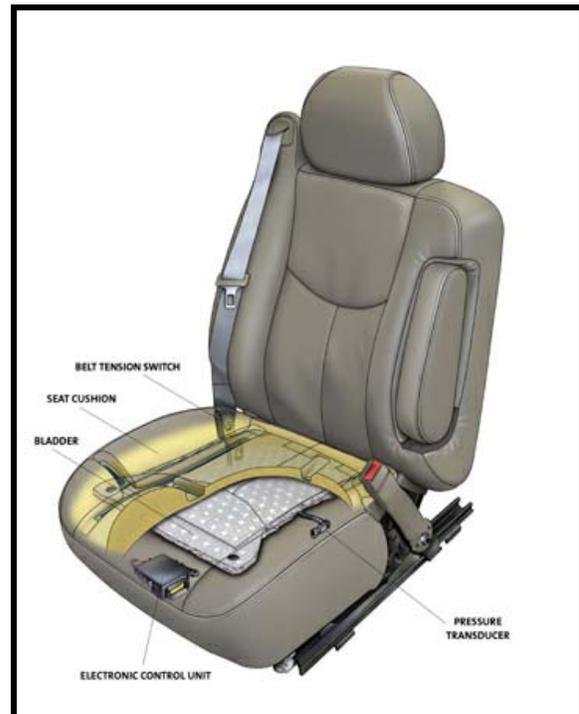
The front right passenger air bag also includes a passenger air bag suppression switch mounted in the center instrument panel. The switch has two positions, air bag OFF and AUTO. The switch was switched to the AUTO position.

The front right passenger air bag did not deploy due to case vehicle being equipped with a Passenger Sensing System, and the absence of a front right occupant. The other vehicle is

**Figure 4.** Front right Passenger Sensing System

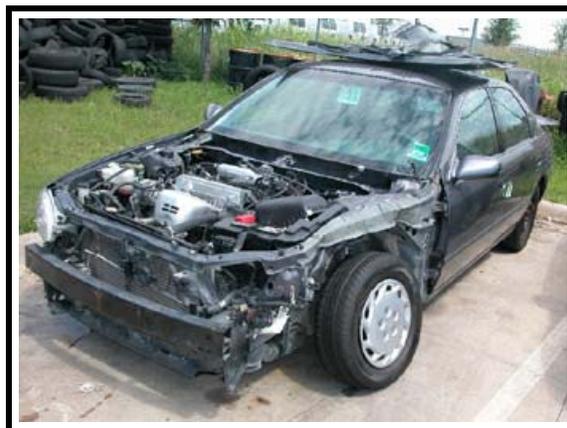
| Damage Description: | Left front fender | |

**Figure 6.** Other vehicle left fender damage

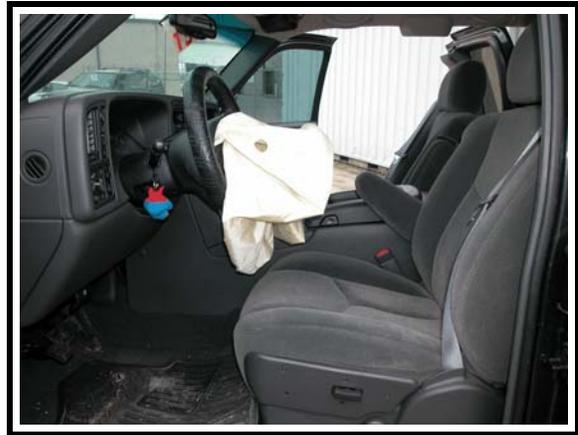
The 20-year-old driver was an upright posture. The manual lap and shoulder belt was not being used. The cloth covered bucket seat was adjusted to the rear most track position. The seat back was slightly reclined rearward. The driver's hand locations are not known. Just prior to impact, he was braking. At impact, the driver's air bag deployed. The driver initiated a forward and slightly right trajectory. He likely engaged the deployed air bag in some fashion, but there were no witness marks on the air bag and no reported injuries.

**Figure 7.** Driver's seated position
