INDIANA UNIVERSITY

REMOTE CHILD AIR BAG-RELATED FATALITY INVESTIGATION

CASE NUMBER - IN-03-025
LOCATION - Ohio
VEHICLE - 1996 FORD CONTOUR
CRASH DATE - July 2001

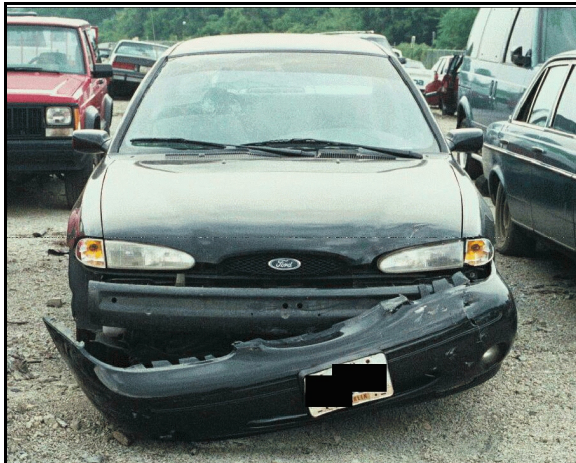
The case vehicle sustained minor direct contact damage on the left corner area of the front bumper, with slight denting and scraping on the hood above the bumper (**Figures 1 and 2**). The bumper cover was loosened and hanging down but was not torn off completely. The left turn signal lens was broken out but the left headlamp was intact. There was an area of focal cracking on the right side of the windshield, directly above the front right passenger's air bag module (**Figures 3 and 4**), and no other glazing damage. None of the tires were deflated or restricted. There are no available photographs that show the case vehicle's interior, but this was a very minor crash and there were no intrusions.

Figure 1: Case vehicle's front, straight on (case photo #01)

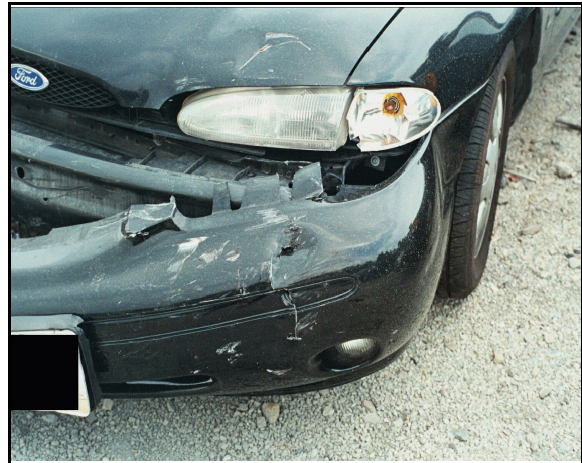
Figure 2: Case vehicle's front left corner, angle view from left (case photo #02)

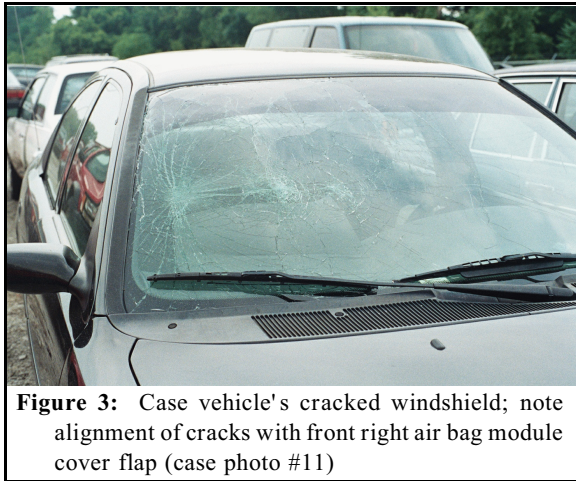
Figure 3: Case vehicle's cracked windshield; note alignment of cracks with front right air bag module cover flap (case photo #11)

The front right passenger's air bag was located at the right portion of the instrument panel, in the top-mount position (**Figure 6**). The areas of deformation on the air bag module cover flap align with areas of focal cracking of the windshield and it seems apparent that the cover flap impacted the windshield (see **Figure 4**). The available photographs do not show any obvious evidence of occupant contact or damage to the air bag.

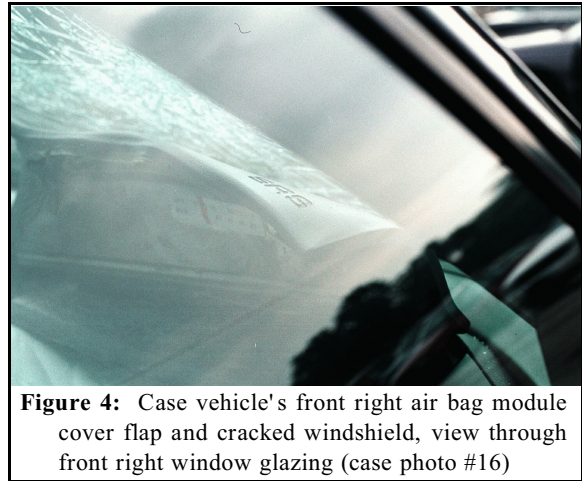
Figure 4: Case vehicle's front right air bag module cover flap and cracked windshield, view through front right window glazing (case photo #16)

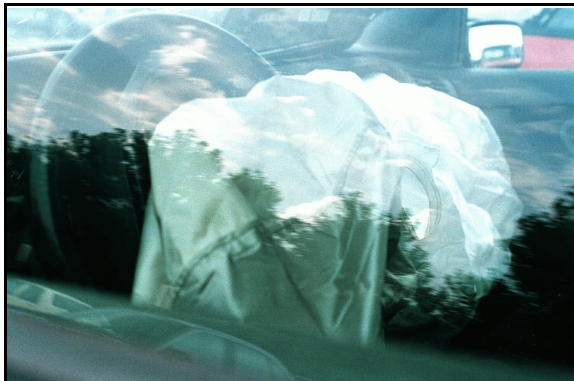
The driver's air bag was mounted in the steering wheel hub (**Figure 5**). There is no knowledge of the cover flap configuration or the size of the air bag, and it is not possible to evaluate whether there was any occupant contact or damage to the driver's air bag. The one available photograph does not show any obvious evidence of contact or damage.

Figure 5: Case vehicle's driver air bag and steering wheel, view through front left window glazing (case photo #13)

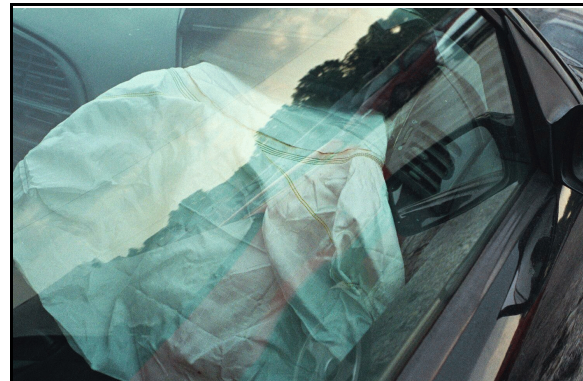
Figure 6: Case vehicle's front right passenger air bag, view through front right window glazing (case photo #14)

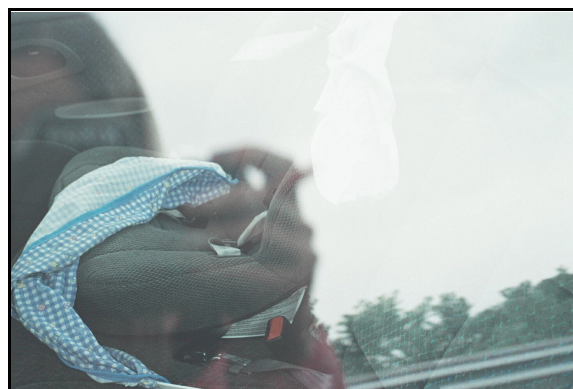
Figure 7: High back booster seat in back right seat position, view through left rear window glazing (case photo #18a)

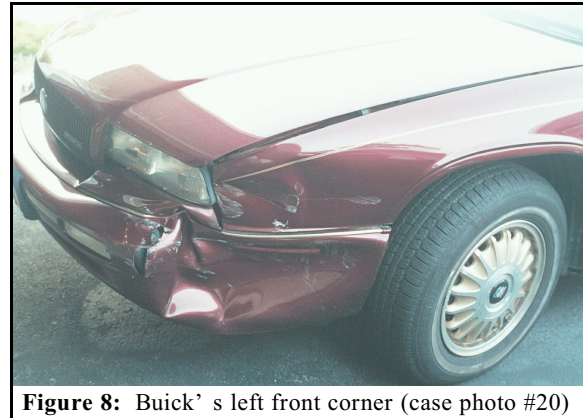
The Buick sustained denting and scraping in the area of the left front overhang. The fender and the left corner of the front bumper were crushed inward but the left headlamp/turn signal assembly was intact. There was no glazing damage and none of the tires were deflated or restricted.

The CDC for the Buick's single impact was estimated from the available photographs as **10-LFEW-2 (310)**. The WinSMASH reconstruction program, CDC only algorithm based on the photo estimated CDCs for the two vehicles, was used. The total, longitudinal and lateral delta-Vs for the Buick are, respectively: 10 km.p.h. [6.2 m.p.h.], -6.4 km.p.h. [-4.0 m.p.h.] and + 7.7 km.p.h. [+ 4.8 m.p.h.]. This is a borderline reconstruction but the results appear reasonable. This was a crash of minor severity (1-13 km.p.h. [1-8 m.p.h.]) for the Buick.

Figure 8: Buick's left front corner (case photo #20)
