**GENERAL DYNAMICS ON-SITE CHILD SAFETY SEAT INVESTIGATION
SCI TECHNICAL SUMMARY REPORT**

CASE NO. CA03-036

VEHICLE – 1994 DODGE GRAND CARAVAN

CRASH DATE – JUNE 2003

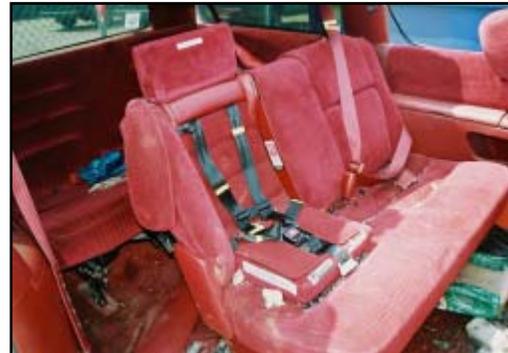
Figure 1. Integrated CSS in the 1994 Dodge Grand Caravan

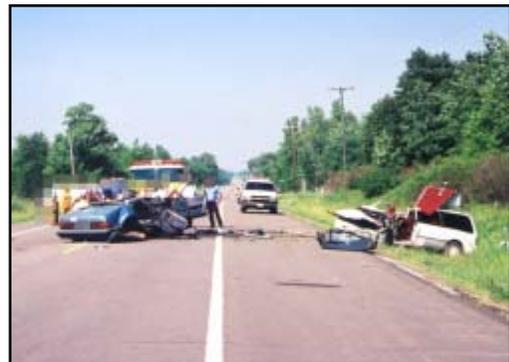
The Grand Caravan impacted the Pontiac 6000 in an angled, offset, head-on configuration. The impact resulted in severe damage to both vehicles, and resulted in the deployment of the frontal air bag system in the Grand Caravan. The directions of force were in the 12 o'clock sectors for both vehicles. The damage algorithm of the WinSMASH program computed a total delta-V of 54.0 km/h (33.6 mph) for the Grand Caravan and a total delta-V of 76.0 km/h (47.2 mph) for the Pontiac 6000 based on the respective crush profiles. The vehicles remained engaged and rotated in a counterclockwise (CCW) direction. Due to the continued engagement and rotation of the vehicles, direct contact from the Pontiac 6000 extended down the left side of the Grand Caravan. Two curved tire marks from the Grand Caravan's front tires were present on the asphalt shoulder from the post-impact rotation and travel to final rest. The vehicles separated and the Grand Caravan came to rest on the grassy roadside facing northwest. The Pontiac 6000 came to rest straddling the centerline facing southeast. Final rest positions are shown in **Figure 4**.

Figure 4. On-scene police photograph of crash site and final rest positions

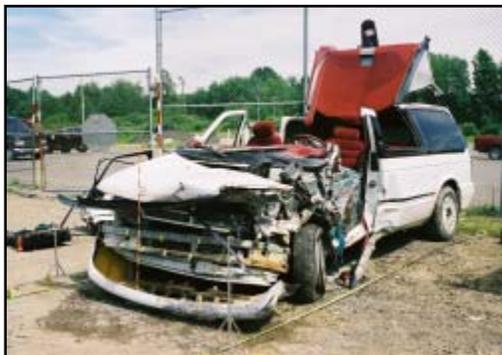
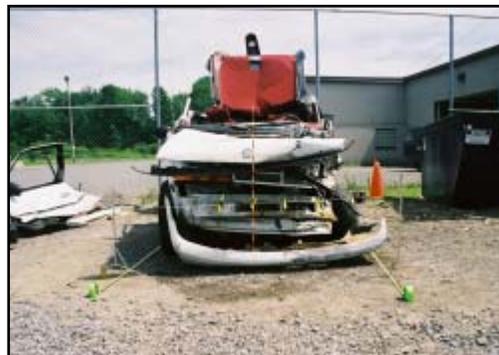
The 1994 Dodge Grand Caravan (**Figures 5 and 6**) sustained severe damage as a result of the frontal impact with the Pontiac 6000. The direct damage began 5.1 cm (2.0”) left of the centerline and extended 78.7 cm (31.0”) to the front left bumper corner. Abrasions and paint transfers were present on the left aspect of the bumper fascia and the bumper fascia was separated from the vehicle. The bumper beam and upper and lower radiator supports were crushed rearward. The maximum crush at the bumper beam was located at the front left corner and measured 94.0 cm (37.0”). The front left aspect of the hood was deflected down and rearward from direct contact and the entire hood was rotated slightly clockwise (CW). The left rear aspect of the hood was separated. The left front fender was completely separated and the left front wheel sustained direct contact, evidenced by tears on the sidewall of the tire and abrasions on the alloy wheel. The frontal crush resulted in a 43.0 cm (16.9”) reduction of the left wheelbase. Due to the post impact engagement and rotation, direct contact abrasions and paint transfers extended along the left side of the Grand Caravan beginning at the left front corner and terminating at the left B-pillar, 123.0 cm (48.4”) aft of the damaged left front axle. The combined direct and induced damage involved the entire frontal width of the Grand Caravan. The bumper

Figure 5. Damaged Dodge Grand Caravan

Figure 6. Frontal view of the damaged Dodge Grand Caravan

beam was shifted to the left and the right front fender was deflected inward at its forward aspect. The left sill was buckled and the plastic cladding along the lower aspect of the left side of the Grand Caravan was separated. Rescue personnel removed the left front door, cut the left and right A- and B-pillars, and folded the roof rearward to facilitate the extrication of the driver. Hydraulic spreaders were used to increase the distance between the left A- and B-pillars, which resulted in post crash deformation to both pillars. The left front door exhibited blue paint transfers and abrasions that extended the entire length of the door. Paint transfers and scuff marks were also present on the plastic cladding that was separated from the bottom aspect of the door. Six crush measurements were documented along the front bumper beam as follows: C1 = 94.0 cm (37.0"), C2 = 73.6 cm (29.0"), C3 = 50.2 cm (19.8"), C4 = 29.8 cm (11.8"), C5 = 12.1 cm (4.8"), C6 = 0.0 cm. The Collision Deformation Classification (CDC) for the impact with the Pontiac 6000 was 12-FYEW-5.

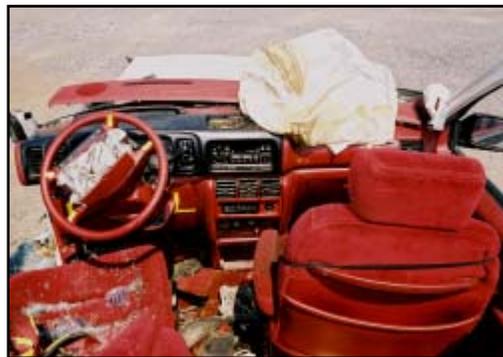
The 1994 Dodge Grand Caravan sustained moderate interior damage as a result of passenger compartment intrusion and occupant contact. **Figure 7** shows the overall front seating positions and related interior damage. The left front door was jammed shut and removed by rescue personnel. The remaining doors were operational. Damage to the windshield and glazing from crash forces could not be determined. The left and right side glazing surrounding the A- and B-pillars was completely removed by rescue personnel to facilitate the removal of the left front door and the folding of the roof. The knee bolster was displaced and deformed on both sides of the steering column from contact with the driver's knees. The tilt steering column was compressed forward and jammed in the full-up position. The plastic cover on the bottom aspect of the steering column was fractured. The steering wheel rim was compressed forward slightly, evidenced by minor separation at the 2, 4, and 8 o'clock spoke locations. The brake pedal arm was cut and the brake pedal removed by rescue personnel to facilitate extrication of the driver. The accelerator pedal was compressed between the left aspect of the center console and the intruded left toe pan. The driver's seat was displaced left and rotated CCW on the seat base. The right instrument panel sustained a diagonal linear impression located 22.9 cm (9.0") inboard of the right instrument panel corner that measured 4.0 cm (1.5") in length. **Figure 8** shows the longitudinal intrusions into the front seating positions. The floor intruded vertically from induced buckling on the left side front and second seat position areas, and measured 8.9 cm (3.5") vertically at the forward aspect of the driver's seat. Lateral intrusions included the left side panel forward of the left A-pillar,

Figure 7. Overall view of damaged front seating positions

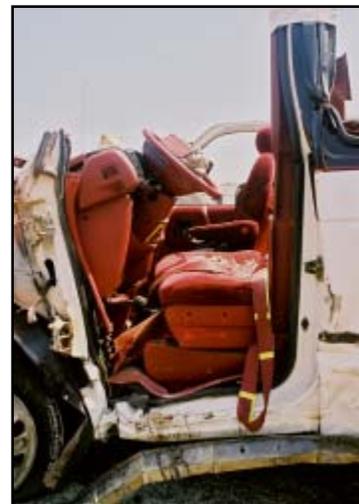
Figure 8. View of displaced driver's seat and related intrusions

left B-pillar and the left side panel rear of the left B-pillar. The driver's seat back was reclined rearward at the time of the vehicle inspection as a result of rescue efforts.

Position	Intruded Component	Magnitude of Intrusion	Direction
LF	Left A-pillar (base)	27.9 cm (11.0")	Longitudinal
LF	Left A-pillar (at level of latch/striker)	19.7 cm (7.8")	Longitudinal
LF	Left toe pan	10.2 cm (4.0")	Longitudinal
LF	Parking brake pedal	10.2 cm (4.0")	Longitudinal
LF	Floor	8.9 cm (3.5")	Vertical
LF	Left B-pillar	11.4 cm (4.5")	Lateral
LF	Left side panel (fwd of A-pillar)	27.9 cm (11.0")	Lateral
2 nd L	Floor	8.9 cm (3.5")	Vertical
2 nd L	Left side panel rear of the left B-pillar	15.2 cm (6.0")	Lateral
2 nd C	Floor	8.9 cm (3.5")	Vertical

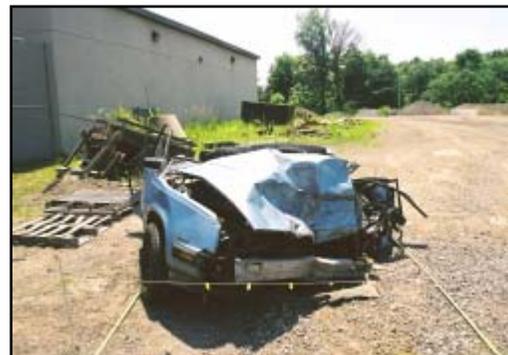
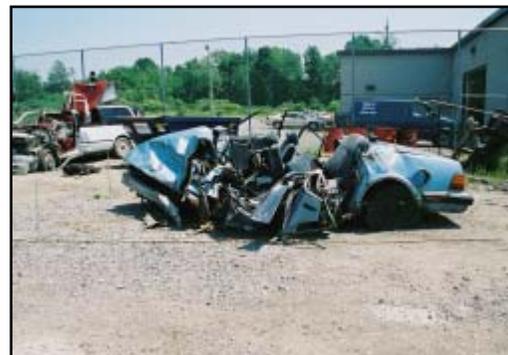
The 1988 Pontiac 6000 sustained severe damage (Figures 9 and 10) as a result of the frontal impact with the Dodge Grand Caravan. The direct damage on the bumper fascia began 11.4 cm (4.5") left of the centerline and extended 69.9 cm (27.5") to the front left corner. The bumper fascia was fractured and completely separated from the vehicle. The hood sustained direct contact abrasions and was crushed and buckled rearward. The front bumper beam exhibited two vertical fractures that were located 27.9 cm (11.0") and 54.6 cm (21.5") left of the centerline. The maximum crush at the front left corner measured 116.8 cm (46.0"). The combined direct and induced damage involved the entire frontal width of the Pontiac 6000. The vehicle frame was buckled and deformed laterally between the B- and C-pillars. The front half of the vehicle was deflected to the right, and the magnitude of the lateral deflection on the right side between the right B-pillar and right C-pillar measured 39.4 cm (15.5"). The right front fender was deflected significantly to the left. The left front wheel was crushed rearward and restricted. The entire left sill was buckled and the left front door was deformed, buckled, and pulled outward from the top aspect by rescue personnel. The frontal crush and frame deflection resulted in a 68.0 cm (26.8") reduction of the left wheelbase and a 9.0 cm (3.5")

Figure 9. Frontal view of damaged Pontiac 6000

Figure 10. Left side view of damaged Pontiac 6000

reduction in the right wheelbase. The rear axle was also displaced due to the vehicle deformation. The roof was removed by rescue personnel to facilitate the extrication of the driver. Six crush measurements were documented along the front bumper beam and were as follows: C1 = 116.8 cm (46.0”), C2 = 109.8 cm (43.2”), C3 = 95.8 cm (37.7”) C4 = 62.8 cm (24.7”), C5 = 42.5 cm (16.7”), C6 = 33.6 cm (13.2”). The CDC for this vehicle was 12-FYEW-5.

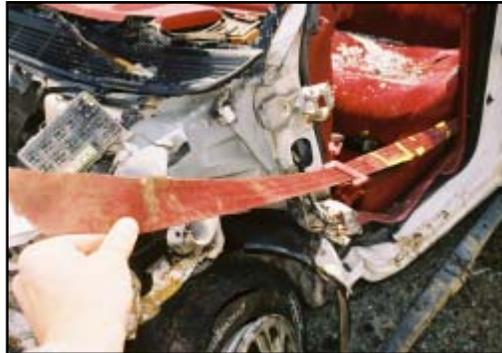
The front seating positions in the Dodge Grand Caravan were configured with manual 3-point lap and shoulder belts. Both front seat safety belts were cut by rescue personnel to facilitate the cutting of the B-pillars, folding of the roof, and extrication of the driver. The driver’s safety belt was configured with a sliding latch plate, adjustable D-ring, and an emergency locking retractor (ELR). The retractor was jammed in the used position, and rescue personnel cut the driver’s safety belt webbing 167.6 cm (66.0”) above the lower anchorage (**Figure 11**). The remaining webbing, which extended from the retractor, measured 50.8 cm (20.0”) from the opening on the B-pillar to the cut point, and 27.9 cm (11.0”) from the driver’s D-ring (located in the full-up position) to the cut point. The driver’s safety belt webbing exhibited minor stretch marks from occupant loading and the D-ring exhibited faint abrasions. A white paint transfer was located 64.8 cm (25.5”) above the lower anchor on the outboard aspect that measured 16.5 cm (6.5”) in length. The plastic hardware of the latch plate sustained minor abrasions as a result of occupant loading.

Figure 11. View of driver's cut safety belt

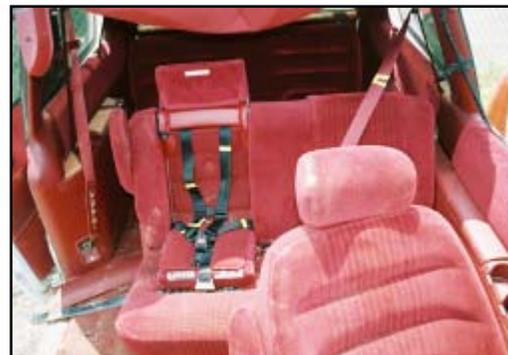
The second row two-person bench seat (**Figure 12**) was configured with manual 3-point lap and shoulder belts for each seating position. Both had fixed D-ring anchors, ELR’s, and cinching latch plates. The right side safety belt was configured with a steel spring clasp on the lower anchor of the lap belt portion. A plastic sleeve that measured 25.4 cm (10.0”) in length and 5.1 cm (2.0”) in width was located adjacent to the clasp on the webbing. The clasp engaged with one of two steel rings labeled “A” and “B”. The “A” ring was located on the floor on the rear right corner aspect of the second row bench seat. The “B” ring was located on the

Figure 12. View of second row restraints

Although the second row right safety belt was not in use during this crash, it was not in the proper position, given the use of the two-person bench seat. The second row left safety belt webbing exhibited an abrasion on the outboard aspect that was located 144.8 cm (57.0”) above the lower anchor. Minor abrasions were noted on the plastic latch plate and faint abrasions were present on the D-ring as a result of occupant loading.

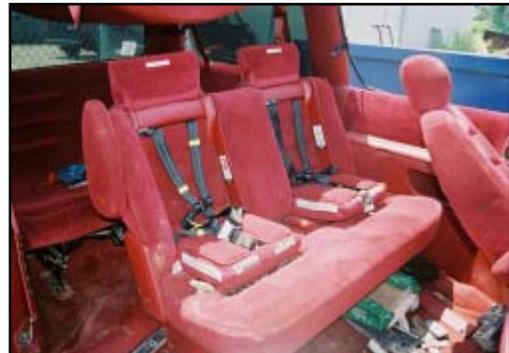
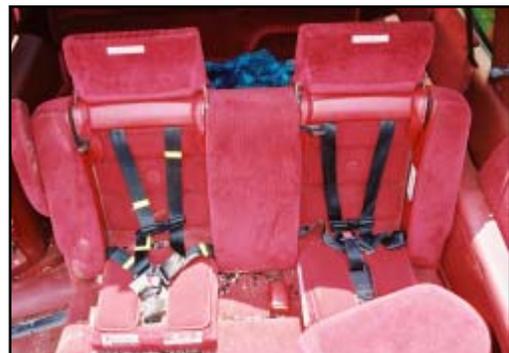
The 1994 Dodge Grand Caravan was equipped with two integrated forward-facing CSS's (**Figure's 13 and 14**) in the second row bench seat. The CSS seat cushions folded forward from the bench seat back and the CSS head restraints rotated upward from the seat back. The CSS head restraints measured 20.3 cm (8.0”) in height, 29.8 cm (11.8”) in width, and 5.7 cm (2.3”) in thickness in the stowed position. In the used position, the CSS head restraint measured 15.2 cm (6.0”) in height. A label was present on the CSS head restraint that read, “This headrest is not intended for use by an adult.” A 7.6 cm (3.0”) long nylon loop was present on the right aspect of each CSS that protruded from under the head restraints in the stowed position, which released the CSS seat cushions and head restraints from the seat back. The CSS head restraint locked into position when fully extended, and could be released to re-stow by pulling on the spring-loaded nylon loop. The CSS seat cushions measured 27.9 cm (11.0”) in width, 33.0 cm (13.0”) in length, and 7.6 cm (3.0”) in height. The CSS cushions extended 21.6 cm (8.5”) forward from the seat back. Horseshoe-shaped removable fabric pads were affixed to each seat cushion with Velcro fasteners, which measured 1.9 cm (0.8”) thick. The

Figure 13. Lateral view of second row integrated CSS's

Figure 14. Overhead view of the integrated CSS's

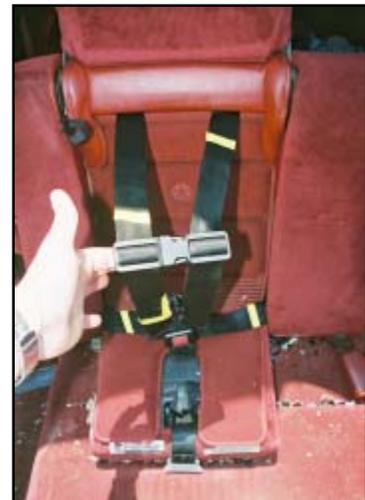
A 13-month-old female child was restrained in the right side integrated CSS. The left side integrated CSS was not used in this crash. At the time of the vehicle inspection, the right side CSS head restraint was found in the stowed position, and it was not known if it was engaged at the time of the crash. The harness system (**Figure 15**) was adjusted such that the length of the harness webbing measured 67.3 cm (26.5") between the harness slots and the lower anchors. The adjustment tab was adjusted to a residual length of 12.7 cm (5.0"). It should be noted that the left side CSS harness system (not used in this crash) was adjusted to the same parameters, and did not show signs of historical use. The pre-crash position of the harness retainer clip was unknown. The harness retainer clip did not exhibit any abrasions or deformation. Minor stretch marks were present on the harness webbing. The loading to the right harness strap began 12.1 cm (4.5") above the lower anchor and extended upward 45.1 cm (17.8"). The loading to the left harness strap began 5.1 cm (2.0") above the lower anchor and extended upward 57.2 cm (22.5"). The plastic harness slots sustained only faint abrasions from the child loading against the harness straps.

Figure 15. Close-up of harness straps of the right side integrated CSS

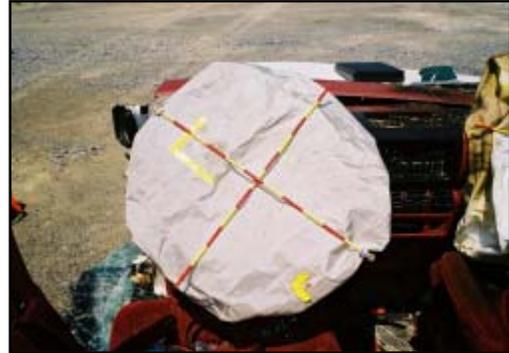
The 1994 Dodge Grand Caravan was equipped with frontal air bags for the driver and front right passenger positions that deployed as a result of the frontal impact. The driver's air bag (**Figure 16**) deployed from the center of the steering wheel hub from symmetrical H-configuration cover flaps. The cover flaps measured 5.7 cm (2.5") in height and 17.8 cm (7.0") in width. The driver's air bag measured 66.0 cm (26.0") in diameter. A fluid transfer (possibly body fluid) was present on the face of the driver's air bag that was vertically centered, located 7.6 cm (3.0") below the horizontal centerline, and measured 10.2 cm (4.0") in length. A small circular body fluid transfer was located 22.9 cm (9.0") above the horizontal centerline and 10.2 cm (4.0") to the right of the vertical centerline that measured 1.3 cm (0.5") in diameter. Faint linear vinyl transfers were present on the outboard aspects of the face of the air bag from engagement against the cover flaps during the deployment. The driver's air bag was vented by two circular ports located at the 12 o'clock position on the rear of the air bag. The vent ports measured 2.5 cm (1.0") in diameter and were located 7.0 cm (2.8") from the circumferential seam and were spaced 5.1 cm (2.0") apart. The air bag was not tethered.

Figure 16. Deployed driver's air bag

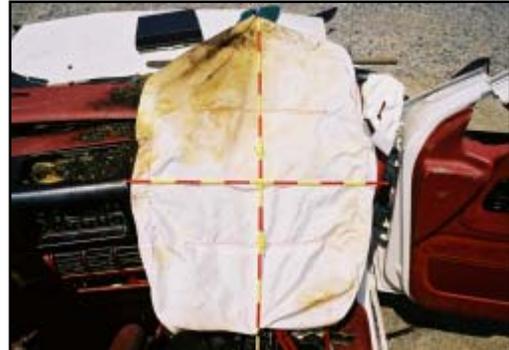
The front right passenger's air bag (**Figure 17**) deployed from a top-mount module with a single cover flap design. The cover flap was rectangular in shape and measured 14.6 cm (5.8") in height and 30.5 cm (12.0") in width. The front right passenger's air bag measured 66.0 cm (26.0") in height and 45.7 cm (18.0") in width. The air bag was vented back through the module, as there were no vent ports located on the air bag. The air bag was tethered by two internal straps that measured 29.8 cm (11.75") in width and were located 15.2 cm (6.0") above and below the horizontal centerline of the air bag. At the time of the inspection, the top aspect of the front right passenger's air bag was covered with of motor oil and crash debris. There was no occupant contact evidence on the air bag.

Figure 17. Deployed front right passenger's air bag
