**GENERAL DYNAMICS ON-SITE ADVANCED OCCUPANT PROTECTION SYSTEM
(AOPS) INVESTIGATION
SCI TECHNICAL SUMMARY REPORT**

CASE NO. CA03-039

VEHICLE – 2001 HYUNDAI ELANTRA

CRASH DATE – JULY 2003

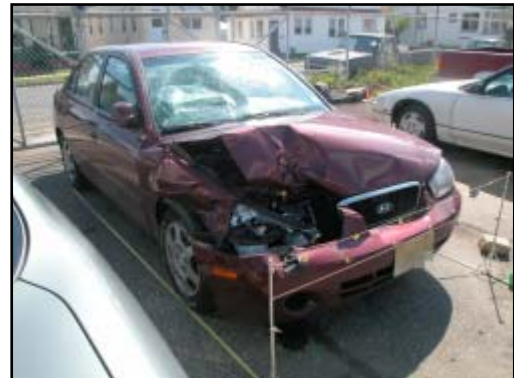
Figure 1. Damaged 2001 Hyundai Elantra

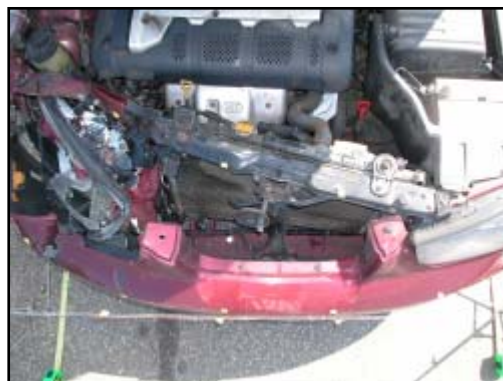
The 2001 Hyundai Elantra sustained moderate frontal damage as a result of the impact with the Blazer. The direct damage on the top aspect of the bumper and leading edge of the hood began 40.0 cm (15.3”) to the right of the centerline and extended laterally 31.1 cm (12.3”) to the front right corner. The top surface of the bumper fascia was scuffed, fractured, and partially separated on the right side aspect. The headlamp was fractured and separated. The hood was crushed and buckled rearward and the right front fender was crushed rearward and buckled outward. Scuffs and paint transfers extended longitudinally on the right front fender. The upper radiator support was crushed rearward (**Figure 5**). The maximum crush was located at the right corner of the upper radiator support and measured 18.0 cm (7.0”). The combined direct and induced damage measured 142.2 cm (52.0”) and involved the entire frontal width of the vehicle. As a result of the above-bumper crush, the engine was displaced rearward. The rearward displacement resulted in the fracture of the front right motor mount at the bolt (**Figure 6**). Direct contact scuffs were present on the upper aspect of the firewall from contact with engine components located in the rear aspect of the engine compartment. Six crush measurements were documented along the upper radiator support and were as follows: C1 = 0.0 cm, C2 = 0.0 cm, C3 = 5.1 cm (2.0”), C4 = 10.2 cm (4.0”), C5 = 15.2 cm (6.0”), C6 = 18.0 cm (7.0”). Bumper crush was present only at C6 (right corner), and measured 2.5 cm (1.0”). Since the above-bumper crush exceeded the bumper crush, the bumper-level crush was used for C1 – C4, and the above-bumper and bumper crush were averaged for C5 and C6, per NASS measurement protocols. The resulting average crush profile used for the WinSMASH

Figure 5. Overhead image of the frontal damage to the Elantra

calculation was as follows: C1 = 0 cm, C2 = 0 cm, C3 = 0 cm. C4 = 0 cm, C5 = 10.7 cm (4.2”), C6 = 10.5 cm (4.1”). The Collision Deformation Classification (CDC) for the impact with the Blazer was 12-FREE-2.

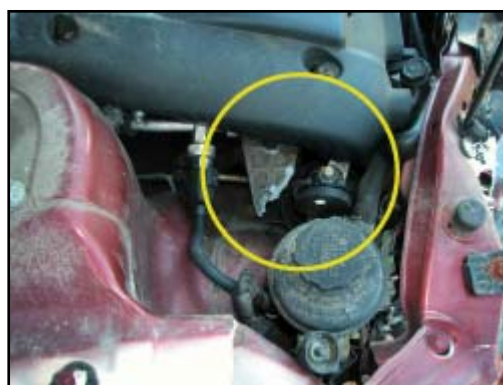
Figure 6. Close-up of fractured motor mount

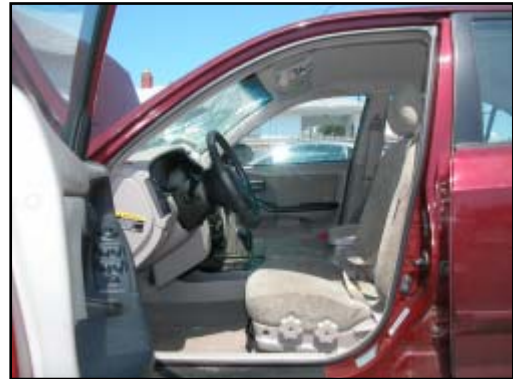
The Elantra sustained minor interior damage (**Figure 7**) as a result of the impact with the Blazer. There were no passenger compartment intrusions. The windshield was fractured from crash forces and from contact with the front right passenger’s air bag and air bag cover flap. A scuff that measured 2.5 x 2.5 cm (1.0 x 1.0”) was located 3.8 cm (1.5”) left of the steering column on the bottom aspect of the knee bolster from probable contact with the driver’s lower leg. The rear view mirror was separated from the windshield. The windshield exhibited white fabric transfers from the front right passenger’s air bag expansion against the interior aspect of the windshield.

Figure 7. Interior view from left side

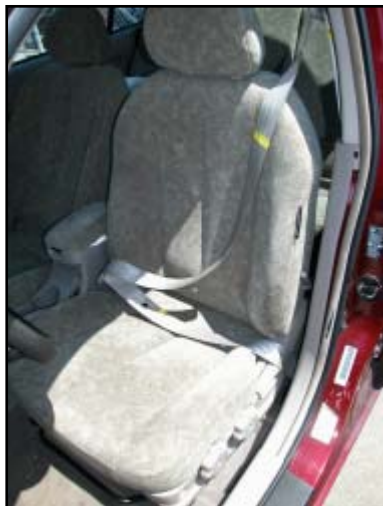
The Hyundai Elantra was configured with manual 3-point lap and shoulder belts for each seating position in the vehicle. The front safety belts (**Figures 8 and 9**) were configured with sliding latch plates and adjustable D-rings that were in the full-up positions. The driver’s safety belt had an Emergency Locking Retractor (ELR) and the front right safety belt had a switchable ELR/Automatic Locking Retractor (ALR). At the time of the vehicle inspection, the driver’s safety belt retractor was locked in the used position. The driver’s safety belt exhibited stretch marks in the webbing that began 47.0 cm (18.5”) above the anchor and extended 82.6 cm (32.5”) upward. Abrasions were present on the plastic D-ring as a result of occupant loading and the retractor pretensioner actuation. A diagonal transfer was present on the safety belt webbing 157.5

Figure 8. Driver's safety belt

cm (62.0”) above the anchor from engagement with the D-ring. Since the front right passenger was unrestrained, the front right safety belt did not exhibit any stretch marks in the webbing and the retractor remained functional. Minor abrasions were present on the front right plastic D-ring from historical use.

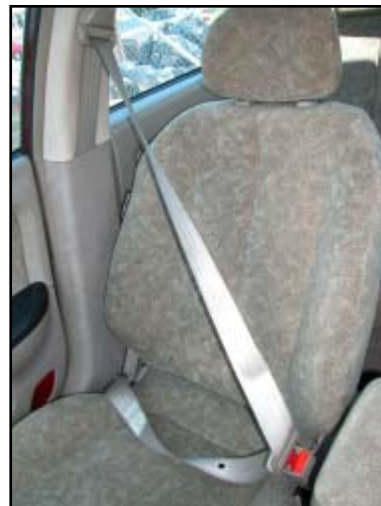
Figure 9. Front right passenger's safety belt

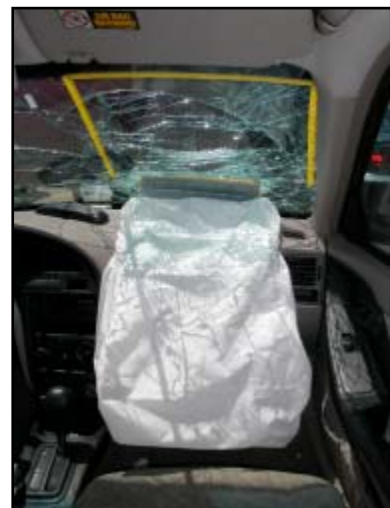
The front right passenger’s air bag deployed from a top-mount module configured with a single rectangular cover flap hinged at the forward aspect that measured 33.0 cm (13.0”) in width and 15.2 cm (6.0”) in height. The cover flap struck and fractured the windshield (**Figure 10**) as the air bag deployed. Air bag transfers

Figure 10. View of cover flap, fractured windshield, and transfer area

were present on the right aspect of the interior windshield. The transfer area measured 43.8 cm (17.3") in width and 40.6 cm (16.0") in height and was located directly over the air bag module. The transfers were longitudinal in orientation and radiated outward on the outboard aspects of the transfer area. Due to the top-mount nature of the air bag module, it appeared that the air bag deployed vertically and was directed rearward (with respect to the vehicle) by the windshield as it expanded. There were no injuries to the front right occupant to support occupant interaction with the air bag during expansion.

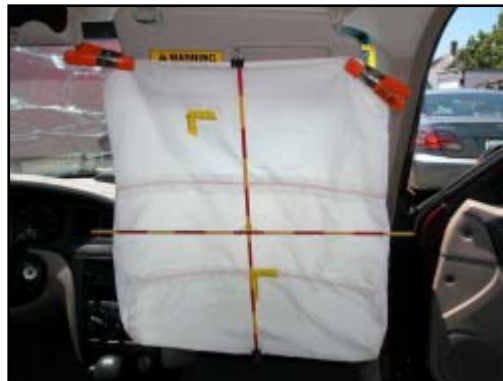
The deployed front right passenger's air bag (**Figure 11**) measured 45.7 cm (18.0") in width and 55.9 cm (22.0") in height. It was vented by two circular ports located on the top aspects of the left and right side panels. The vent ports measured 5.1 cm (2.0") in diameter and were located 17.8 cm (7.0") aft of the face of the air bag. The air bag was tethered by two straps that were horizontally centered and located 19.1 cm (7.5") and 36.8 cm (14.5") from the top aspect of the air bag. Each tether measured 20.3 cm (8.0") in width. A faint scuff mark was located on the top left quadrant of the air bag that measured 2.5 x 1.3 cm (1.0 x 0.5") and was located 7.0 cm (2.5") left of the vertical centerline and 17.1 cm (6.8") above the horizontal centerline. A second faint scuff mark was located on the bottom right quadrant of the air bag that measured 5.1 x 3.2 cm (2.0 x 1.3"). The scuff mark was located 1.3 cm (0.5") right of the vertical centerline and 10.8 cm (4.3") below the horizontal centerline.

Figure 11. Deployed front right passenger's air bag
