**GENERAL DYNAMICS ON-SITE CERTIFIED ADVANCED 208-COMPLIANT  
VEHICLE CRASH INVESTIGATION  
SCI TECHNICAL SUMMARY REPORT**

**CASE NO. CA03-043**

**VEHICLE – 2003 CADILLAC ESCALADE EXT**

**CRASH DATE – JULY 2003**

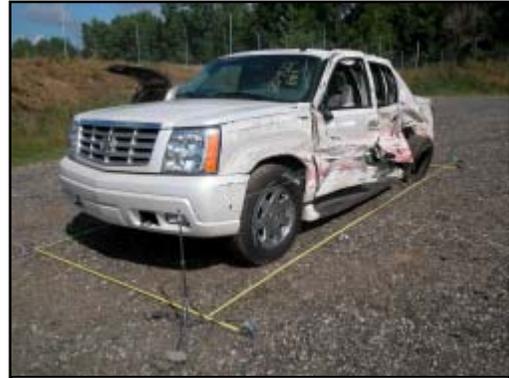
**Figure 1. Damaged 2003 Cadillac Escalade EXT**

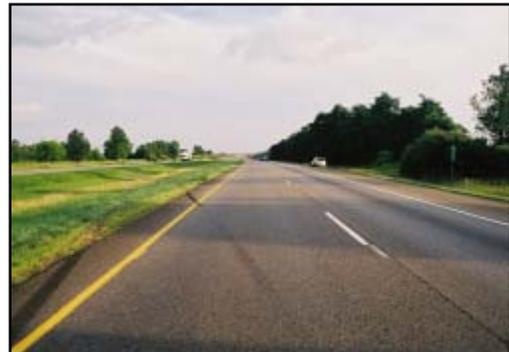
The 57-year-old male driver was operating the Escalade on the southbound inboard lane of the four-lane roadway (**Figure 2**). The EDR summary indicated that the Escalade's travel speed was 126 km/h (78 mph) five seconds prior to the deployment event and 129 km/h (80 mph) one second prior to the deployment event. The 42-year-old female driver of the Pontiac Grand Prix was traveling in the northbound lanes. Her pre-crash travel speed was unknown. The driver of the Grand Prix detected stopped traffic in the northbound lanes, steered left, and lost control of the vehicle. The Grand Prix departed the northbound lanes (**Figure 3**)

**Figure 2. Southbound approach for the Escalade**

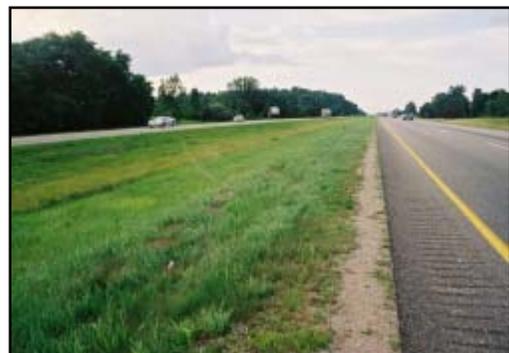
**Figure 3. Northbound approach across the median for the Grand Prix**

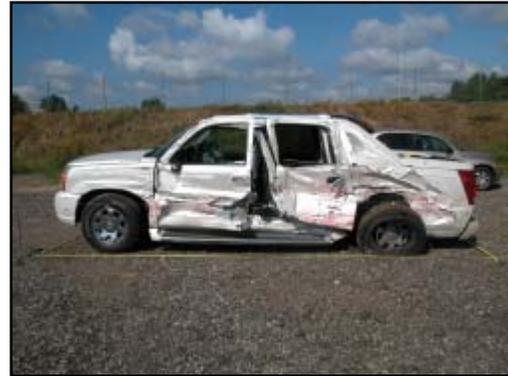
The 2003 Cadillac Escalade sustained moderate left side damage (**Figure 4**) as a result of the initial impact with the Grand Prix. The direct damage began 7.0 cm (2.8") aft of the left front axle and extended rearward 426.0 cm (167.7") along the left side plane. Heavy red paint transfers were present along the entire direct damage length. The transfers began at the bottom aspects of the left side doors and extended 55.9 cm (22.0") vertically. The left front and left rear doors sustained lateral crush and rearward displacement due to the forward momentum of the Escalade and snagging of the Grand Prix. The maximum lateral crush was located 217.0 cm (85.4") aft of the front left axle and measured 27.9 cm (11.0") at mid-door. The base of the left B-pillar was separated and displaced 40.0 cm (16.1") rearward (**Figure 5**). The rear aspect of the left rear door overlapped the left C-pillar 17.8 cm (7.0"). The longitudinal separation between the rear aspect of the left front door and the front aspect of the left rear door measured 34.9 cm (13.8"). The left rear axle was rotated CCW as a result of the direct contact with the Grand Prix. The left rear aspect of the axle was displaced 13.0 cm (5.1") rearward and separated from the left rear control arm. The left rear tire exhibited a tear on the outboard sidewall and was debeaded and restricted against the rear aspect of the left rear quarter panel. The combined direct and induced damage from the initial impact with the Grand Prix measured 426.0 cm (167.7"). The CCW rotation of the rear axle resulted in the reduction of the right side wheelbase by 5.0 cm (2.0"). Although the sideswipe configuration was outside the scope of WinSMASH, six crush measurements were documented along the left side mid-door aspect of the Escalade and were as follows: C1 = 0.0 cm, C2 = 18.4 cm (7.3"), C3 = 25.4 cm (10.0"), C4 = 15.2 cm (6.0"), C5 = 6.6 cm (2.6"), C6 = 5.1 cm (2.0"). The Collision Deformation Classification (CDC) for the impact with the Grand Prix was 12-LDES-2.

**Figure 4. View of left side damage to the Escalade**

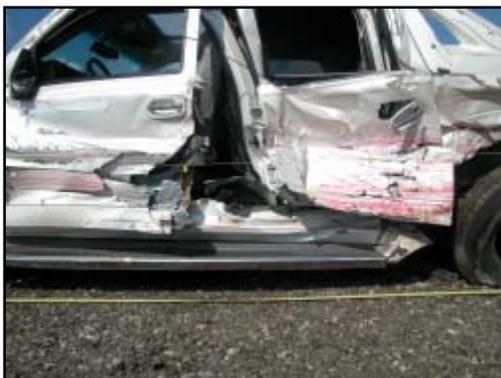
**Figure 5. Close-up of separated left B-pillar**

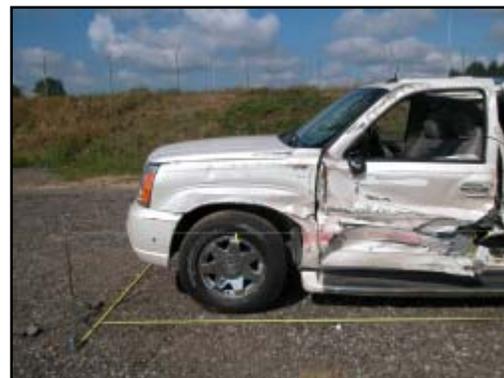
**Figure 6. Close-up of abrasions on the front left aspect from the rollover event**

The Escalade sustained moderate left side damage as a result of the trip-over. Lateral abrasions were present on the left front fender, left A-pillar, left roof side rail, left front door, left rear door, and left rear quarter panel from contact with the asphalt roadway surface (**Figure 6**). The direct

contact damage began 63.0 cm (24.8”) forward of the left front axle and measured 523.0 cm (205.9”) rearward. The combined direct and induced damage from the trip-over event involved the entire left side plane of the Escalade. The CDC for the trip-over event was 00-LDAO-2.

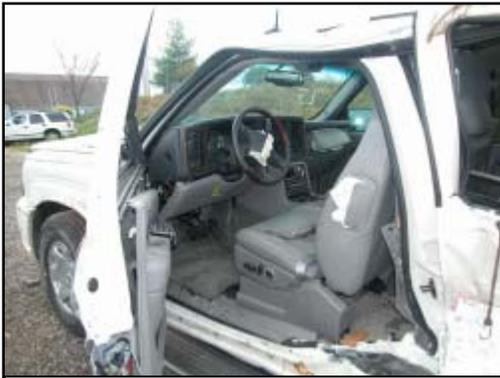
The Escalade sustained moderate interior damage as a result of passenger compartment intrusion and occupant contact (**Figure 7**). The interior left front door panel was deformed and partially separated. Two minor scuff marks were present on the knee bolster 7.0 cm (2.8”) left of the steering column. The left B-pillar was intruded laterally and rearward, and was engaged against the outboard aspect of the driver’s seat back (**Figure 8**). A scuff mark was present on the right forward aspect of the center console 25.4 cm (10.0”) above the floor from contact with the front right passenger’s left leg. The left rear seat cushion was deformed laterally due to the passenger compartment intrusion and the center rear seat cushion was deformed laterally and downward against the rear right seat cushion. The vertical displacement of the center cushion measured 5.1 cm (2.0”).

**Figure 7. Left side view of intrusions and occupant contacts**

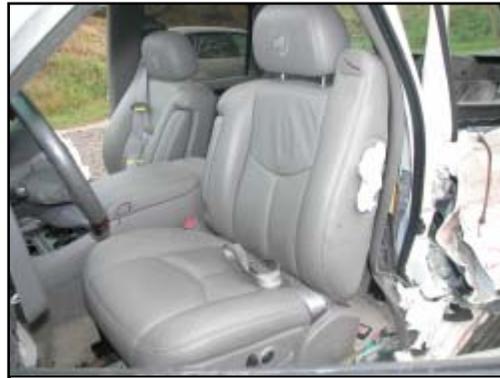
**Figure 8. Left side view showing B-pillar intrusion**

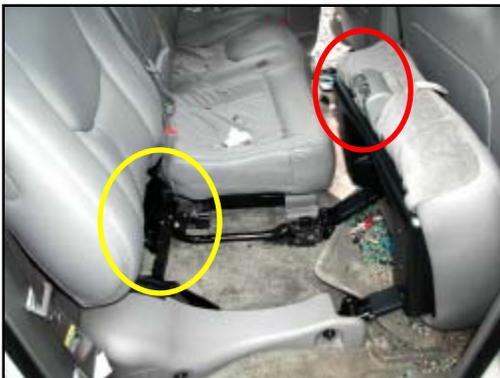
The right rear seat cushion latch located at the rear aspect of the cushion was deformed to the left, and the respective anchor was deformed 6.4 cm (2.5”) to the right, as a result of the left and center seat cushion lateral displacement. Refer to **Figures 9 and 10**.

**Figure 9. Overall view of rear right seat cushion**

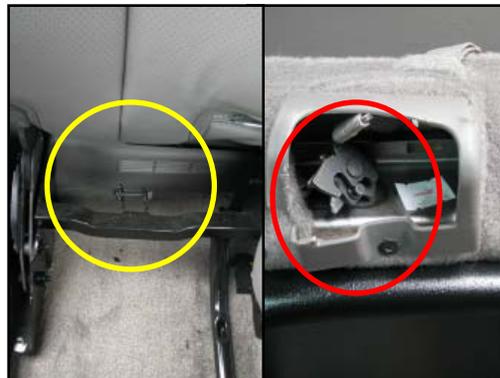
**Figure 10. Close-ups of deformed anchor and latch**

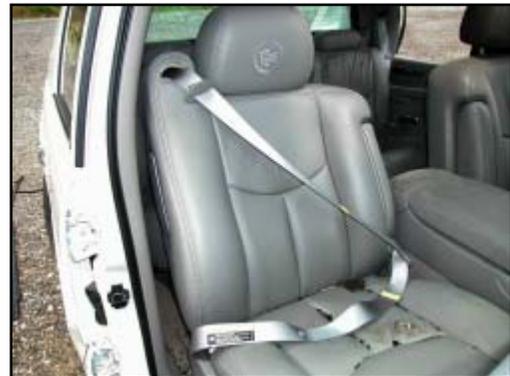
The 2003 Cadillac Escalade EXT was equipped with integrated 3-point lap and shoulder belts for the front seat positions. There was no height adjustment present for the integrated restraints. The driver’s safety belt was configured with an Emergency Locking Retractor (ELR) and a sliding latch plate. The driver’s safety belt webbing had been cut post-crash and used to secure the left front door to the vehicle. The segment of webbing measured 103.5 cm (40.8”) in length. The plastic cover on the driver’s seat back-mounted shoulder belt guide exhibited minor abrasions from engagement with the shoulder belt webbing as a result of driver loading. The front right passenger’s safety belt (**Figure 11**) was configured with a switchable ELR/Automatic Locking Retractor (ALR) and a sliding latch plate. Minor stretching of the webbing measured 24.8 cm (9.8”) in length and was located 63.5 cm (25.0”) above the anchor. The plastic cover on the front right passenger’s shoulder belt guide was abraded from engagement with the shoulder belt webbing from occupant loading.

**Figure 11. View of front right passenger's safety belt**

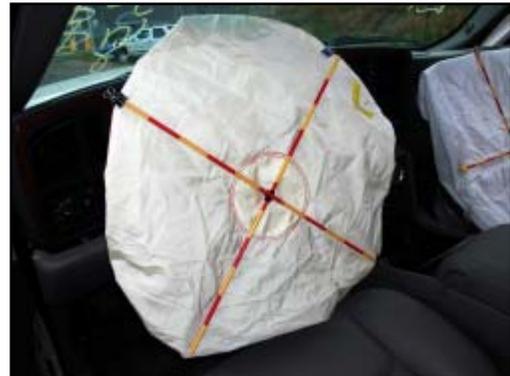
The driver's air bag (**Figure 12**) deployed as a result of the rapid longitudinal deceleration of the Escalade during the initial impact with the Grand Prix. The driver's air bag deployed from the steering wheel hub through symmetrical I-configuration cover flaps. Each flap measured 12.1 cm (4.8") in height and 6.4 cm (2.5") in width. The deployed air bag measured 66.0 cm (26.0") in diameter. The air bag was vented by two circular ports located at the 11 and 1 o'clock positions on the rear aspect of the air bag. The vent ports measured 2.5 cm (1.0") in diameter and were located 8.9 cm (3.5") inboard of the circumferential seam. The air bag was tethered by two internal straps located at the 3 and 9 o'clock positions that measured 12.7 cm (5.0") in width. A minor body fluid transfer that measured 2.5 cm (1.0") in length was located 11.4 cm (4.5") right of the vertical centerline and 24.1 cm (9.5") above the horizontal centerline. Small body fluid transfers were present on the rear right aspect of the air bag from post-crash handling by the occupant.

**Figure 12. Deployed driver's air bag**

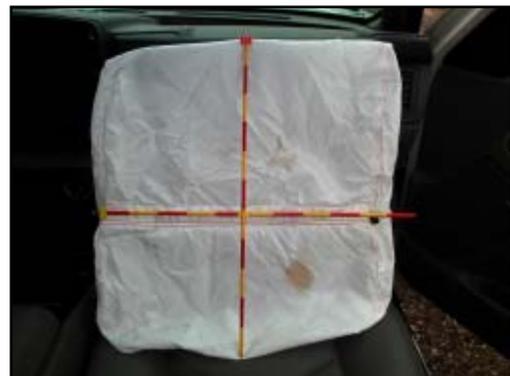
The front right passenger's air bag (**Figure 13**) deployed from a mid-mount module configured with a rectangular cover flap hinged at the forward aspect. The cover flap measured 38.7 cm (15.3") in width and 14.0 cm (5.5") in height. The deployed air bag measured 50.8 cm (20.0") in width and 61.0 cm (24.0") in height. The air bag was vented by two circular ports located at the 3 and 9 o'clock positions on the side panels of the air bag. The vent ports measured 2.4 cm (1.0") in diameter and were located 10.2 cm (4.0") below the top of the air bag and 10.2 cm (4.0") rear of the face of the air bag. The air bag was configured with a full-width tether vertically centered in the air bag. There was no occupant contact evidence on the air bag or cover flap. Dirt and vehicle fluid transfers were present on the face of the air bag.

**Figure 13. Deployed front right passenger's air bag**

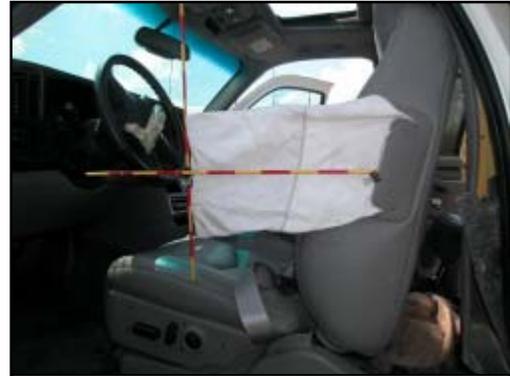
The Escalade was configured with seat back-mounted side impact air bags for the driver and front right passenger positions. Each side impact air bag was configured with a vinyl module cover flap that measured 5.1 cm (2.0”) in width and 15.9 cm (6.3”) in height and was hinged at the rear aspect. The driver’s side impact air bag (**Figure 14**) deployed as a result of the initial left side contact with the Grand Prix. The driver’s air bag deployed forward from the driver’s seat back-mounted module. The air bag measured 40.6 cm (16.0”) in length and 22.9 cm (9.0”) in height, and provided only torso protection. The side impact air bag forward excursion measured 24.1 cm (9.5”) forward of the front aspect of the driver’s seat back. There was no occupant contact evidence present on the driver’s side impact air bag.

**Figure 14. Deployed driver's side impact air bag**

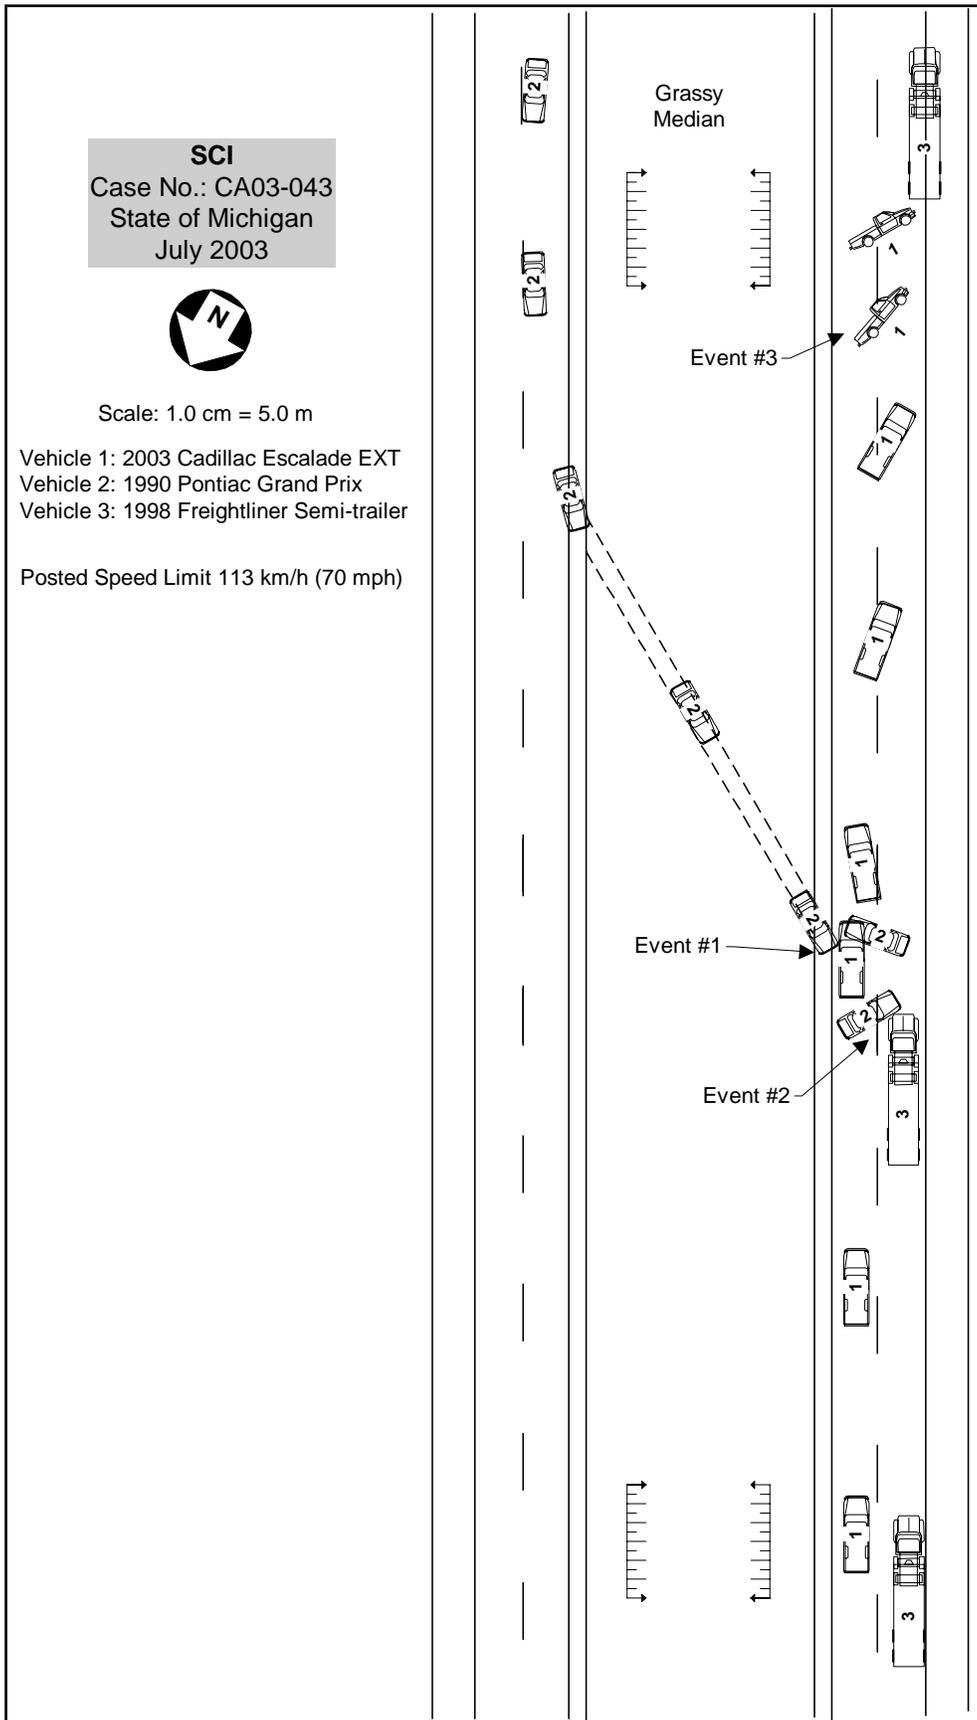
Figure 15. Scene schematic

This three-vehicle crash occurred during the daylight hours of July 2003 in the state of Michigan. At the time of the crash, the weather was clear and the asphalt roadway surface was dry. The crash occurred on the southbound lanes of a four-lane divided roadway. The roadway was straight and level at the crash site. It was configured with two travel lanes in each direction that were separated by a grassy median that measured 18.4 m (60.4') in width. The southbound travel lanes were separated by a broken white centerline and bordered on the inboard aspect by a solid yellow fog line and on the outboard aspect by a solid white fog line. The travel lanes were bordered by asphalt shoulders that measured 1.4 m (4.6') and 3.4 m (11.2') on the inboard and outboard aspects, respectively. The posted speed limit for the north/south roadway was 113 km/h (70 mph). The scene schematic is included as **Figure 15** of this report.
