ON-SITE CHILD SAFETY SEAT INVESTIGATION

CASE NUMBER - IN-03-047

VEHICLE - 1996 TOYOTA CAMRY

CRASH DATE - November 2003

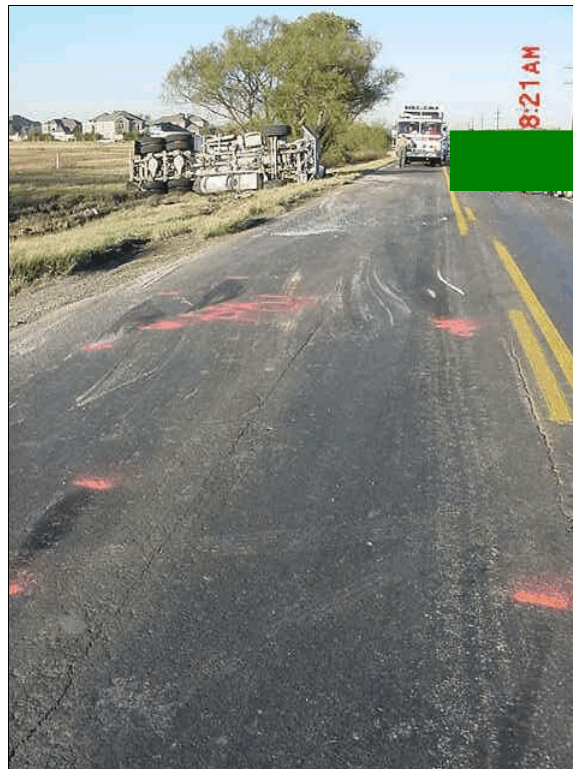
Crash: The left side of the Mack truck (i.e., specifically, the cement tank of the mixer) impacted the eastbound lane of the roadway (**Figure 3**) and began to slide along the eastbound lane in a west-southwesterly direction toward the south edge of the roadway. As the Mack truck was rolling over, its rear end rotated clockwise (**Figure 4**). As a result, the Mack truck was "heading" in a west-northwesterly orientation as it slid along the eastbound lane. The case vehicle's driver braked attempting to avoid the crash (**Figure 5** below). The case vehicle's involvement also occurred in the eastbound lane of the roadway.

Figure 3: On-scene view of Mack truck's westerly travel path across centerline before rolling over and depositing tire scuffs and scrapes in eastbound lane; Note: POI mark indicates area where Mack's cab struck pavement and final rest position on south roadside (case photo #13a)

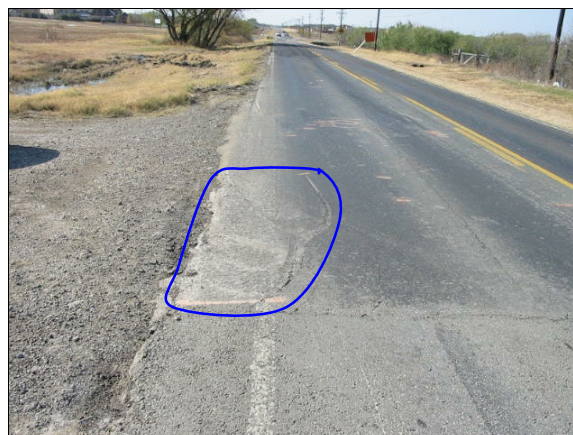
Figure 4: Impact evidence (circle) on south edge of pavement from Mack truck's left rear as a result of truck's rollover in eastbound lane; Note: POI mark indicates cab's impact area (case photo #14)

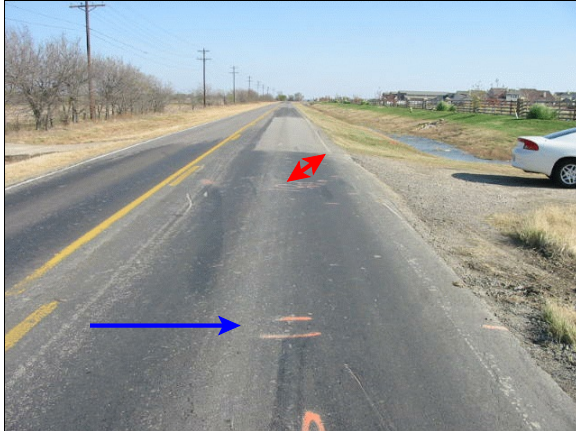
Figure 5: Case vehicle's eastbound travel path at point of impact (blue arrow) with Mack truck which had rolled onto its left side (red arrows) and was sliding in a west-southwesterly direction (case photo #03)

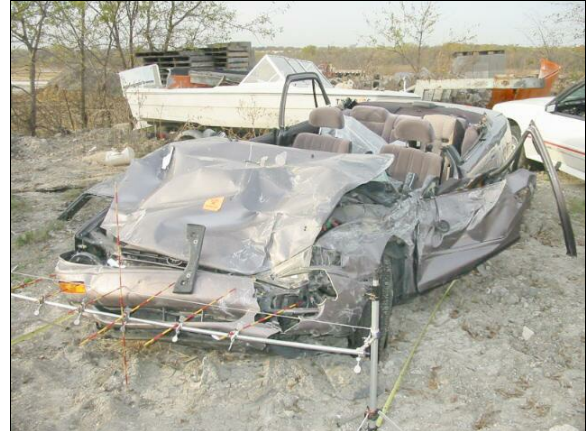
Figure 6: Damage to case vehicle's front, both at and above bumper levels, as a result of vehicle's penetration over Mack truck's engine compartment and into cab area; Note: damage occurred to left side and most likely undercarriage as well (case photo #25)

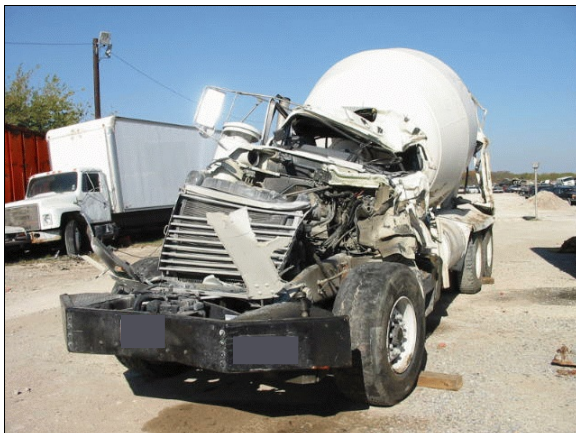
Figure 7: Mack truck's damaged engine and cab areas, viewed from left of front, as a result of case vehicle's penetration impact while Mack was on its left side (case photo #110)

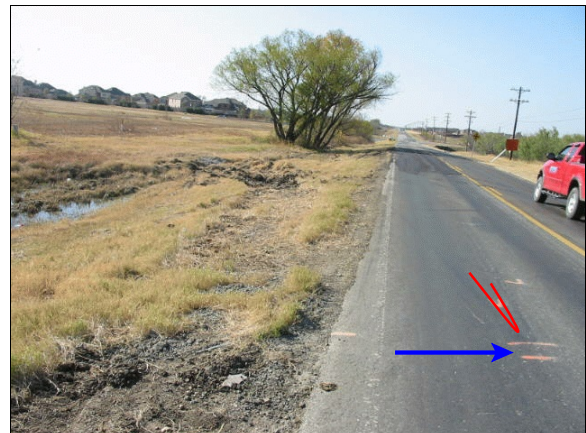
Figure 8: Case vehicle's point of impact (blue arrow) and post-crash travel path; Note: backward deflection path (red line) of rear tire skid mark (case photo #05)

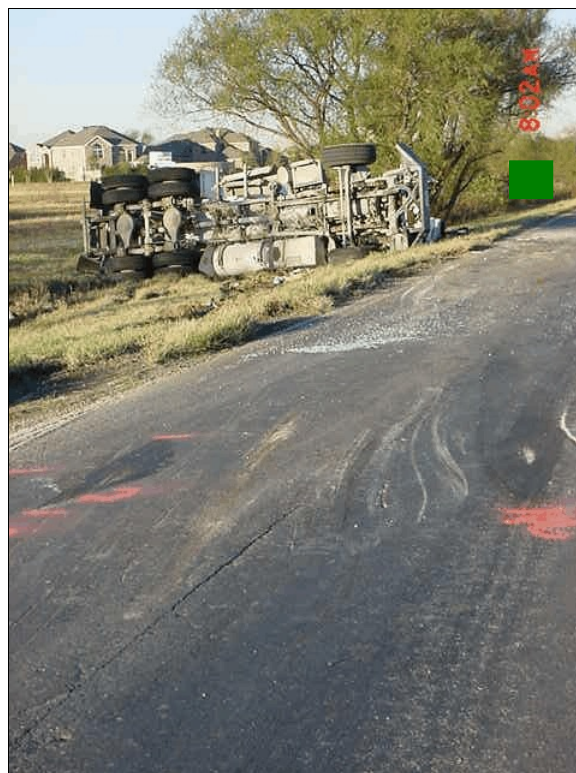
Figure 12: On-scene view of Mack truck's west-southwesterly path on its left side, after rolling over; Note: Mack rotated clockwise as it slid into impact with case vehicle and toward final rest position on south roadside (case photo #15a)

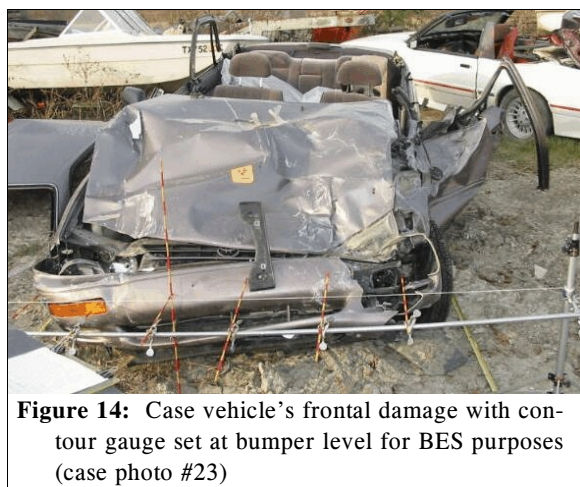
Figure 14: Case vehicle's frontal damage with contour gauge set at bumper level for BES purposes (case photo #23)

Exterior Damage: The case vehicle's initial contact with Mack truck involved the entire front end (**Figure 14**). Direct damage extended across the entire width of the front bumper, a measured distance 140 centimeters (55.1 inches). Undeformed end width was determined to be 162 centimeters (63.8 inches). Residual maximum crush was measured as 25 centimeters (9.8 inches) at C₂ (**Figure 15**). The table below shows the case vehicle's crush profile.

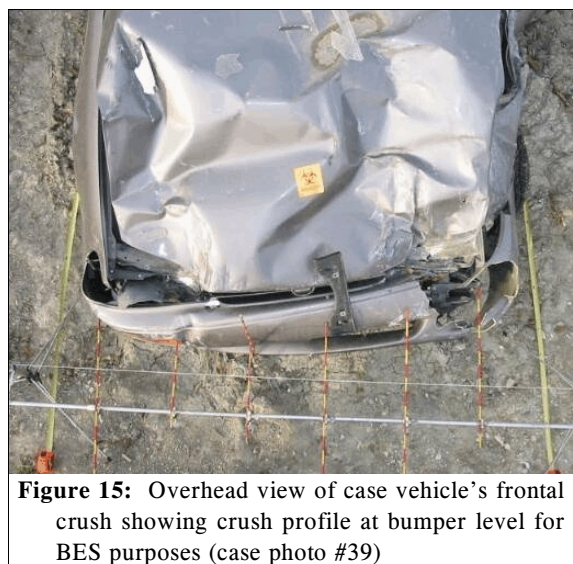
Figure 15: Overhead view of case vehicle's frontal crush showing crush profile at bumper level for BES purposes (case photo #39)

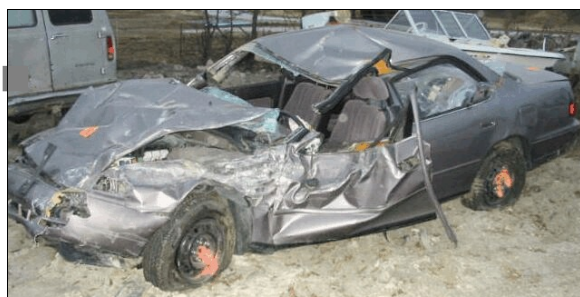
Figure 16: Case vehicle's front and left side damage viewed from front of left with roof, cut for extrication purposes, placed back on top of body (case photo #25a)

The wheelbase on the case vehicle's left side was shortened 12 centimeters (4.7 inches) while the right side was extended 7 centimeters (2.8 inches). The case vehicle's front bumper, bumper fascia, grille, radiator, hood, and right and left headlight and turn signal assemblies were directly damaged and crushed rearward (**Figure 6** above). Contact was also made to the left fender and left front door, both of which were crushed inward (**Figure 16**). Furthermore, there was direct damage to the front left portion of the roof, which was crushed downward (**Figure 17**). In addition, there was possible direct contact to the windshield; although, this is difficult to tell as the roof and all pillars were removed from the vehicle by rescue personnel.

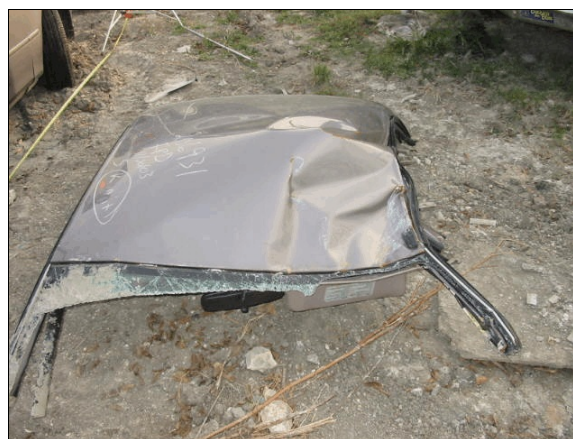
Figure 17: Case vehicle's roof, removed for extrication purposes, showing direct damage above driver's seating area most likely from contact with hood of Mack truck (case photo #23a)

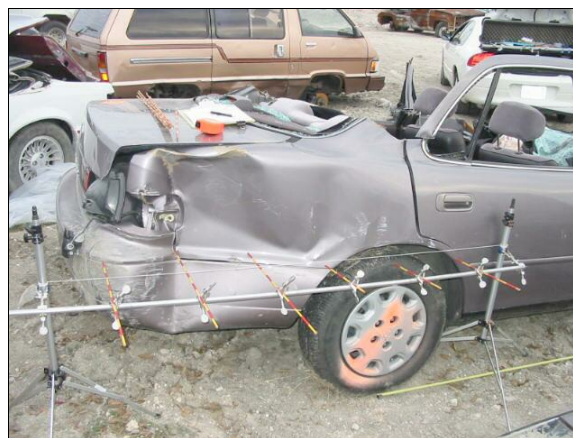
The case vehicle's secondary contact with the Mack truck involved its right rear side. Direct damage began 15 centimeters (5.9 inches) forward of the right rear axle and extended a measured distance of 120 centimeters (47.2 inches), rearward to the left rear bumper corner (**Figure 18**). The Field L was determined to be 130 centimeters (51.2 inches). Residual maximum crush was

Figure 18: Damage to case vehicle's right quarter panel (3rd event) from impact by unknown portion of Mack truck's left side during vehicle's counter-clockwise rotation to final rest (case photo #32)

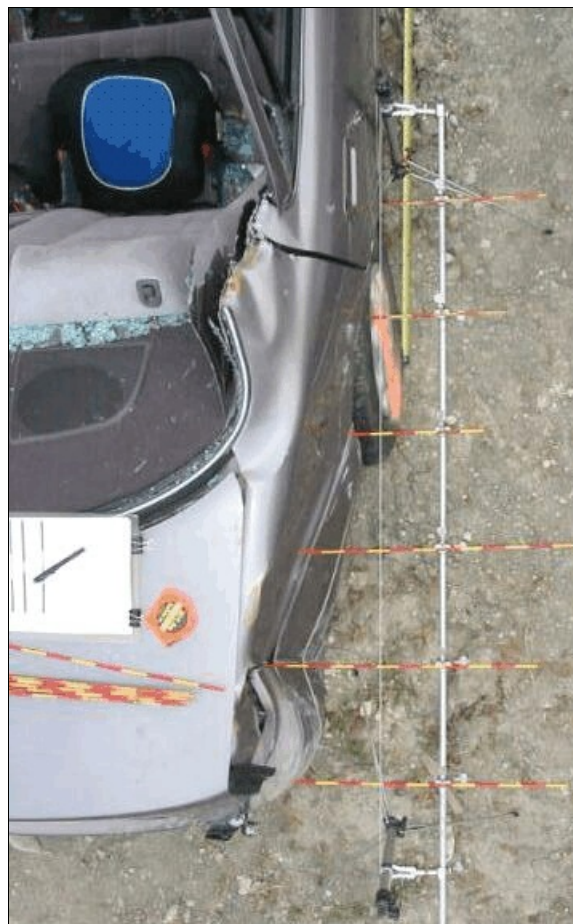
measured as 21 centimeters (8.3 inches) at C₂ (**Figure 19**). The table above shows the case vehicle's crush profile. The case vehicle's right quarter panel, right rear taillight and turn signal assemblies, and right rear bumper fascia—including the portion extending just under the rear quarter panel, were directly damaged and crushed inward. There was induced damage to right front and rear turn signal assemblies as well as to the hood, roof, the windshield's glazing, and the right fender. All right and left side glazing as well as the backlite were disintegrated, but it is unclear if this resulted from the crash or occupant extrication.

Figure 19: Overhead view of case vehicle's right side damage showing crush profile for BES purposes (case photo #34)

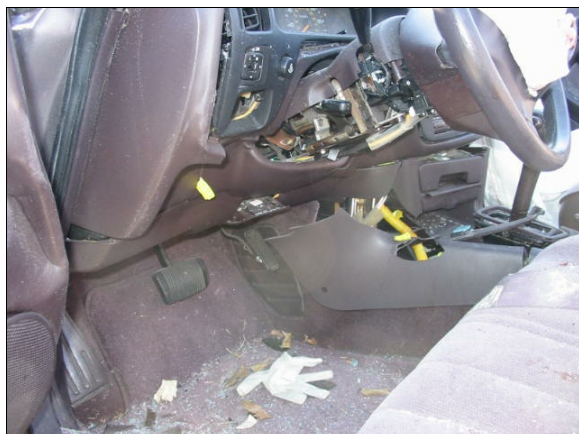
Interior Damage: Inspection of the case vehicle's interior revealed contact on the left side (**Figure 20** below) of the driver's knee bolster and on the left lower instrument panel area. Furthermore, there was contact to the right (**Figure 21** below) side of the driver's knee bolster, just to the right of the steering column and possibly to the underneath side of the steering column as well as the left side of center instrument panel/center console. In addition, there was contact to the driver's sun visor and the left windshield header (**Figure 22** below). The vehicle's roof was intruded downward, but because of its removal, the intrusion could not be measured. Finally, there was no evidence of compression to the energy absorbing shear capsules in the steering column and no deformation to the steering wheel rim.

Figure 20: Case vehicle's driver seating area showing contact evidence on knee bolster and lower left instrument panel (case photo #56)

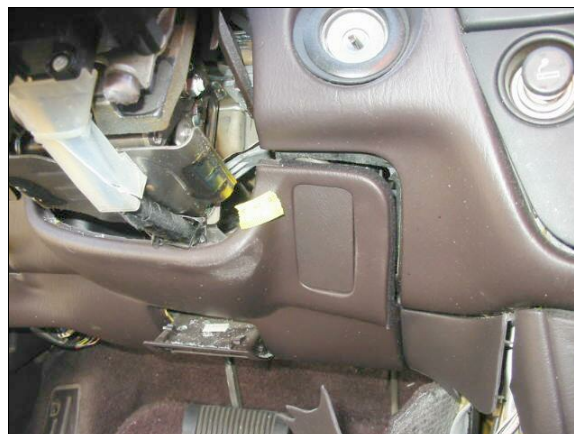
Figure 21: Close-up of contact evidence (i.e., scuff) on case vehicle's driver knee bolster, just right of steering column (case photo #58)

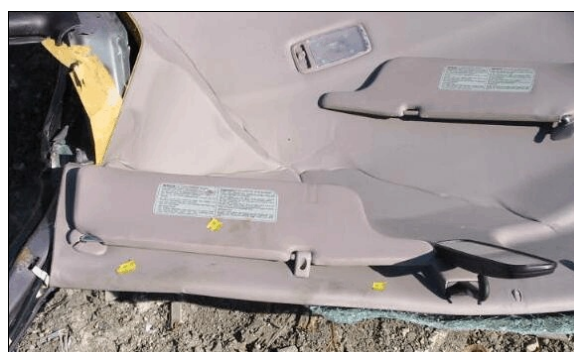
Figure 22: Overhead view of interior surface of case vehicle's roof showing contact evidence on driver's sun visor and roof's windshield header (case photo #62)

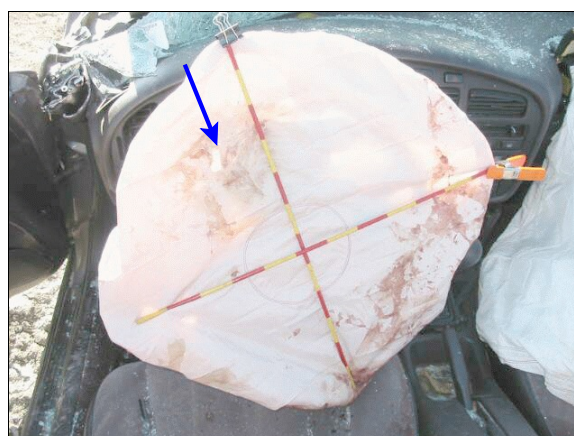
Figure 25: Case vehicle's deployed driver air bag showing copious blood evidence on air bag's front surface; Note: hole (arrow) in upper left quadrant toward 11 o'clock position (case photo #50)

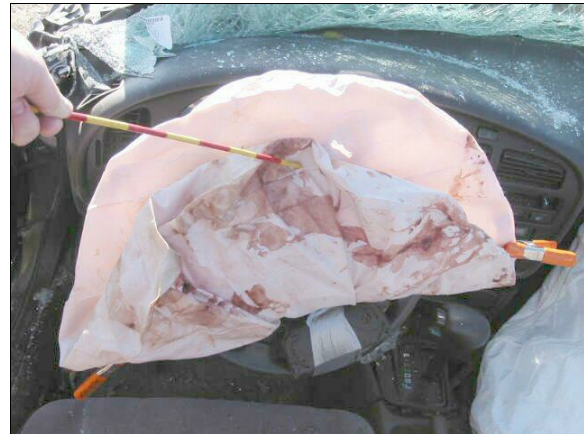
Figure 26: Case vehicle's deployed driver air bag showing copious blood stains on back lower half (case photo #53)

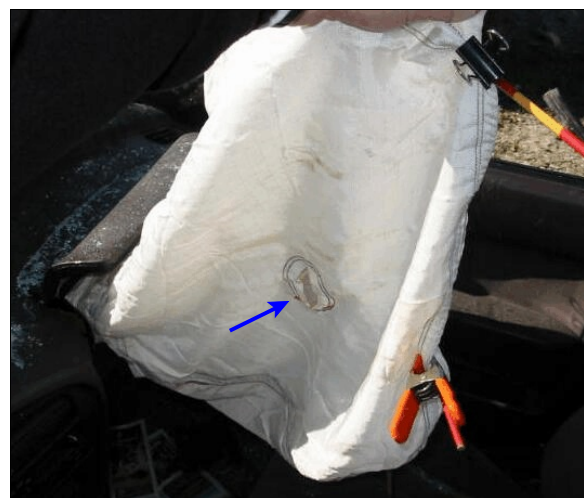
driver's module. The flap's dimensions were 36 centimeters (14.2 inches) at the lower horizontal seam and 17 centimeters (6.7 inches) along both vertical seams. The profile of the case vehicle's instrument panel was flush with the leading edge of the cover flap. An inspection of the front right air bag module's cover flap and the air bag's fabric revealed that the cover flap opened at the designated tear points, and there was no evidence of damage during the deployment to the air bag or the cover flap. The front right passenger's air bag was designed without any tethers. The front right air bag had two vent ports, approximately 4 centimeters (1.6 inches) in diameter, located at the 3 and 9 o'clock positions. The deployed front right air bag was rectangular with a height of approximately 80 centimeters (31.5 inches) and a width of approximately 53 centimeters (20.9 inches). There was no distance (i.e., touched seat back) between the mid-center of the front right seat back, as positioned at the time of the vehicle inspection, and the front surface of the air bag's fabric at full excursion. An inspection of the front right passenger's air bag fabric revealed no contact evidence readily apparent on the front surface of the front right air bag's fabric (**Figure 27**). However, there was a blood spot on the left side surface (**Figure 28**), most likely a splatter spot from the case vehicle's driver.

Figure 28: Left side surface—relative to the front right seating position, of case vehicle's deployed front right air bag, showing blood (arrow) on surface near vent port, most likely from driver (case photo #66)

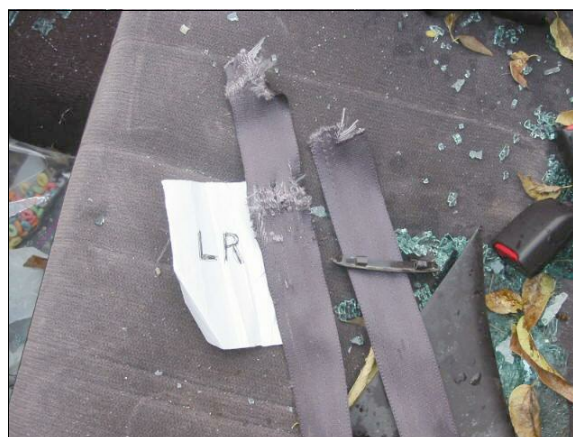
Figure 41: Webbing of case vehicle's back left safety belt showing extrication cuts (case photo #71)

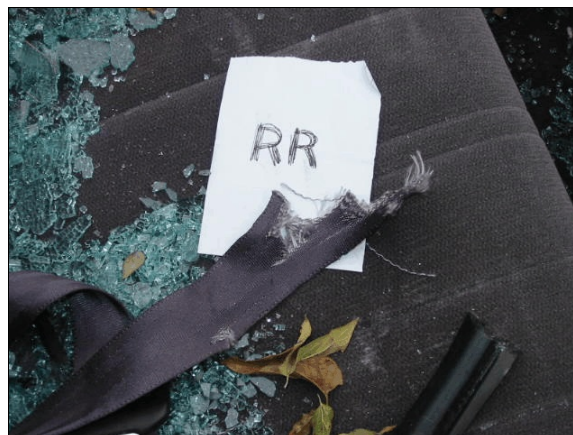
Figure 42: Webbing of case vehicle's back right safety belt showing extrication cuts (case photo #71a)

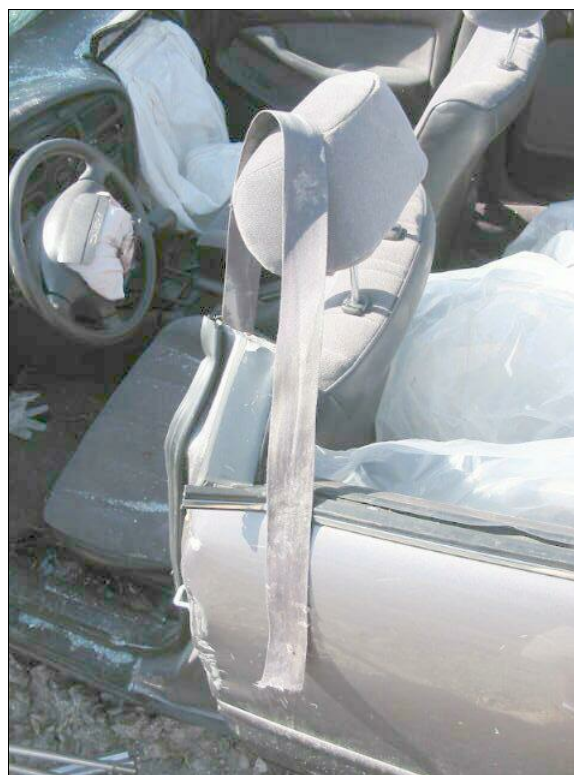
Figure 43: Webbing of case vehicle's driver safety belt showing extrication cuts (case photo #60)

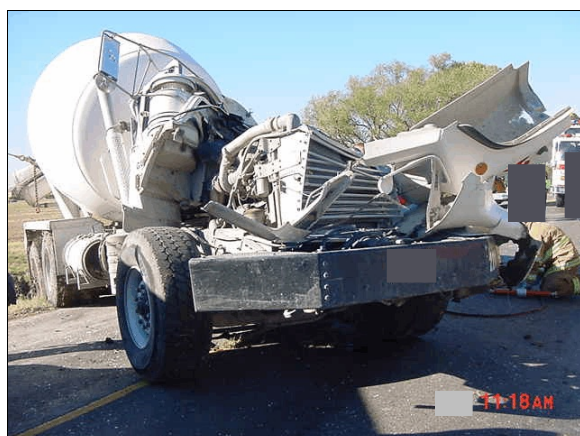
Figure 44: Mack truck's damaged front viewed from right of front; Note: truck was sliding along on its left side when case vehicle struck and overrode engine compartment, penetrating into cab area (case photo #116)

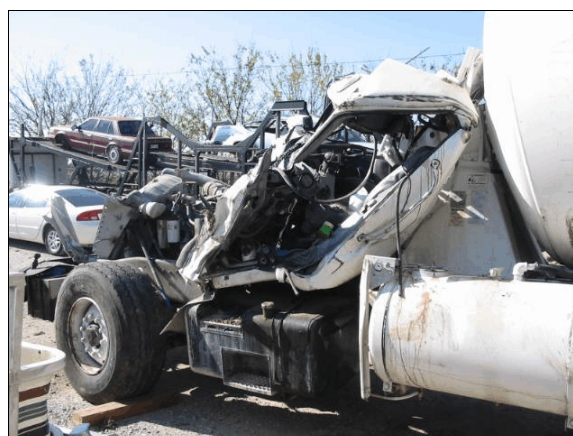
Figure 45: Mack truck's damaged cab area, viewed from back of left; Note: front of case vehicle penetrated into truck's cab while Mack was sliding along on its left side (case photo #113)
