**ON-SITE PASSENGER AIR BAG RELATED FATALITY INVESTIGATION
GENERAL DYNAMICS CASE NO: CA03-049**

**SUBJECT VEHICLE – 1998 DODGE NEON
LOCATION - PENNSYLVANIA
CRASH DATE – AUGUST 2003**

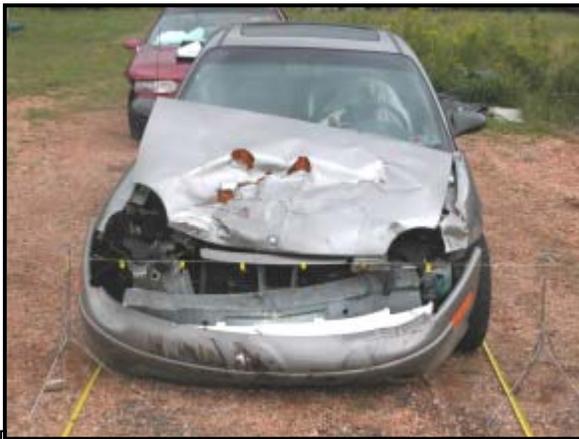
Figures 4 and 5 are the front and left lateral views of the 1998 Dodge Neon. The Dodge sustained moderate frontal damage as a result of the impact with the Ford. The direct contact damage began at the left front bumper corner and extended across the vehicle's entire 142.2 cm (56.0 in) front end width. The front structure of the Dodge was shifted 11.4 cm (4.5 in) to the right as a result of the lateral momentum of the Ford during the vehicle engagement. The hood, both front fenders and front support structures were also deformed rearward. The longitudinal length of the direct contact to the hood measured 42.9 cm (16.5 in) along the vehicle's centerline. A 66 cm x 20 cm (26 in x 8 in) area of paint transfer from the Ford was identified within the hood's direct contact damage. The windshield, roof and side glazing were not damaged. All four doors remained closed during the crash and were operational post-crash. There was no change in the wheelbase dimensions. The bumper fascia was partially separated and rotated down. The residual crush documented along the bumper reinforcement was as follows: C1 =

22.0 cm (8.6 in), C2 = 23.0 cm (9.1 in), C3 = 25.0 cm (9.8 in), C4 = 20.0 cm (7.9 in), C5 = 9.0 cm (3.1 in), C6 = 0. Maximum crush was located on the centerline of the vehicle and measured 27.9 cm (11.0 in). The Collision Deformation Classification (CDC) for the impact with the Ford was 71-FDEW-2 with an incremented shift value of 60. The damage algorithm of the WinSmash program computed a total velocity change of 19.0 km/h (11.8 mph) for the Dodge. The longitudinal and lateral components were -17.9 km/h (-11.1 mph) and 6.5 km/h (4.0 mph), respectively.

Figure 4: Front view of the Dodge.

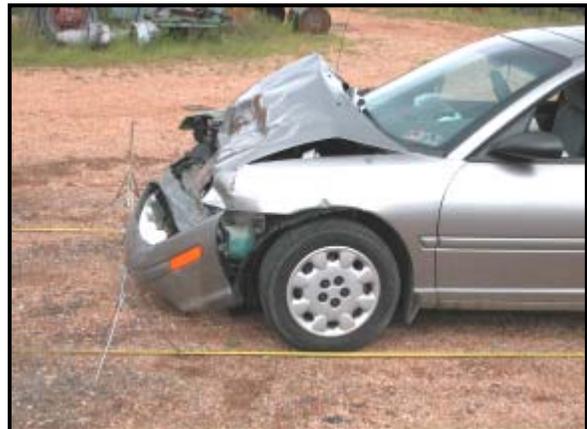
The left front fender exhibited sideswiping damage from secondary contact with the right doors of the Ford that occurred during vehicle separation. The direct contact measured 55.9 cm (22.0 in) in length. The damage began 8.9 cm (3.5 in) rear of the left front axle and extended forward. The CDC for this impact was 06-LFES-1.

Figure 5: Left lateral view.

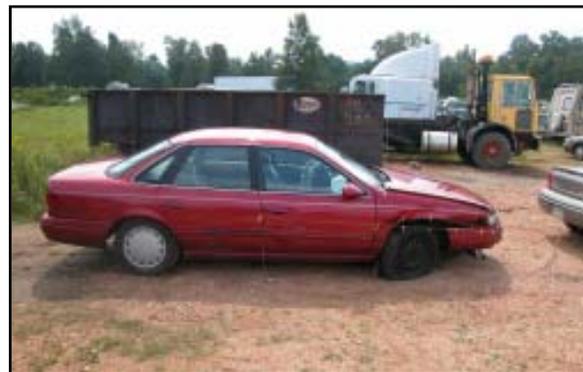
The 1994 Ford Taurus sustained moderate right side damage as a result of the crash. **Figure 6** is a right side view of the vehicle. The direct contact damage began on the right front bumper corner and extended rearward 108.4 cm (42.7 in). The damage consisted of left lateral deformation to the right front fender and right front suspension. The front end of the Ford was shifted left 6.4 cm (2.5 in). The right front wheel was deformed and restricted. The right wheelbase was reduced 3.8 cm (1.5 in). The windshield was fractured from the lateral deformation. The side and rear glazing were not damaged. The four doors remained closed during the crash and were operational post-crash. The crush profile documented at the mid-door elevation on the right side was as follows: C1 = 0, C2 = 7.0 cm (2.8 in), C3 = 7.0 cm (2.8 in), C4 = 25.0 cm (10.0 in), C5 =

Figure 6: Right side view of the 1994 Ford Taurus.

20.0 cm (7.9 in), C6 = 18.0 cm (7.1 in). The CDC for the impact was 02-RYEW-2. The total velocity change computed for the Ford was 15.0 km/h (9.3 mph). The longitudinal and lateral components for the Ford were -9.6 km/h (6.0 mph) and -11.5 km/h (7.1 mph), respectively.

The right doors of Taurus exhibited abrasions and paint transfers resultant to the secondary contact with the left front fender of the Dodge during separation. The contact damage began 152.1 cm (59.9 in) forward of the right rear axle on the mid-aspect of the right front door. The contact extended 116.6 cm (45.9 in) rearward and ended on the mid-aspect of the right rear door. The CDC of this was 12-RPES-1.

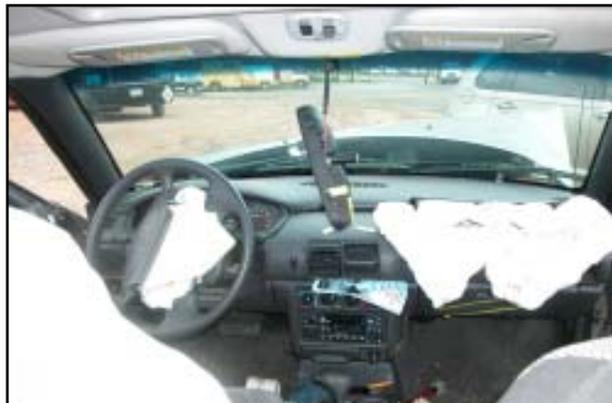
The interior damage to the Dodge was minor and attributed to occupant contacts and deployment of the Supplemental Restraint System. There was no intrusion as a result of the exterior crash forces. **Figure 7** is an interior view of the Dodge.

Figure 7: Interior view of the Dodge.

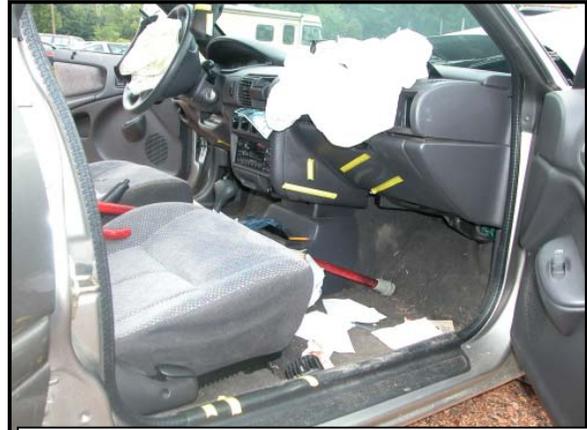
The front right and front center aspects of the interior exhibited contacts consistent with the forward left trajectory of the front right passenger, **Figure 8**. The glove box door exhibited two contact scuffs attributed to contact with the passenger's right lower extremity. The scuffs measured 20.3 cm (8.0 in) and 12.7 cm (5.0 in), respectively. The scuffs were oriented in an angular manner from the upper center aspect of the glove box door to lower left inboard corner. A 15.2 cm (6.0 in) longitudinal abrasion was located on the lower edge of the center stack side panel. This abrasion was attributed to contact with the passenger's left knee. The front right passenger sustained a 7.9 cm (3.1 in) laceration over the left knee consistent with the loading.

Figure 8: Front right passenger interior.

A 5.1 cm (2.0 in) vertical abrasion was also noted on the side panel attributed to probable left hand contact. A 1 m (3 ft) red cane was found within the front right occupant space. The cane was fractured 0.6 m (2.0 ft) above its base. The fracture probably occurred due to the forward and left kinematic pattern of the rear right passenger. Red paint transfers consistent with loading from the side of the cane were identified on the vertical edge of the instrument stack side panel. Two linear red abrasions on the top center instrument panel measuring approximately 6.4 cm (2.5 in) in length were also identified. These abrasions resulted from contact with the top aspect (hook) of the cane. The outboard (right) air conditioner/heater vent louver was noted to be displaced from the instrument panel. The occupant contacted the louver in a bracing action with her right hand at impact. During her bracing, the occupant loaded and fractured her right forearm displacing the louver.

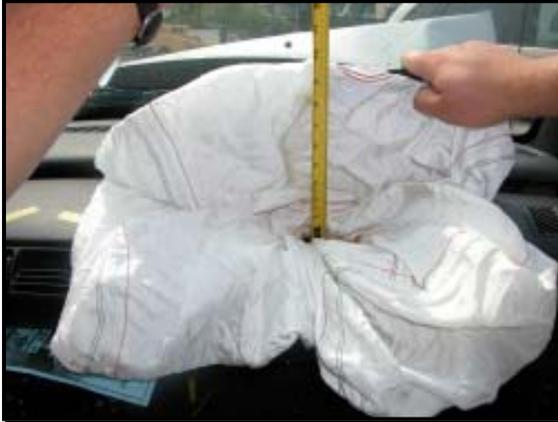
Upon initial inspection, the front right passenger air bag membrane was found partially tucked back into the module and the membrane was fused (melted) to the inflator, **Figure 9**. Upon freeing the membrane, it was observed that the face of the membrane was melted in two regions, **Figure 10**. Referring to Figure 10, the upper and lower melted regions measured 51.6 cm x 6.4 cm (8.0 in x 2.5 in) and 10.2 cm x 5.1 cm (4.0 in x 2.0 in), respectively. After the Dodge came to rest at the time of the crash, the membrane was partially tucked back into the module, presumably by the front right passenger. The membrane then partially melted due to the residual heat of the inflator and became fused. None of the police investigators involved in the crash investigation were aware of the post-crash state of this air bag prior to SCI involvement.

Figure 9: Front right passenger air bag upon initial inspection.

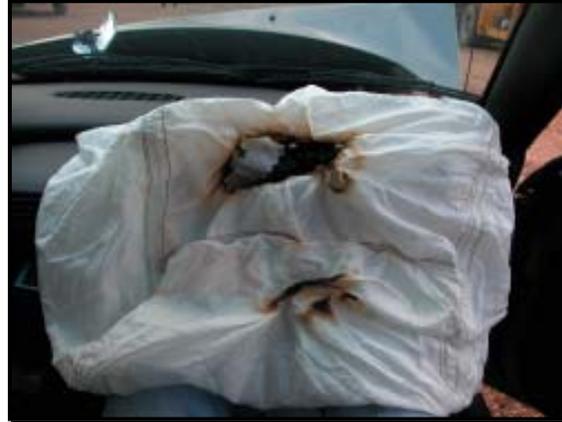
Figure 10: View of the face of the air bag.

The face of the front right passenger air bag measured 46 cm x 61 cm (18 in x 24 in), width by height. It was tethered by two straps sewn to the center and upper aspects face. The rearward excursion of the bag measured 28 cm (11 in) from the vertical face of the instrument panel. The air bag was vented by a 6.4 cm (2.5 in) diameter port located on the top panel of the air bag. Examination of the face of the air bag was unremarkable. There was no evidence of occupant contact identified on the face of the air bag.

Two faint blood spatter patterns were noted on the bottom surface of the air bag. These spatter patterns were attributed to contact with the front right occupant's lower extremities. The areas measured 8.9 cm x 7.6 cm (3.5 in x 3.0 in) and 15.2 cm x 7.6 cm (6.0 in x 3 in) and were located on the inboard lower corner and center aspects of the bottom surface, respectively.
