**GENERAL DYNAMICS ON-SITE CHILD SAFETY SEAT CRASH INVESTIGATION
SCI TECHNICAL SUMMARY REPORT**

CASE NO. CA03-051

VEHICLE – 1994 PLYMOUTH VOYAGER

CRASH DATE – JULY 2003

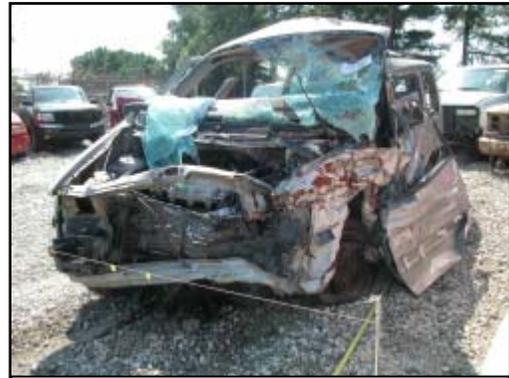
Figure 1. Damaged 1994 Plymouth Voyager

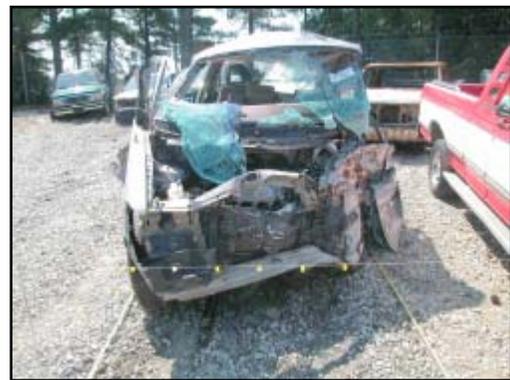
The 1994 Plymouth Voyager sustained severe damage as a result of the multiple impacts. The direct contact damage from the initial impact with the Cadillac began on the front left corner of the bumper fascia and extended laterally 92.7 cm (36.5") across the frontal plane (**Figure 4**). The direct contact extended vertically from the bumper fascia to the hood, and direct contact abrasions extended 31.8 cm (12.5") rearward from the

Figure 2. Frontal view of the damaged Voyager

front left corner of the hood. Due to the rotation of the DeVille, the direct damage continued onto the left side plane, which resulted in two planes of engagement from the initial impact. The bumper fascia, headlights, and grille were separated. The upper and lower radiator supports were crushed rearward, the maximum crush measuring 71.1 cm (28.0") at the front left corner. The left front fender was crushed rearward and inward from direct contact. The combined direct and induced damage involved the entire frontal width of the Voyager and measured 96.5 cm (38.0") across the upper radiator support. The windshield was fractured and out of place. The right front fender was displaced outward. The left A-pillar sustained considerable rearward displacement. The A-pillar displacement resulted in significant vertical buckling of the left roof side rail and outward buckling of the left front door. The frontal crush displaced the left front axle rearward, which resulted in the reduction of the left wheelbase by 54.0 cm (21.3"). The left front wheel sustained two opposing dents on the outboard aspect as a result of the rearward compression against the left sill. Six crush measurements were documented along the upper radiator support and were as follows: C1 = 71.1 cm (28.0"), C2 = 65.7 cm (25.9"), C3 = 51.4 cm (20.3"), C4 = 12.9 cm (5.1") C5 = 13.3 cm (5.3"), C6 = 5.7 cm (2.3"). The Collision Deformation Classification for the initial impact with the Cadillac DeVille was 12-FYEW-4.

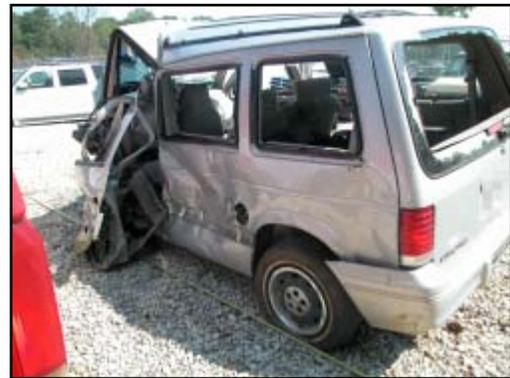
The Voyager sustained moderate left side damage as a result of the secondary sideslap with the Cadillac DeVille. The direct and induced damage on the left side began 37.0 cm (14.6") forward of the left front axle, extended 334.0 cm (131.5") rearward, and terminated at the left rear bumper corner. The maximum crush measured 34.9 cm (13.8), located 37.0 cm (14.6") forward of the left front axle. Numerous abrasions and paint transfers from the Cadillac were present along the entire left side of the Voyager from direct contact. Red paint transfers from the Cadillac's right side pinstripe were also present. The left trim was separated and lateral crush was present on the entire left side plane. A scuff mark was present on the left rear aspect of the rear bumper fascia from contact with the Cadillac, and left aspect of the fascia was partially separated. All left side glazing as well as the backlight disintegrated. Six crush measurements were documented along the left side of the Voyager and were as follows: C1 = 1.9 cm (0.8"), C2 = 3.8 cm (1.5"), C3 = 14.0 cm (5.5"), C4 = 12.7 cm (5.0"), C5 = 20.3 cm (8.0"), C6 = 34.9 cm (13.8). The CDC for the secondary sideslap with the Cadillac DeVille was 09-LDEW-3.

Figure 5. Left side sideslap damage

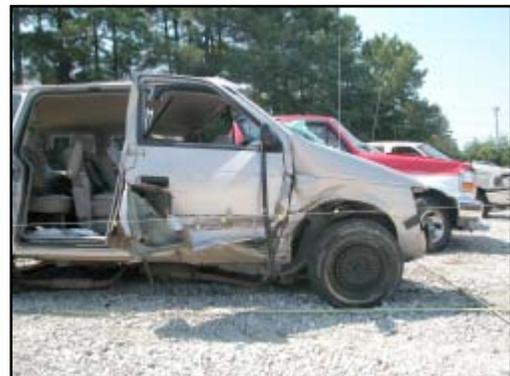
The Voyager sustained moderate right side damage as a result of the impact with the Ford Ranger. The direct damage began 3.0 cm (1.2") forward of the right front axle and extended 133.0 cm (52.4")

Figure 6. Right side damage showing sill deformation

rearward along the right side (**Figure 6**). White paint transfers from the Ranger were present on the right front fender, the right front door, and the right front sill. The right side door trim was separated. The rear aspect of the right front fender was crushed rearward and inward, and the forward aspect of the right sill sustained lateral crush. The combined direct and induced damage began 16.0 cm (6.3") forward of the front right axle and extended 155.0 cm (61.0") rearward to the rear aspect of the right front door. The right front door was buckled rearward slightly. All of the right side glazing was disintegrated. Six crush measurements were documented along the right side and were as follows: C1 = 14.6 cm (5.8"), C2 = 24.8 cm (9.8"), C3 = 14.0 cm (5.5"), C4 = 11.4 cm (4.5"), C5 = 15.9 cm (6.3"), C6 = 12.7 cm (5.0"). The CDC for the right side impact with the Ford Ranger was 02-RYEW-3.

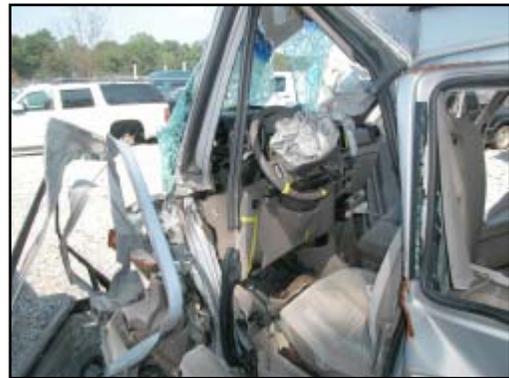
The Plymouth Voyager sustained severe interior damage as a result of passenger compartment intrusion and occupant contact. The driver's space was reduced as a result of intrusion (**Figure 7**). The left, right, and bottom aspects of the steering wheel rim were deflected forward from driver loading. The maximum deflection measured 15.2 cm (4.0") at the 6 o'clock position. An abrasion was present on the bottom aspect of the steering wheel rim that began at the spoke located at the 8 o'clock position and extended CCW 15.9 cm (6.3"). The top of the steering wheel rim was engaged against the top aspect of the left instrument panel. The intrusion of the left instrument panel combined with the driver's forward loading resulted in steering column compression and upward deflection. The outboard corner of the knee bolster sustained an area of longitudinal scuff marks from engagement against the displaced left front door. The scuff marks measured 3.4 cm (2.5") in width and 21.6 cm (8.5") in height. A scuff mark was centered on the top aspect of the knee bolster from the driver's knee that measured 14.0 cm (5.5") in width and 16.5 cm (6.5") in height. The driver's seat track was jammed as a result of the crash, and the seat cushion was buckled longitudinally and rotated inboard 10 degrees.

Figure 7. Interior view showing intrusions and contacts in the driver's position

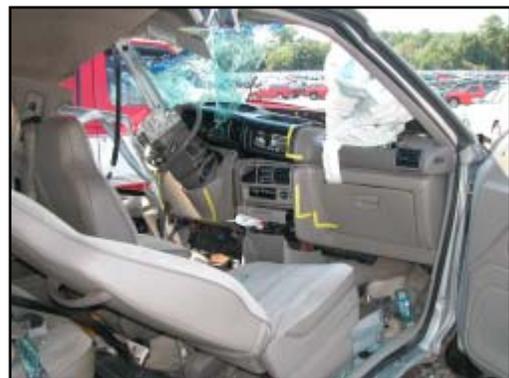
The front right position also sustained interior damage (**Figure 8**). A heavy abrasion was present on the right aspect of the upper center instrument panel from expansion of the air bag as it was compressed against the instrument panel by the front right occupant. The abrasion measured 2.5 cm (1.0") in width and 14.0 cm (5.5") in height. Two air bag-related scuff marks were located on the outboard aspect of the lower center instrument panel, immediately inboard of the glove box door. The upper scuff mark measured 5.1 cm (2.0") in width and 12.7 cm (5.0") in height. The lower scuff

Figure 8. Interior view of front right passenger's position

mark measured 8.9 cm (3.5”) in width and 5.1 cm (2.0”) in height. The headliner and sun visor were abraded over and area that measured 50.8 cm (20.0”) in width from the right roof side rail and 30.5 cm (12.0”) in length from the windshield header. The cargo drawer under the front right seat opened during the crash. The second row bench seat back was bowed 12.7 cm (5.0”) forward 15.2 cm (6.0”) left of the seat back centerline due to contact with the loose vehicle battery. The third row bench seat was displaced forward and CCW as a result of contact with the loose vehicle tire and wheel. The right side aspect was disengaged from the floor anchors. The right aspect of the bench seat was deflected forward 17.8 cm (7.0”). The entire rear aspect of the seat back exhibited scuff marks, and the maximum seat back deflection measured 10.2 cm (4.0”) and was located 17.8 cm (7.0”) right of the seat back centerline.

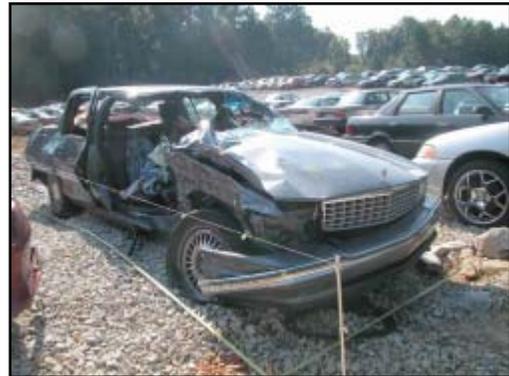
The Cadillac DeVille sustained moderate right side damage as a result of the multiple impacts (**Figure 9**). The right side damage was separated into two impacts at the right B-pillar. This was based on the assumption that the initial impact with the Voyager terminated in the vicinity of the right B-pillar, given the Voyager's damage pattern and damage length. The direct damage from the initial impact with the Plymouth Voyager began 81.3 cm (32.0") aft of the right front axle and extended 154.9 cm (61.0") forward along the right side plane to the right front bumper corner. The front aspect of the right sill was crushed laterally, and the right front door had been removed from the vehicle. The maximum crush on the right front aspect measured 42.2 cm (16.6") at the right A-pillar. The right front fender was crushed laterally and the right front axle was displaced forward from snagging against the Voyager. The forward displacement of the right front wheel resulted in the elongation of the right wheelbase by 20.6 cm (8.1"). The right side of the hood was displaced upward. The combined direct and induced damage for the impact with the Voyager began at the right B-pillar and extended 256.5 cm (101.0") forward to the right front bumper corner. Six crush measurements were documented along the mid-door level (projected for the missing door) and were as follows: C1 = 18.5 cm (7.3"), C2 = 23.6 cm (9.3"), C3 = 42.2 cm (16.6"), C4 = 29.5 cm (11.6"), C6 = 2.5 cm (1.0"). The CDC for the initial impact with the Voyager was 04-RYEW-3.

Figure 9. View of right side damage to the DeVille

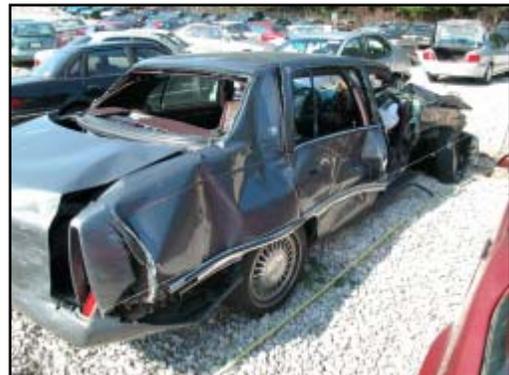
The secondary sideslap impact with the Voyager resulted in moderate right rear damage to the Cadillac (**Figure 10**). The combined direct and induced damage began at the right B-pillar and extended rearward 238.8 cm (94.0") to the right rear bumper corner. The right rear door panel and rear quarter panel sustained minor lateral crush and abrasions. A silver paint transfer was present on the right C-pillar of the DeVille from direct contact with the Voyager during the sideslap. The CDC for the sideslap event was 03-RDEW-1. Damage to the right rear quarter panel was also present from the third impact with the Ford Ranger. White paint transfers were present on the right rear corner and extended around the tail light onto the face of the trunk.

Figure 10. View of right rear damage to the DeVille

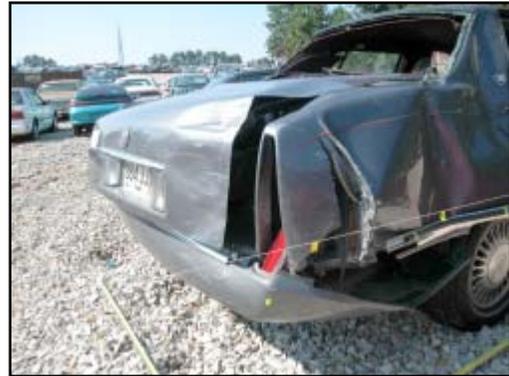
A red paint transfer from the Cadillac's pinstripe was located on the left front fender of the Ranger, which supported the right side plane damage (Figure 11). The right rear quarter panel was fractured and deformed around the taillight. The CDC for the impact with the Ford Ranger was 05-RBES-1. Although the third impact with the Ford Ranger resulted in overlapping damage to the right rear quarter panel, six crush measurements were documented along the right side of the DeVille, resulting in a single crush profile for both events. Six crush measurements were documented along the right rear aspect of the Cadillac and were as follows: C1 = 0.0 cm, C2 = 0.0 cm, C3 = 0.0 cm, C4 = 7.0 cm (2.8"), C5 = 14.0 cm (5.5"), C6 = 8.1 cm (3.2").

Figure 11. Close-up of the right rear damage from the Ranger

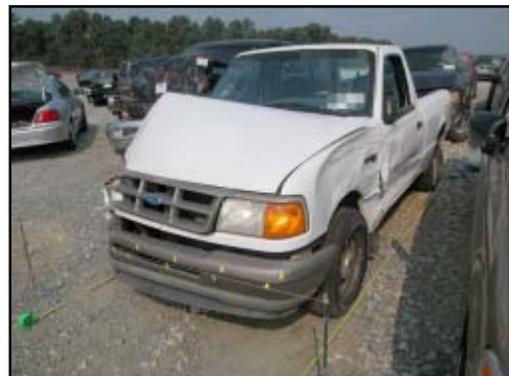
The Ford Ranger pickup truck (Figure 12) sustained moderate left side damage as a result of the initial sideswipe impact with the Cadillac DeVille. The direct contact damage began at the left front bumper corner and extended rearward 278.0 cm (109.4") along the left side. A red paint transfer from the pinstripe on the right rear quarter panel of the Cadillac was present on the rear aspect of the left front fender. The left front fender and left door sustained abrasions and lateral deformation. The combined direct and induced damage began at the left front bumper corner and extended rearward 305.0 cm (120.1"). Minor inward deflection was noted on the left rear quarter panel forward of the left rear axle. The CDC for the initial sideswipe impact with the DeVille was 11-LDES-1. Six crush measurements were documented along the left side aspect and were as follows: C1 = 0.0 cm, C2 = 1.9 cm (0.8"), C3 = 6.1 cm (2.4"), C4 = 7.4 cm (2.9"), C5 = 10.2 cm (4.0"), C6 = 27.9 cm (11.0").

Figure 12. Left side damage to the Ranger

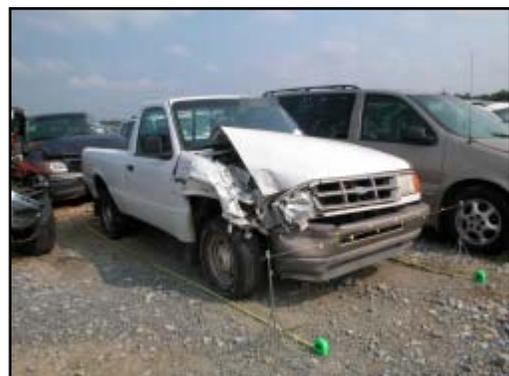
The Ford Ranger (Figure 13) also sustained moderate front right damage as a result of the secondary impact with the Voyager. The direct contact damage began at the right front bumper corner and extended 50.0 cm (19.7") laterally to the left. Silver paint transfers and abrasions were present on the bumper and on the forward left aspect of the hood. The front right corner of the bumper was crushed rearward, as well as the right front fender. The combined direct and induced damage involved the entire frontal width of

Figure 13. Front right damage to the Ranger

the Ranger and measured 137.0 cm (53.9") across the bumper. The right aspect of the hood was buckled rearward and upward and the right front fender was displaced rearward against the leading edge of the right door. The CDC for the frontal impact with the Voyager was 12-FREW-2. Six crush measurements were documented along the front bumper and were as follows: C1 = 2.3 cm (0.9"), C2 = 1.9 cm (0.8"), C3 = 6.1 cm (2.4"), C4 = 7.4 cm (2.9"), C5 = 10.2 cm (4.0"), C6 = 27.9 cm (11.0").

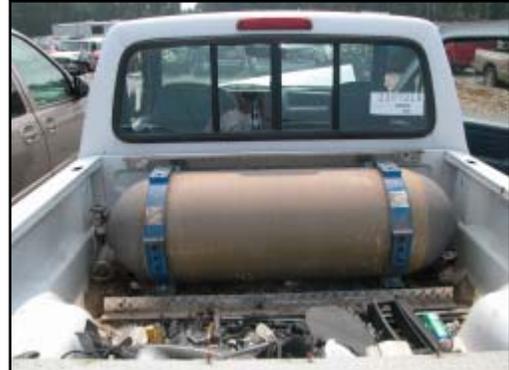
The 1994 Ford Ranger pickup truck was equipped with a commercial aftermarket conversion CNG fuel system (**Figure 14**), which augmented the vehicle's OEM unleaded fuel system. The Ranger was purchased in December 1994 as a new vehicle for business use. The CNG fuel system was installed by NGV Southeast Technology Center shortly after the vehicle was purchased. A company representative stated that the Ranger had a range of approximately 209 km (130 miles) per tank of CNG, and was refueled with CNG daily. The company was equipped with a CNG compressor, which was installed onto a quick disconnect fitting in the vehicle's grille for refueling, once the tank valve was opened. The company representative stated that there was no routine maintenance performed on the CNG system other than periodic adjustments of the timing system, and that the CNG storage tank had not been pressure tested.

Figure 14. CNG cylinder in the bed of the Ford Ranger

The Ranger was running on CNG at the time of the crash. At the time of the vehicle inspection, the cylinder valve was closed. Upon opening the valve, a slight leak was detected by the SCI Investigator at the outbound fitting off of the valve assembly. The pressure gauge did not move from the zero position upon the opening of the regulator.

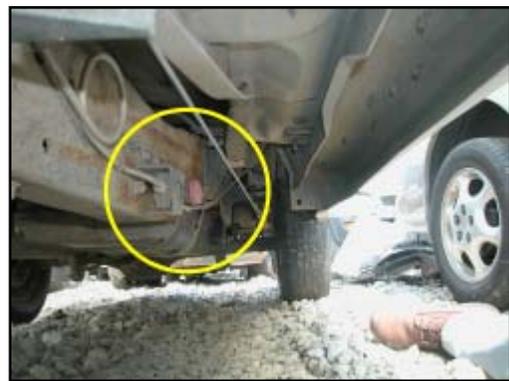
The CNG system consisted of a pressurized fiberglass-wrapped, aluminum, cylinder that was rated to 3,000 PSI. A valve was present on the left aspect of the cylinder (relative to the vehicle) with a pressure gauge fixed to the valve assembly that was rated to 700,000 kPa (10,000 PSI). A section of 0.6 cm (1/4") diameter aluminum tubing delivered the CNG to the engine compartment through the pickup truck bed, forward along outboard aspect of the left frame rail, and to a pressure regulator in the engine compartment. A ball-valve (**Figure 15**) was present on the aluminum delivery tubing and was located 149.9 cm (59.0") forward of the left rear axle and was vertically centered on the outboard left frame rail. The CNG flowed through a regulator, through a filter, into a Combined Computer and Metering Valve (Compuvalve), and into a multi-point injection system.

Figure 15. View looking rearward of aluminum tubing and ball valve on the left frame rail

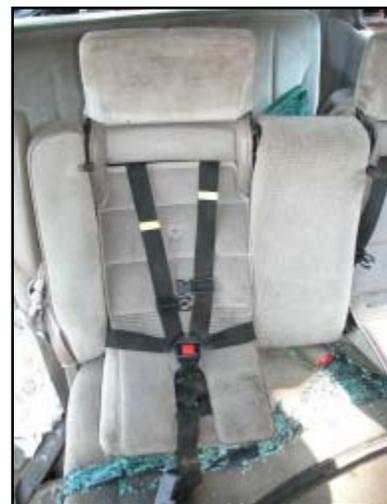
The left side integrated CSS was not used in this crash. A 3-year-old male child was restrained in the right side integrated CSS (**Figure 16**). At the time of the vehicle inspection, the right side CSS head restraint was found in the upright position. The harness system was adjusted such that the length of the harness webbing measured 53.3 cm (21.0”) between the harness slots and the lower anchors. The adjustment tab was adjusted to a residual

Figure 16. Second row right side integrated CSS

length of 22.9 cm (9.0"). The pre-crash position of the harness retainer clip was unknown. The harness retainer clip did not exhibit any abrasions or deformation. Minor stretch marks were present on the harness webbing. The loading to the right harness strap began 12.7 cm (5.0") below the harness slot and extended downward 33.0 cm (13.0"). The loading to the left harness strap began 6.4 cm (2.5") below the harness slot and extended downward 38.1 cm (15.0"). The plastic harness slots sustained only faint abrasions from the child loading against the harness straps.

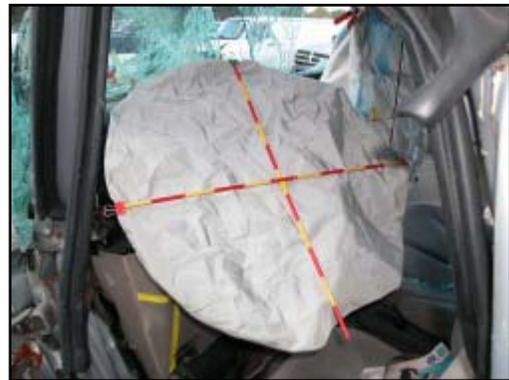
The 1994 Plymouth Voyager was equipped with frontal air bags for the driver and front right passenger positions that deployed as a result of the frontal impact. The driver's air bag (**Figure 17**) deployed from the center of the steering wheel hub from symmetrical H-configuration cover flaps. The cover flaps measured 5.7 cm (2.5") in height and 17.1 cm (6.8") in width. The driver's air bag measured 61.0 cm (24.0") in diameter. The driver's air bag was vented by two circular ports located at the 12 o'clock position on the rear of the air bag. The vent ports measured 2.5 cm (1.0") in diameter and were located 7.0 cm (2.8") from the circumferential seam and were spaced 5.1 cm (2.0") apart. The air bag was not tethered. The face of the air bag did not exhibit any contact evidence. The rear aspect of the air bag exhibited a moderate semi-circular scuff mark on the bottom left quadrant from compression against the steering wheel rim. The scuff mark measured 2.5 cm (1.0") in width and 22.9 cm (9.0") in length.

Figure 17. Deployed driver's air bag

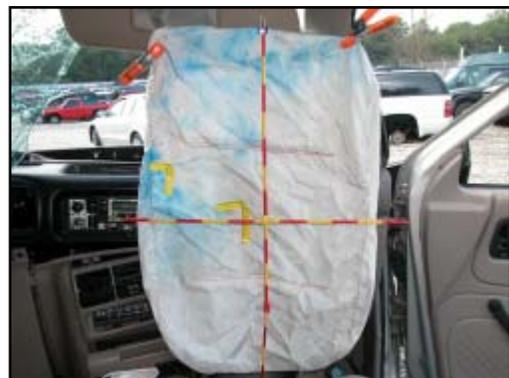
The front right passenger's air bag (**Figure 18**) deployed from a top-mount module with a single cover flap design. The cover flap had been removed prior to the vehicle inspection and was not present in the vehicle. The front right passenger's air bag measured 66.0 cm (26.0") in height and 45.7 cm (18.0") in width. The air bag was vented through the porous bag membrane, as there were no vent ports located on the air bag. The air bag was tethered by two internal straps that measured 27.9 cm (11.0") in width and were located 12.7 cm (5.0") above and below the horizontal centerline of the air bag. The top panel and top and left side aspect of the face of the air bag exhibited blue discoloration. At the time of the vehicle inspection, the air bag and was found under the fractured

Figure 18. Deployed front right passenger's air bag

and out-of-place windshield. The discoloration was a result of moisture and sunlight, which transferred the blue tint at the top aspect of the windshield to the air bag fabric. A small area of orange fabric was present on the left seam on the air bag face. The fabric was located 5.1 cm (2.0”) above the horizontal centerline and measured 3.8 cm (1.5”) in height and 2.5 cm (1.0”) in width. What appeared to be two circular burn marks were present 5.7 cm (2.3”) left of the vertical centerline and 2.5 cm (1.0”) above and below the horizontal centerline, respectively. The upper burn mark measured 1.3 cm (0.5”) in diameter and the bottom burn mark measured 0.6 cm (0.3”) in diameter.
