**GENERAL DYNAMICS ON-SITE ALLEGED SEAT FAILURE INVESTIGATION  
SCI TECHNICAL SUMMARY REPORT**

**CASE NO. CA03-054**

**VEHICLE – 2003 JEEP GRAND CHEROKEE**

**CRASH DATE – JULY 2003**

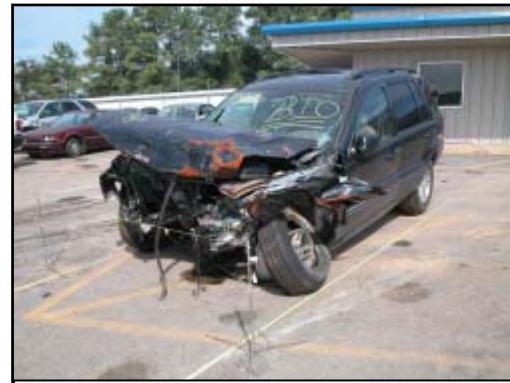
**Figure 1. Damaged 2003 Jeep Grand Cherokee**

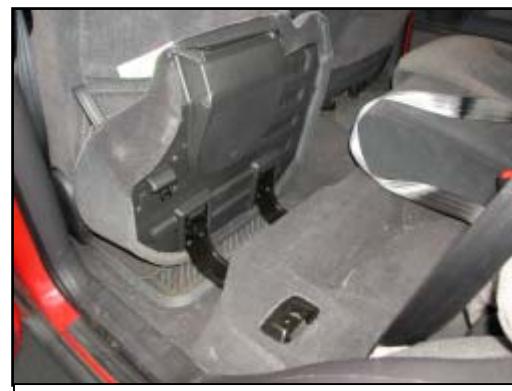
**Figure 2. Exemplar rear left seat rotated forward**

spring-tensioned bar rotated the tab slightly forward (relative to the seat) and upward to release the seat cushion from the bracket, which allowed the seat cushions to rotate forward 90 degrees.

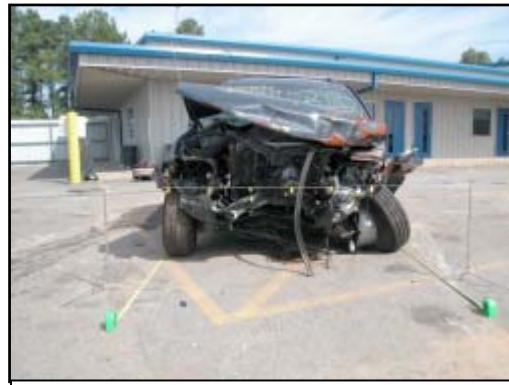
The 2003 Jeep Grand Cherokee sustained severe frontal damage (**Figure 7**) as a result of the impact with the Pontiac Grand Am. The maximum crush was located 24.1 cm (9.5") left of the centerline and measured 37.5 cm (14.8"). The direct damage began 76.2 cm (30.0") left of the centerline and extended laterally 124.5 cm (49.0") across the frontal plane. The leading edge of the hood was buckled downward and rearward, and direct contact abrasions were present on the right aspect. The grille, headlights, bumper fascia, and bumper beam were separated. The upper and lower radiator supports were crushed rearward, and direct contact scuffs and deformations were present on the radiator core. As shown in **Figure 8**, the left front tire was debeaded and the left front alloy rim was abraded. The front axle was crushed rearward. The rearward displacement of the front axle resulted in the reduction of the left side wheelbase by 8.0 cm (3.1") and the reduction of the right wheelbase by 14.0 cm (5.5"). The left front tie rod was fractured inboard of the left front wheel. The left front fender was crushed rearward and partially separated. The combined direct and induced damage involved the entire frontal width of the vehicle and measured 124.5 cm (49.0"). The frontal structure was shifted to the right 10.2 cm (4.0") on the left aspect and 6.4 cm (2.5") on the right aspect. The roof side rails were buckled at the B-pillars and the left and right side doors were displaced rearward. Six crush measurements were documented at the lower radiator support and were as follows: C1 = 21.6 cm (8.5"), C2 = 22.9 cm (9.0"), C3 = 30.5 cm (12.0"), C4 = 26.7 cm (10.5"), C5 = 17.8 cm (7.0"),

**Figure 7.** Frontal view of the damaged Grand Cherokee

$C_6 = 20.3$  cm (8.0"). The Collision Deformation Classification (CDC) for the frontal impact with the Grand Am was 12-FDEW-2.

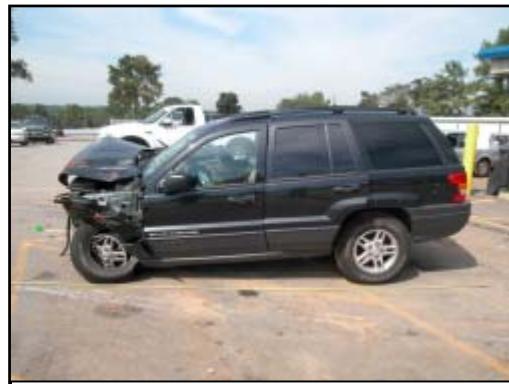
**Figure 8.** Left side view of the damaged Grand Cherokee

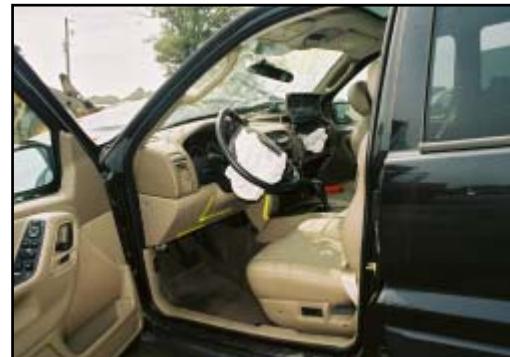
**Figure 9. Interior view showing driver contacts and steering wheel rim deflection**

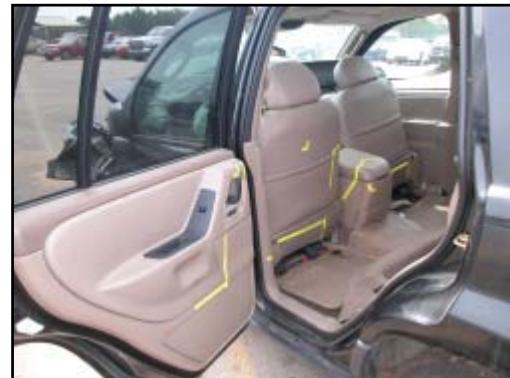
The left rear interior door panel was scuffed below the armrest, and minor scuffs were present on the forward aspect adjacent to the window opening. A scuff was also present on the lower rear aspect of the B-pillar trim, possibly from the rear left passenger's shoe.

The rear aspect of the left and right front seat backs sustained damage as a result of contact from the rear-seated occupants. Minor deformation was noted on the lower rear aspect of the left front seat cushion from contact with the rear left passenger's lower legs. The deformation began 8.9 cm (3.5") right of the seat's centerline and extended 31.8 cm (12.5") to the left corner. Body fluid (blood) was present on the right aspect of the seat back from the rear center passenger. A small 1.3 x 1.3 cm (0.5 x 0.5") scuff was located 8.3 cm (3.3") above the rear seat back pocket and 2.5 cm (1.5") left of center from contact with the rear left occupant. The bottom rear aspect of the front right seat cushion also sustained minor deformation as a result of loading from the rear right occupant's lower legs. The front right seat was moved by police after the crash, and the seat back exhibited 1.9 cm (0.8") of slack in the recline adjustment at the time of the inspection. The center console/armrest sustained direct contact with the rear center passenger's face due to her jackknifing over the lap belt. Scuffs and body fluid (blood) were present on the entire width of the rear aspect of the top cover. The cover, which was hinged at the rear aspect, was displaced

**Figure 10. View of rear seating positions and related occupant contacts**

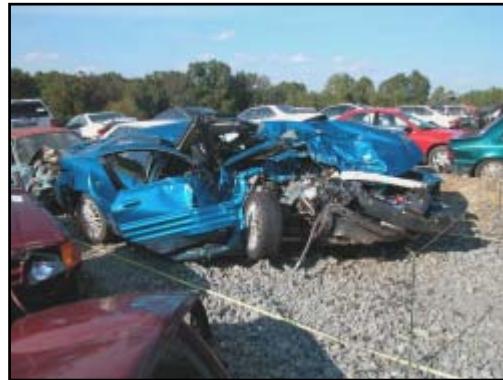
The 1999 Pontiac Grand Am sustained severe frontal damage (**Figure 11**) as a result of the impact with the Grand Cherokee. The direct damage on the Grand Am began 10.2 cm (4.0") left of the centerline and extended laterally 68.6 cm (27.0") to the right across the frontal structure. Direct contact abrasions were present on the leading edge of the hood, and the hood was crushed and buckled rearward. The entire bumper fascia was separated and the bumper beam was crushed rearward, most severely on the right side. The right front fender was crushed rearward, and the angled impact resulted in direct contact abrasions and deformation on the right front fender, right front wheel, and right aspect of the hood. The combined direct and induced damage involved the entire frontal width of the vehicle and measured 69.9 cm (27.5"). The angled impact resulted in the lateral end shift of the frontal structure to the left. At the time of the inspection, the centerline of the bumper beam was located 36.8 cm (14.5") left of the centerline of the windshield header. The severe crush displaced the front right wheel rearward and resulted in the reduction of the right wheelbase by 76.0 cm (29.9"). The left wheelbase was reduced by 3.0 cm (1.2"). The right sill was buckled downward and both right side doors were displaced rearward. Six crush measurements were documented along the front bumper beam of the Grand Am and were as follows: C1 = 1.3 cm (0.5"), C2 = 17.8 cm (7.0"), C3 = 27.9 cm (11.0"), C4 = 53.3 cm (21.0"), C5 = 74.9 cm (29.5"), C6 = 97.8 cm (38.5"). The CDC for the impact with the Grand Cherokee was 01-FZEW-4. The incremented CDC adjusted for the lateral end shift to the left was 81-FZEW-4.

**Figure 11. Damaged 1999 Pontiac Grand Am**

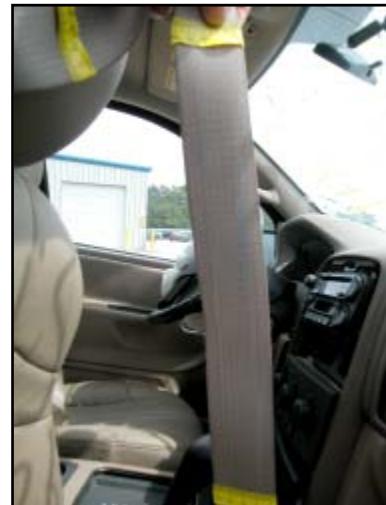
The front right safety belt was configured with a sliding latch plate and switchable ELR/automatic locking retractor (ALR). The adjustable plastic-coated D-ring was positioned one detent up from full-down and exhibited heavy abrasions from occupant loading. The webbing displayed a matching heavy plastic transfer that measured 12.1 cm (4.8") in length and was located 154.9 cm (61.0") from the anchor. The plastic-coated latch plate also exhibited abrasions from loading. The shoulder and lap belt portions of the webbing were stretched from occupant loading and an area of blue fabric transfer was located 49.5 cm (19.5") above the anchor and extended 32.4 cm (12.5") in length up the webbing (**Figure 12**). The outboard aspect of the plastic seat cushion adjacent to the seat bight was abraded from engagement with the lap belt webbing. The top of the seat back was also abraded on the outboard aspect from contact with the shoulder belt webbing.

**Figure 12. View of blue fabric transfers on the front right safety belt webbing**

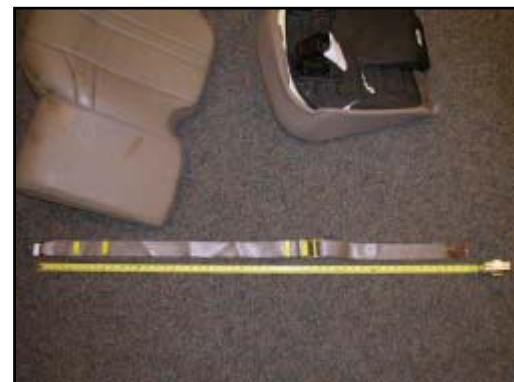
The rear center lap belt had been removed by the investigating agency prior to the SCI inspection, and was inspected separately. The fixed-length, adjustable, lap belt (**Figure 13**) measured 129.5 cm (51.0") in total length. Creases in the webbing from latch plate loading began 74.9 cm (29.5") from the anchor and extended 2.5 cm (1.0") along the full width of the webbing. Significant stretching on the webbing began 31.1 cm (12.5") from the anchor and extended 29.2 cm (11.5") along the webbing, most notably on the bottom aspect (facing toward the occupant). The top aspect of the webbing (facing away from the occupant) exhibited a scuff mark from the engagement against the bottom aspect of the rear seat back. The scuff mark began 12.1

**Figure 13. View of rear center lap belt (removed)**

cm (4.8") from the anchor and extended 7.0 cm (2.8") along the webbing. Body fluid (blood) was also present on various aspects of the safety belt webbing.

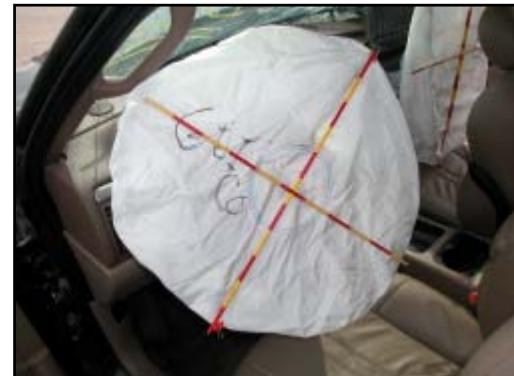
The 2003 Jeep Grand Cherokee was equipped with dual-stage frontal air bags for the driver and front right passenger positions. The driver's air bag (**Figure 14**) deployed from the center of the steering wheel from an asymmetrical H-configuration cover flap design. Both flaps measured 17.1 cm (6.8") in width. The top flap measured 8.9 cm (3.5") in height and the bottom flap measured 5.1 cm (2.0") in height. The driver's air bag measured 61.0 cm (24.0") in diameter and was vented back through the air bag module. The air bag was tethered by two internal straps at the 3 and 6 o'clock positions. There was no occupant contact evidence on the air bag.

**Figure 14. Deployed driver's air bag**

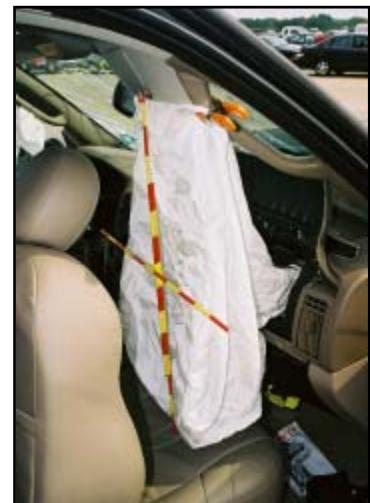
The front right passenger's air bag deployed from a mid-mount module with a rectangular cover flap hinged at the forward aspect. The cover flap measured 40.0 cm (15.8") in width and 14.0 cm (5.5") in height. The top aspect of the cover flap was contoured to the curvature of the top aspect of the instrument panel. The front right passenger's air bag (**Figure 15**) measured 35.6 cm (14.0") in width and 61.0 cm (24.0") in height. The air bag was vented back through the module and was not tethered. There was no contact evidence present on the air bag.

**Figure 15. Deployed front right passenger's air bag**

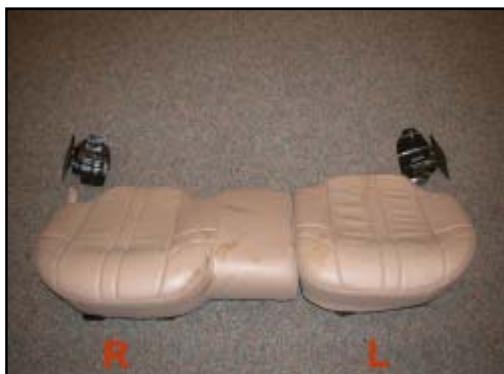
The rear seat cushions, seat hardware, and rear center lap belt had been removed from the vehicle by the investigating officer prior to this SCI investigation. The rear seat cushion (**Figures 16 and 17**) was inspected at a separate location, and later transported to the vehicle inspection for photographs. The seat cushion consisted of two sections. The left outboard position measured 55.9 cm (22.0") in width (lateral) and 52.1 cm (20.5") in length (longitudinal). The rear center and rear right positions were combined into a single section that measured 78.7 cm (31.5") in width and 52.1 cm (20.5") in length. The center seating position measured 43.2 cm (17.0") in length. The thickness of the front of the cushion measured 20.3 cm (8.0") on the outboard positions and measured 16.5 cm (6.5") at the center position. Each position measured 6.4 cm (2.5") in thickness at the rear aspect. Two receiving holes in the plastic were present under the center aspect of each outboard seat position for stowage of the removable head restraints. The driver stated that the seats were rarely rotated forward for stowage and there had been no previous issues with the seat system. Upon inspection, there were no scuffs or deformation on the top of the receiver brackets to suggest misalignment of the seat bottoms.

**Figure 16.** View of top aspect of the damaged rear seat and receiver brackets

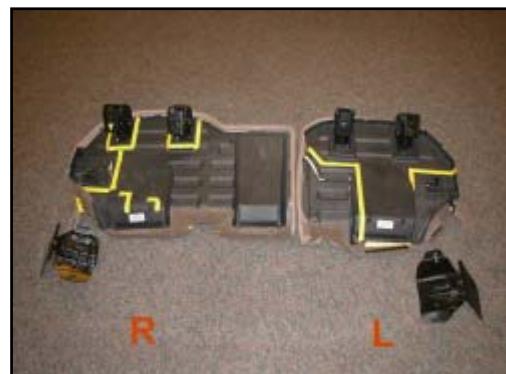
**Figure 17.** View of bottom aspect of the damaged rear seat and receiver brackets

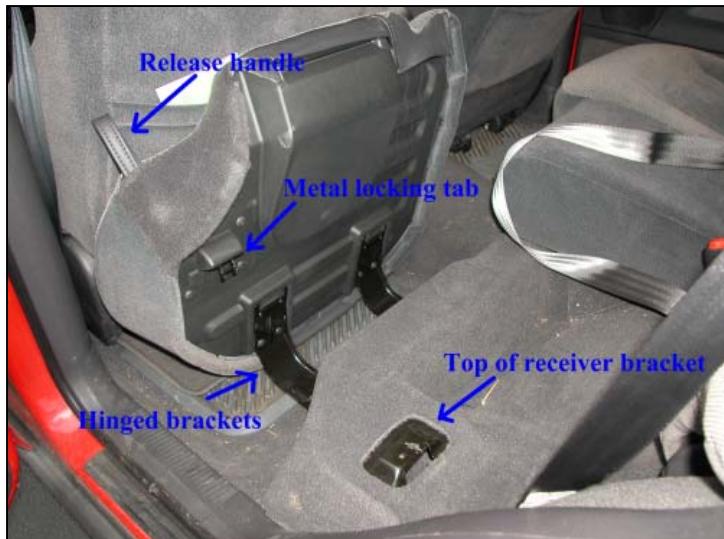
**Figure 18** illustrates the components of the rear seat from an exemplar Grand Cherokee. The 40/60 split bench seat was fixed to the vehicle floor by four angled, hinged brackets. Each seat section was configured with two brackets, located at the forward aspect of the seat bottom, spaced 19.1 cm (7.5") apart, under the center aspects of the outboard seating positions. The seat was designed to rotate forward about the hinges for stowage. A metal tab that measured 2.5 cm (1.0") in width was located on the bottom rear outboard aspect of each seat section. The tab was linked to a release handle via a metal rod and spring release mechanism. The tab was angled toward the front of the vehicle, and engaged the top lip of a raised rectangular opening that measured 4.4 cm (1.8") wide on the forward aspect of a metal receiver bracket. The receiver bracket was secured by two bolts to the outboard floor of the vehicle under the rear outboard aspects of the seat, and the top aspect of the bracket supported the outboard aspects of the seat. A leather loop handle was present on the end of the release lever at the rear outboard aspects of the seat, and pulling on the lever would move the tab rearward and upward to disengage it from the metal receiver bracket.

**Figure 18.** Exemplar view of rear seat components

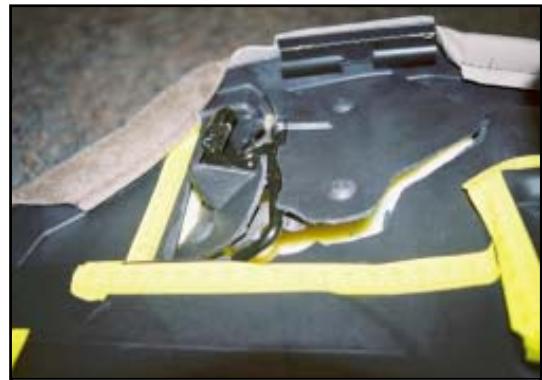
The rear seat cushions sustained moderate damage as a result of the crash. The bottom aspect (mounted to the vehicle) of each hinged bracket was deformed laterally to the right. The maximum lateral deformation measured 1.3 cm (0.5") on the left inboard and right outboard brackets. The plastic seat bottom fractured around the hinged mounting brackets under the right seating position. The fractures were noted around the forward and side aspects of each bracket and the brackets were partially torn away from the seat bottom. Lateral fractures in the plastic seat bottom were present around the metal tabs and underlying release mechanisms, as result of the loading of the tabs pulling against the receiver brackets. The left and right linear fractures measured 14.0 cm (5.5") in length extended to the outboard aspects of the plastic seat bottom. The release mechanism was displaced and protruding slightly through the fracture on the right side (**Figure 19**). Although each metal tab exhibited scuffing consistent with loading and engagement with the metal receiver bracket, there was only minor deformation and deflection of the tabs. An additional large fracture was located on the inboard aspect of the left seat bottom that began at the outboard aspect near the inboard hinge bracket. The fracture radiated toward the outboard side of the seat bottom and measured 31.2 cm (12.5") longitudinally to the rear edge. Scuff marks were present on the right seat bottom in the area of the head restraint receiver holes. Close-up photographs of the damaged left and right seat bottoms are included as **Figures 20 and 21** on the following page.

**Figure 19.** Close-up of right side locking tab and related fracture

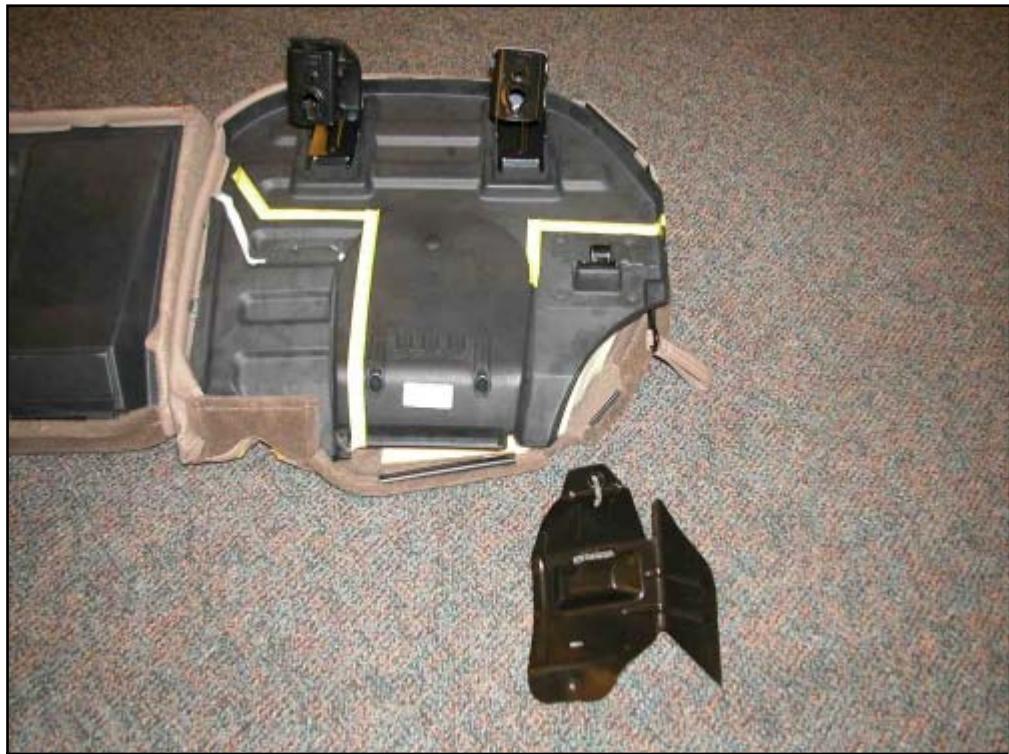
**Figure 20. Close-up of damaged left seat bottom and receiver bracket**

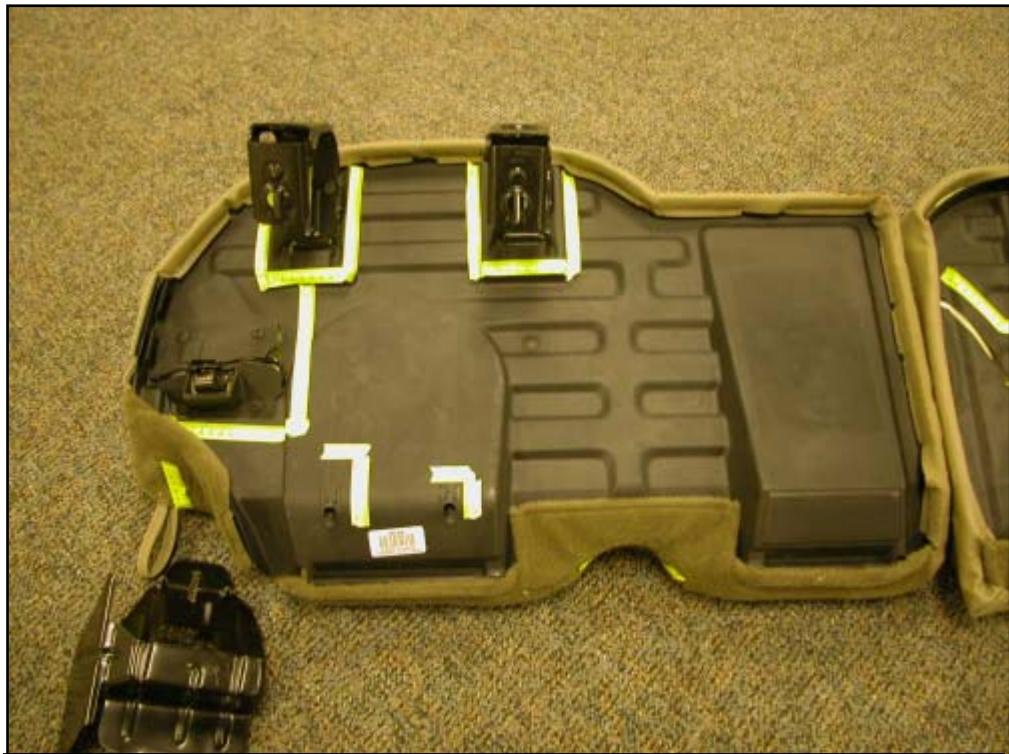
**Figure 21. Close-up of damaged right/center seat bottom and receiver bracket**

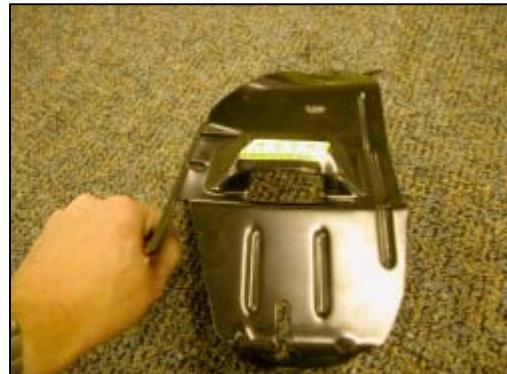
The metal receiver brackets for the locking tabs were deformed as a result of the rear seat loading. The left side bracket was moderately deformed as a result of the seat loading. The overall contour of the bracket was deformed and the upper inboard aspect of the receiver cutout was strained in an upward direction (**Figure 22**). Scuff marks and abrasions were also present on the upper inboard corner of the receiver cutout from engagement and loading of the metal seat tab. Small notches and scuffing were present on the upper inboard aspect of the receiver cutout on the right bracket from the forward loading of the seat tab. Minor scuffs were present on the top aspect of the bracket above the receiver cutout from post-impact engagement of the tab.

**Figure 22. Close up of deformed left receiver bracket**

At impact, the occupants' forward trajectories combined with the Grand Cherokee's high delta-V resulted in the forward loading of the seat cushion. The significant crash forces caused the seat to pull forward and the metal locking tabs to engage against the upper lips of the receiver brackets. Based on the damage pattern on the rear seat, it appears that the tabs remained secured in the receiver brackets early in the crash, which increased the stress on the plastic seat bottom. The plastic seat bottom fractured in multiple locations as a result of the loading, and the linear lateral fractures of the plastic around the locking tabs probably allowed for the rear aspect of the seat to move slightly upward around the tabs. The slight lateral displacement of the seat, evidenced by the lateral deflection of the hinged brackets also contributed to the instability of the seat bottom. The continued stress on the locking tabs coupled with the seat's instability that resulted from the plastic fractures, resulted in the tabs pulling away from the receiver brackets. It should be noted that the rear seat safety belts were anchored to the vehicle floor, and were independent of the rear seat cushion. Although the rear aspect of the seat dislodged from the receiver brackets, the performance of the vehicle's manual restraints was not compromised due to the independent anchors. Given the independent nature of the safety belt anchors, the manual restraints most likely held the occupants in position. The weight of the occupants, in addition to the use of the manual restraints, prevented the full forward rotation of the seat until the occupants released and removed the safety belts.
