**GENERAL DYNAMICS ON-SITE AIR BAG NON-DEPLOYMENT  
INVESTIGATION**

**GENERAL DYNAMICS CASE NO. – CA03-057**

**SUBJECT VEHICLE – 1995 PONTIAC GRAND PRIX**

**CRASH DATE – OCTOBER 2003**

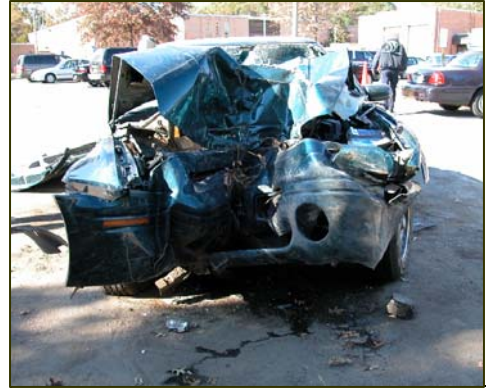
**Figure 1. Frontal damage to the 1995 Pontiac Grand Prix.**

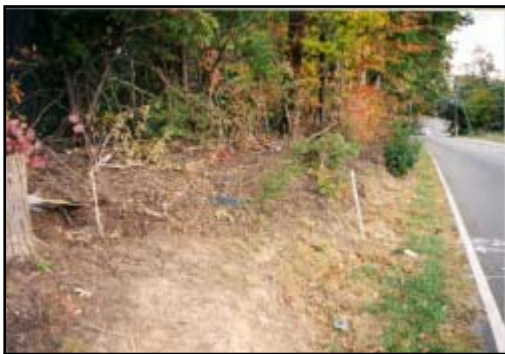
As the Pontiac departed the east road edge, the front right undercarriage area impacted and overrode an embankment. This impact negated the CCW yaw and redirected the Grand Prix in a clockwise direction, returning the vehicle to a tracking attitude as it continued in a southerly direction. The front left bumper area of the Pontiac impacted and overrode a small diameter tree cluster. As the Pontiac continued forward, the front right area impacted and deflected a delineator post. The Pontiac continued forward for a distance of 8.5 m (28.0’) and impacted a series of small diameter trees and a rotted 17.8 cm (7.0”) diameter tree trunk (**Figure 4**). The Pontiac overrode these trees and deflected the stump at ground level. This series of impacts did not alter the Pontiac’s southerly trajectory or tracking trajectory. It should be noted that all tree impacts involved impact forces that were within the 12 o’clock sector.

**Figure 4. Impacts with the embankment and numerous small diameter trees.**

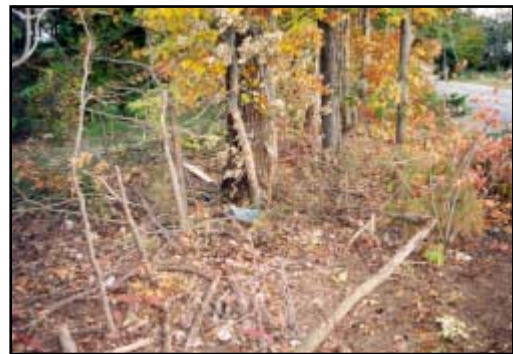
**Figure 5. Struck 48.3 cm (19.0”) diameter tree.**

The center front area of the Pontiac impacted a 48.3 cm (19.0”) diameter tree (**Figure 5**) that was located 4.3 m (14.0’) outboard of the east road edge. A 7.6 cm (3.0”) diameter tree was growing

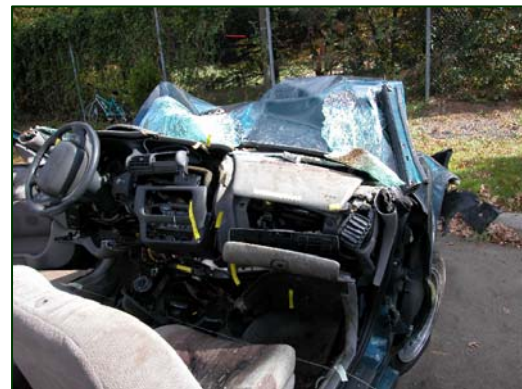
The front right passenger's knees contacted the glove box door. His left knee scuffed and fractured the door 7.6-12.7 cm (3.0-5.0") right of the left edge of the door and 20.3-30.5 cm (8.0-12.0") below the top of the door. The front right passenger was presumably slumped pre-crash, which allowed his head to contact the leading edge of the front right passenger air bag module cover. Hair was embedded in the leading edge and the cover flap was rotated forward, similar to a deployed flap position. Blood was also noted on the non-deployed front right air bag membrane. The front right passenger subsequently impacted the windshield with his head 22.9 cm (9.0") inboard of the right A-pillar and 12.7-33.0 cm (5.0-13.0") above the bottom edge of the glazing. Hair and blood deposits were noted in this area of contact. The front right

**Figure 9. Overall view of front right area and the passenger's contact points.**

passenger's head contacted the deformed hood as he penetrated the windshield a dent was located 23.4-30.0 cm (8.8-11.8") inboard of the right hood edge and 3.8-15.2 cm (1.5-6.0") forward of the rear hood edge and measured approximately 1.3 cm (0.5") in depth. **Figure 9** is an overall view of the front right area and the passenger's contact points.
