Certified Advanced 208 Compliant Vehicle Investigation/ Vehicle to Vehicle
Dynamic Science, Inc. / Case Number: 2004-75-153E
2004 Chevrolet Silverado
Colorado
October, 2004

1. Report No. 2004-75-153E		2. Government Accession No.		3. Recipient Catalog No.	
4. Title and Subtitle Certified Advanced 208 Compliant Vehicle Investigation				5. Report Date February 1, 2006

Dynamic Science, Inc.
Crash Investigation
Case Number:2004-75-153E

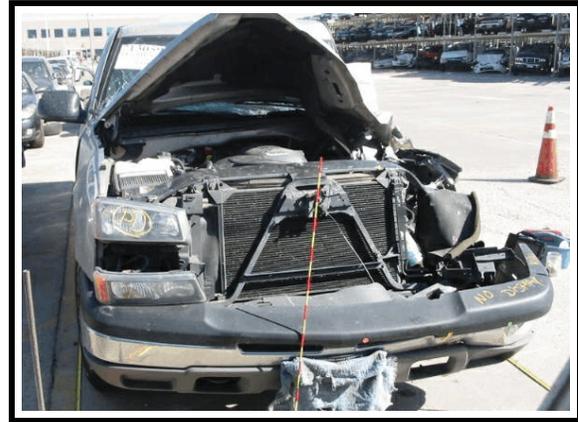
Figure 1. Front, 2004 Chevrolet Silverado

The front of the case vehicle (12FYAA6) struck and then under rode the rear of the Ford flat bed truck. There was extensive above bumper damage and the hood buckled rearward into the windshield. This generated a deployment event. The Electronic Data Recorder (EDR) reported a maximum Sensing and Diagnostic Module (SDM) recorded velocity change of -24.17 km/h (-15.02 mph). The driver's air bag deployed but the passenger air bag did not. The cut off switch was in the OFF position. There was a non-deployment event that was generated while both vehicles were engaged. A comparison of the pre-crash vehicle speeds found in the deployment and non deployment events would seem to indicate that the Silverado had decelerated from 113 km/h (70 mph) to 89 km/h (53 mph) at about the time of the non-deployment event.

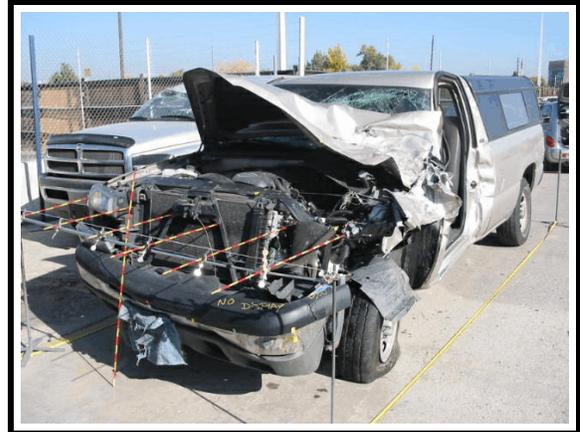
Figure 3. Front left, 2004 Chevrolet Silverado

Damage Description: The vehicle sustained moderate damage. The bumper sustained only one area of crush; maximum crush of 2.0 cm (0.78 in) was measured at the front-left corner (C1), while the above bumper crush measured 17.0 cm (6.7 in)

The vehicle sustained minor, almost non-existent damage to the bumper area. The only crush at this level was recorded at the front-left corner (C1) and was an insignificant 2.0 cm (0.8 in) in depth. The majority of the direct damage fell above the bumper, in the region of the hood. The hood was displaced rearward, which resulted in this vehicle component striking the windshield. The hood did not penetrate the glazing; no integrity loss resulted. Since the hood represented no structural rigidity, upper level C values were obtained by measuring the stiffer radiator support.

The Direct L was 68.0 cm (26.8 in) and began at the front-left corner. The Field L encompassed the entire frontal plane, and was recorded as 186.0 cm (73.2 in), which was also width of the undeformed end plane. There was continual engagement between the front of the case vehicle and the back of the truck; the direct contact extended onto the A pillar and past the driver's door. Because the flat bed truck fell well outside the parameters of any acceptable speed reconstruction programs, and given the additional fact that the majority of the crush to the case vehicle occurred high up in the hood area, the Win Smash Reconstruction Program was not utilized. A review of the EDR data shows that the Chevrolet Silverado was traveling at 114.3 km/h (71 mph), 5 seconds prior to the Algorithm Enable (AE), and that there was no braking. This continued until 2 seconds before AE, when the braking switch circuit switch was now on, and the vehicle was

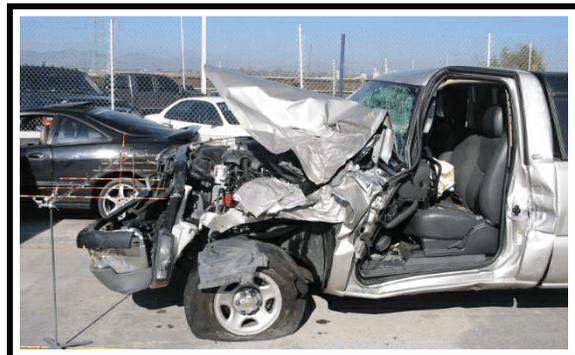
Figure 4. Left side, 2004 Chevrolet Silverado

Although the A pillar had been displaced rearward for approximately 20.0 cm (7.9 in), it must be noted that the A pillar falls outside of the normal passenger compartment area. Therefore, this longitudinal displacement was not encoded on the intrusion table. As the A pillar was moving rearward, it may have also been displaced both laterally and vertically; the amount of the intrusion could not be ascertained from the accompanying photos.

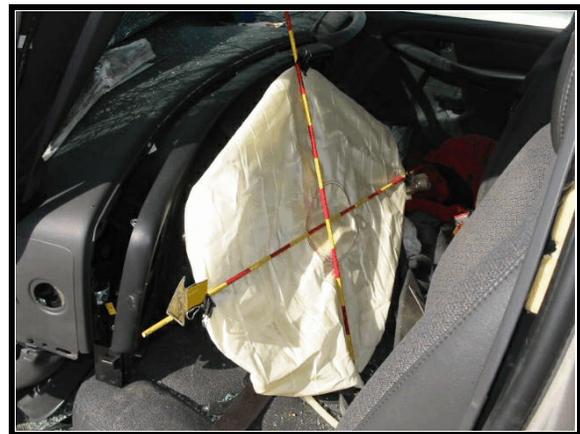
Figure 5. Driver's air bag

The case vehicle was equipped with advanced, dual stage driver and front right passenger air bags. The driver's air bag was mounted in the steering wheel hub. The deployed driver's air bag was round. The dual module cover flaps opened in an "I" type configuration. There were no indications of any damage to driver's air bag or the module cover flaps. The front right passenger air bag was a mid instrument panel mount. The front right air bag switch was set in the OFF position and the air bag was suppressed.

At impact the steering wheel mounted air bag deployed. This component prevented the driver's head, which had initiated a forward trajectory, from sustaining any trauma; it did not allow his upper extremities to come into contact with the steering wheel. The air bag performed as designed; no defects were observed.

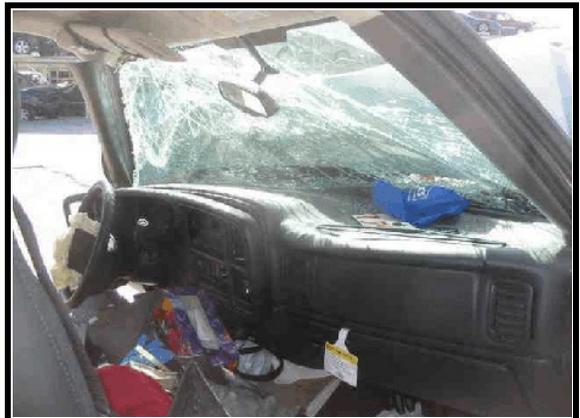
Figure 6. Front right passenger area—shows non deployment of front right passenger air bag
