**CALSPAN ON-SITE SIDE IMPACT INFLATABLE OCCUPANT PROTECTION  
INVESTIGATION**

**CASE NO: CA04-005**

**VEHICLE: 2002 FORD EXPLORER**

**CRASH DATE: FEBRUARY 2004**

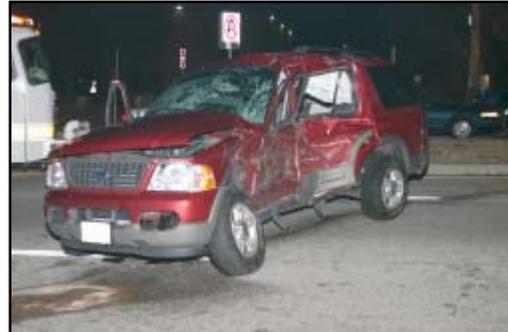
**Figure 1. On-scene view of damaged Ford Explorer**

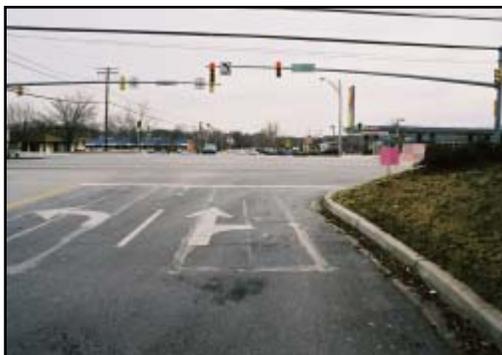
The 60-year-old female driver of the Ford Explorer was eastbound and brought the vehicle to a controlled stop at the mouth of the west leg of the intersection (**Figure 2**). The traffic signal was in the red phase for eastbound traffic. The 24-year-old male driver of the Chevrolet Astro minivan was operating the vehicle on the outboard southbound lane and was attempting to elude police pursuit. The pursuing police vehicle abandoned the pursuit due to safety concerns and continued to follow the Astro minivan in a non-emergency mode. The minivan continued to accelerate and was traveling at a police-estimated speed of 113 km/h (70 mph) as it approached the four-leg intersection (**Figure 3**). The driver of the minivan steered into the right turn lane. As the Astro minivan approached the intersection, the traffic signals cycled to green for eastbound traffic and red for north/south traffic. The driver of the Explorer did not detect the approaching minivan and proceeded into the intersection across its path upon the green traffic signal. The driver of the Astro minivan disregarded the red traffic signal and entered the intersection while moving from the right turn lane to the outboard travel lane. Neither driver attempted any

**Figure 2. Eastbound path of travel for the Ford Explorer**

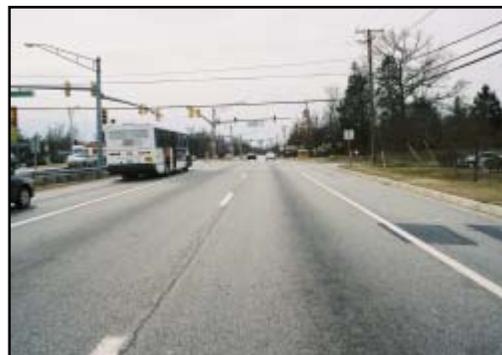
**Figure 3. Southbound approach for the Chevrolet Astro minivan**

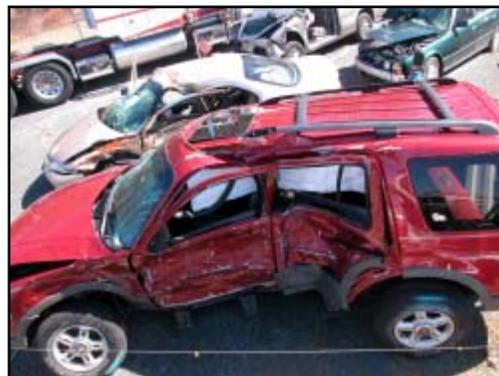
The 2002 Ford Explorer sustained severe left side damage (**Figure 5**) as a result of the impact with the Chevrolet Astro minivan. The direct contact damage began 13 cm (5.0”) aft of the left front axle and extended rearward 206 cm (81.0”). White paint transfers were present along the direct damage width from contact with the Astro minivan. The left side trim and left side step bar were separated and the left sill was crushed. Direct contact abrasions extended 13 cm (5.0”) above the beltline on the rear aspect of the left front door. The severe crush resulted in the bowing of the Explorer. The maximum crush was located 23 cm (9.0”) aft of the left B-pillar and measured 67 cm (26.5”). The frontal end shift measured 28 cm (11.0”) to the left. The combined direct and induced damage measured 440 cm (173.0”), beginning at the front bumper corner and terminating at the rear bumper corner. The left front fender was deformed and crushed laterally at the rear aspect. The plastic fender trim was fractured. The roof and roof side rail were deflected laterally. Vertical separation between the left roof side rail began at the windshield header and extended rearward 83 cm (32.5”). The maximum vertical separation measured 6 cm (2.5”) and was located 18 cm (7.0”) forward of the left B-pillar. The Collision Deformation Classification (CDC) for the impact with the Astro minivan was 89-LPAW-4, which was incremented by 80 to reflect the bowing. Six crush measurements were documented at the mid-door and were as follows: C1 = 15 cm (5.7”), C2 = 11 cm (4.2”), C3 = 61 cm (24.0”), C4 = 44 cm (17.5”), C5 = 18 cm (20.7”), C6 = 0.0 cm.

**Figure 5. View of the damaged left side of the Ford Explorer**

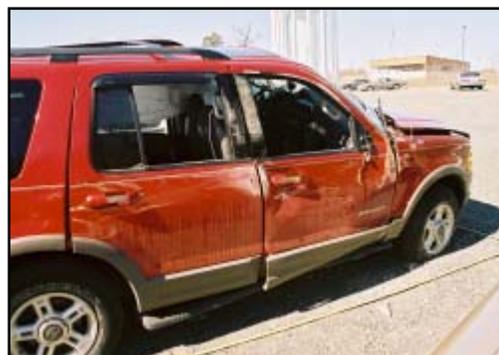
The Explorer sustained moderate right side damage as a result of the trip-over (**Figure 6**). The direct contact began 13 cm (5.0”) aft of the right front bumper corner and extended rearward 305 cm (120.0”) along the right side plane. The right mirror was separated. Heavy abrasions were present on the right front fender, the leading edge of the right front door, the leading edge of the right rear door, and on both door handles. Yellow paint transfers were present on the front door handle and the leading edge of the right front door from contact with the yellow inboard delineation line adjacent to the median. Heavy abrasions were also present on the right front roof side rail. The CDC for the turn-over was 00-RDAO-2.

**Figure 6. View of the right side trip-over damage to the Ford Explorer**

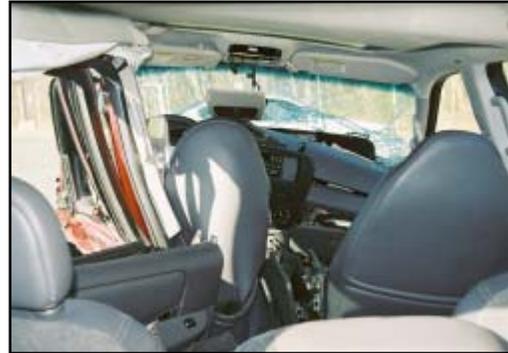
The 2002 Ford Explorer sustained severe interior damage as a result of lateral passenger compartment intrusion (**Figure 7**). The left front and left rear doors were jammed shut. The tilt-steering wheel was jammed in the mid-position. Lateral intrusions into the driver’s seating position included the left front door, left A- and B-pillars, left sill, and the left roof side rail. The driver’s seat was compressed laterally, which reduced its overall width by 15 cm (6.0”). The instrument panel was compressed laterally and deflected upward at the center aspect, which resulted in the partial separation and deformation of the knee bolster, instrument panel trim, and the displacement of the non-deployed front right passenger’s air bag module. The lateral deflection of the driver’s seat caused compression and fractures of the center console between the driver’s and front right seats. The rear inboard aspect of the driver’s seat was disengaged from the inboard track and was displaced laterally 13 cm (5.0”) inboard of the track. The rear view mirror and roof-mounted console were separated. Intrusions into the rear left seating position included the left B- and C-pillars, left door, left sill, and the left roof side rail. The rear left seat and mounting hardware were deflected laterally and compressed due to intrusion.

**Figure 7. View of interior from the rear showing intrusions**

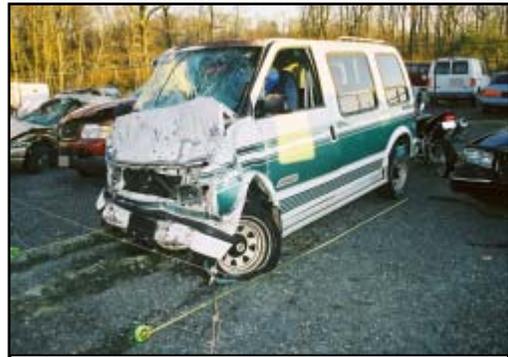
The 1989 Chevrolet minivan sustained severe frontal damage (Figure 8) as a result of the impact with the 2002 Ford Explorer. The direct damage involved the entire frontal width of the minivan and measured 160 cm (63.0"). The entire frontal structure was crushed rearward. The front bumper was partially separated at the front left corner. The combined direct and induced damage also involved the entire frontal width of the vehicle. The hood was buckled upward and rearward. Both front fenders were crushed rearward and buckled outward. The maximum crush was located at the front right bumper corner and measured 59 cm (23.3"). The frontal crush displaced the front axle rearward, which reduced the left wheelbase by 18 cm (7.1") and the right wheelbase by 5 cm (2.0"). The left and right side doors were jammed shut. The impact deflected the right A-pillar rearward which resulted in the vertical deflection of the right roof side rail. The CDC for the frontal impact with the Ford Explorer was 12-FDEW-4. Six crush measurements were documented along the front bumper and were as follows: C1 = 50 cm (19.5"), C2 = 34 cm (13.5"), C3 = 48 cm (19.0"), C4 = 52 cm (20.4"), C5 = 49 cm (19.3"), C6 = 58 cm (23.3").

Figure 8. Damaged Chevrolet Astro minivan

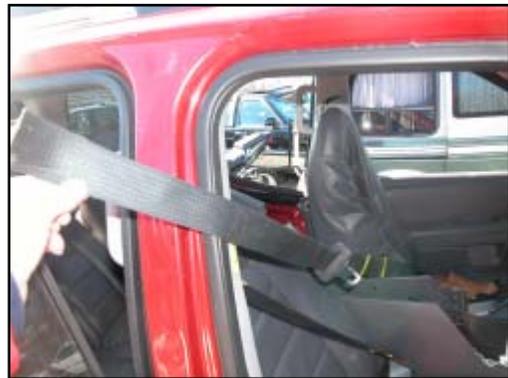
The 2002 Ford Explorer was equipped with continuous loop, manual 3-point lap and shoulder belts with adjustable D-rings for each outboard seating position. The rear center position was configured with a lap belt. The driver's safety belt was configured with a belt-sensitive, Emergency Locking Retractor (ELR) and the remaining outboard safety belts were configured with belt-sensitive, switchable ELR/Automatic Locking Retractors (ALR). The driver's D-ring was found in the mid-position at the time of the vehicle inspection; however, due to the B-pillar intrusion and deformation, the D-ring would not lock in position. Rescue personnel cut the driver's safety belt. The driver's safety belt webbing (Figure 9) measured 130 cm (51.0") in length from the plastic stop button, and the webbing below the stop button was restricted between the outboard seat cushion and the intruded left front door. The entire length of the webbing was corrugated and red/pink fabric transfers were present on the inboard aspect of the webbing near the edges (against the occupant), and were located 38 cm (15.0") from the stop button and extended 13 cm (5.0") up the webbing. The driver's plastic-covered latch plate exhibited heavy abrasions as a result of occupant loading against the webbing.

Figure 9. View of the cut driver's safety belt

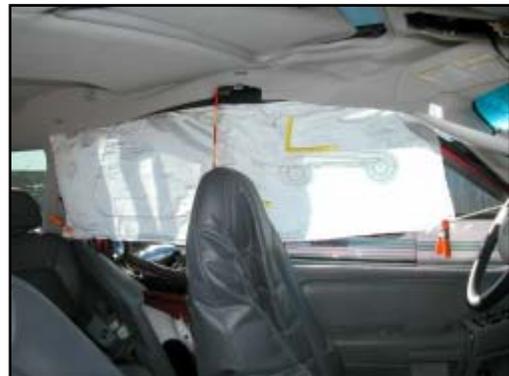
The 2002 Ford Explorer was equipped with side impact Inflatable Curtains (IC). The left side IC deployed as a result of the left side impact with the Chevrolet Astro minivan. The IC (**Figure 10**) deployed downward from the left roof side rail through a separation of the roof headliner from the side-rail that measured 152 cm (60.0") between the left A- and C-pillars. The left IC was rectangular in shape and measured 152 cm (60.0") in length and 43 cm (16.8") in height. The IC was tethered on the forward aspect by a 1 cm (1/4") diameter rope-type tether, which measured 36 cm (14.0") in length. The tether was located 20 cm (8.0") above the base of the left A-pillar and had been cut by rescue personnel. The bottom of the IC was located 9 cm (3.5") above the belt line. The bottom of the IC measured 75 cm (29.5") above the driver's seat cushion and 61 cm (24.0") above the rear left seat cushion. A light scuff mark was present on the inboard aspect of the IC from contact with the top outboard aspect of the driver's seat back. The intrusion of the passenger compartment deflected the IC laterally into the seat back. The scuffmark, which measured 9 cm (3.5") in height and 12 cm (4.8") in width, was located 52 cm (20.5") aft of the leading edge of the IC and 10 cm (4.0") above the bottom edge. A faint diagonal scuffmark from probable contact with the driver's head was located 32 cm (12.8") aft of the leading edge of the IC and 4 cm (1.5") below the top aspect. The scuffmark measured 9 cm (3.5") in height and 12 cm (4.8") in width.

**Figure 10. Inboard view of the deployed left IC**

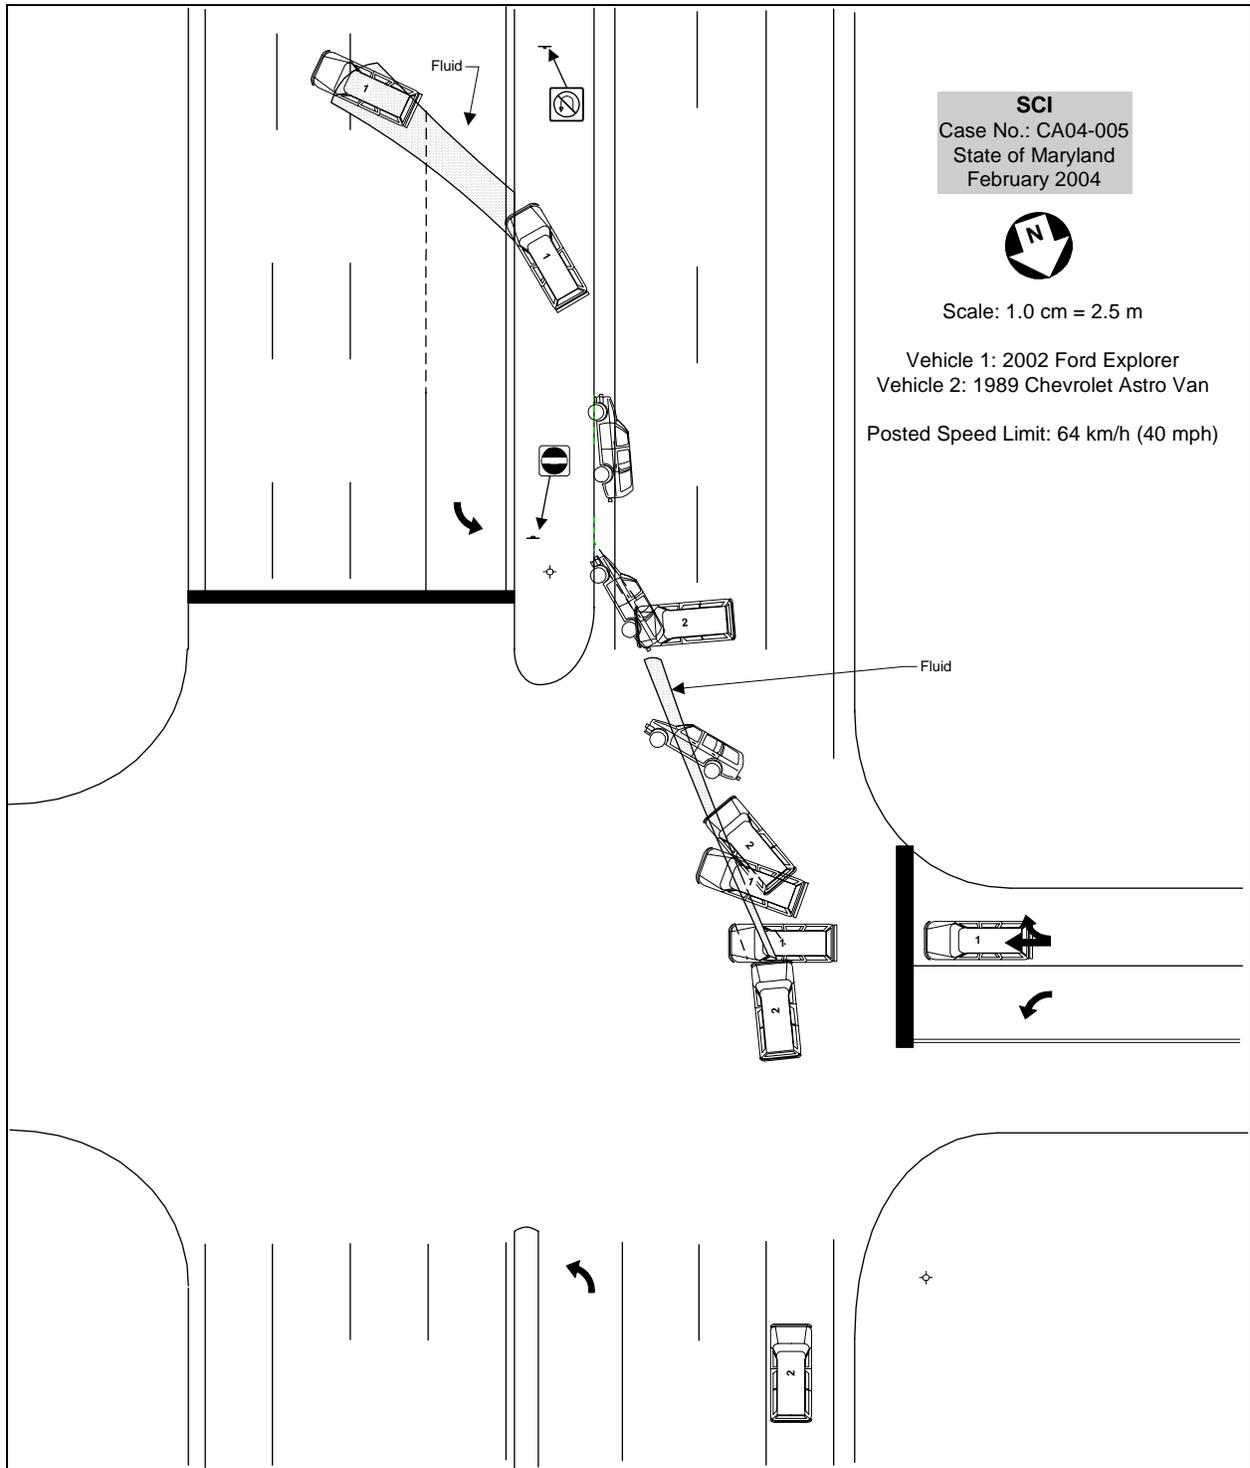
**Figure 11. Scene Schematic**

This two-vehicle crash occurred during the nighttime hours of February 2004 in the state of Maryland. At the time of the crash it was dark, and the roadway was illuminated by overhead luminaires. The weather was clear and the asphalt roadway surfaces were dry. The crash occurred on a four-leg intersection consisting of an eight-lane divided roadway, which crossed a three-lane divided roadway and a three-lane commercial driveway. Traffic flow through the intersection was controlled by overhead three-phase traffic signals. The north/south roadway was straight and level and consisted of two southbound travel lanes and three northbound travel lanes that were separated by a curbed median barrier and bordered by concrete curbs. The southbound lanes widened at the intersection to accommodate an outboard right turn lane, and the curbed median width was reduced at the intersection to accommodate center left turn lanes. The three-lane commercial driveway on the west leg was configured with one right turn lane and one through/left turn lane for outbound traffic and single inbound lane. The driveway surface was asphalt and bordered by concrete curbs. The east leg was configured with two travel lanes in each direction separated by a curbed median barrier and bordered by concrete curbs. The posted speed limit was 64 km/h (40 mph). The scene schematic is included as **Figure 11** of this report.
