TRANSPORTATION RESEARCH CENTER

ON-SITE CERTIFIED ADVANCED 208- COMPLIANT VEHICLE INVESTIGATION

CASE NUMBER - IN-04-007
LOCATION - Texas
VEHICLE - 2004 FORD F150 PICKUP TRUCK
CRASH DATE - February 2004

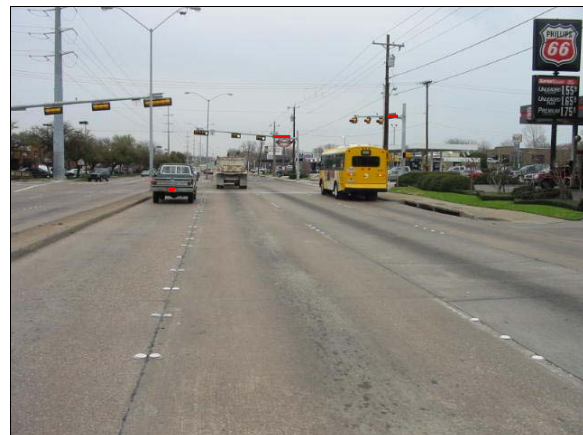
Figure 1: Approach of case vehicle northeast bound to the intersection in the inside through lane.

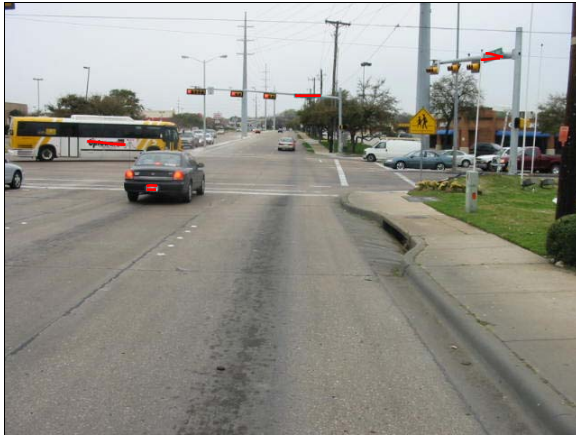
Figure 2: Approach of the Nissan Pathfinder northwestbound to the intersection.

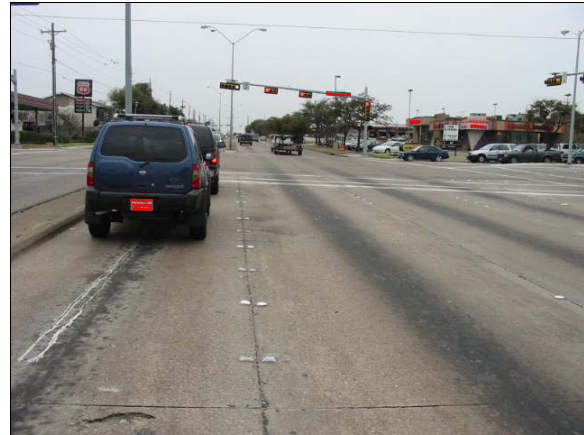
Figure 3: View southwest to the intersection. The Cadillac, Frontier and the Toyota were stopped in the two center through lanes.

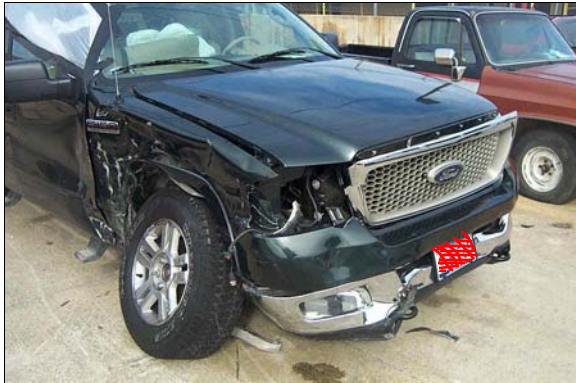
Figure 4: Insurance photo showing right front damage to the case vehicle from the initial impact with the Pathfinder.

Exterior Damage: The case vehicle’s initial contact with the Nissan Pathfinder involved the right front bumper corner, right fender, right front wheel and forward edge of the right front door. Due to the removal of the right fender, right front wheel and front bumper, damage measurements could not be taken to the front and right fender area. The secondary (side-slap) impact to the case vehicle involved the right rear door, right side of the truck bed, and the right rear wheel. Direct damage from this impact began 104 centimeters (40.9 inches) forward of the right rear axle and extended 224 centimeters (88.2 inches) along the right side of the truck bed. Residual maximum crush was 17 centimeters (6.7 inches) occurring at C₂. The table below shows the case vehicle’s crush profile for the secondary side-slap impact.

Damage Classification: The damaged right fender and front bumper had been removed from the case vehicle. However, based on the vehicle inspection and a photograph provided by the insurance adjuster, the CDCs for the case vehicle were determined to be: **01-RYEW-2 (30 degrees)** for the right front impact with the front of the Pathfinder (event 1), **03-RBEW-2 (90 degrees)** for the side-slap impact with the left side of the Pathfinder (event 2), **12-FREW-1 (0 degrees)** for the front impact with the front of the Frontier (event 4) and **12-FLEE-1 (0 degrees)** for the front impact to the left side of the Toyota (event 6). The WinSMASH reconstruction program, missing vehicle algorithm, was used to reconstruct the case vehicle's highest severity impact (i.e., event 1). The Total, Longitudinal, and Lateral Delta Vs are, respectively: 39.0 km.p.h. (24.2 m.p.h.), -33.8 km.p.h. (-21.0 m.p.h.), and -19.5 km.p.h. (-12.1 m.p.h.). The case vehicle was towed due to damage.

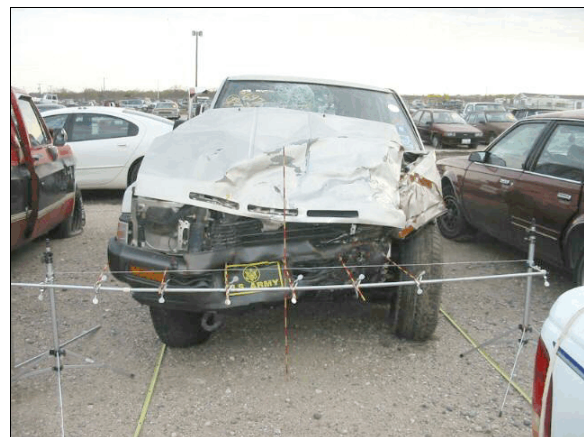
Figure 5: Front damage to the Pathfinder from the initial impact with case vehicle.

Exterior Damage: The Pathfinder’s initial impact with the case vehicle involved the front of the vehicle. The front bumper, left headlamp/turn signal assembly, left fender, hood and grille were directly contacted and crushed rearward and to the right. The direct damage began at the left bumper corner and extended 85 centimeters (33.5 inches) to the right. The maximum residual crush occurred at C₁ and was measured as 34 centimeters (13.4 inches). The secondary side-slap impact with the case vehicle involved the left rear corner and quarter panel of the Pathfinder. The left corner of the back bumper and the quarter panel were directly damaged and crushed inward. The maximum residual crush was estimated as 9 centimeters (3.5 inches), occurring at C₁. The rollover involved the left side of the Pathfinder. Direct damage involved the left “A”-pillar, left front door, left rear door and the quarter panel. Maximum crush due to the rollover consisted of surface scratches. The table below shows the crush profile for the Pathfinder’s front impact.

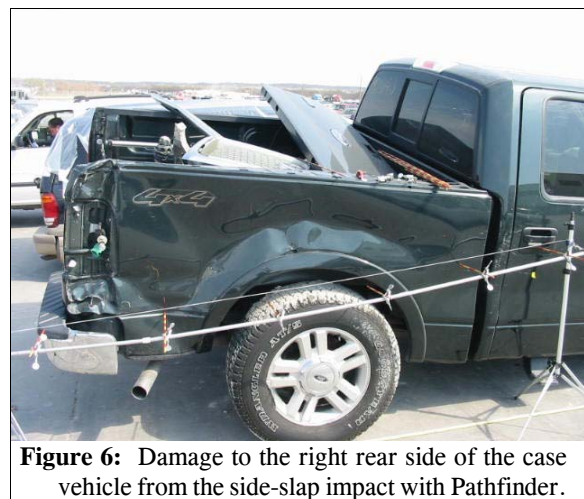
Figure 6: Damage to the right rear side of the case vehicle from the side-slap impact with Pathfinder.

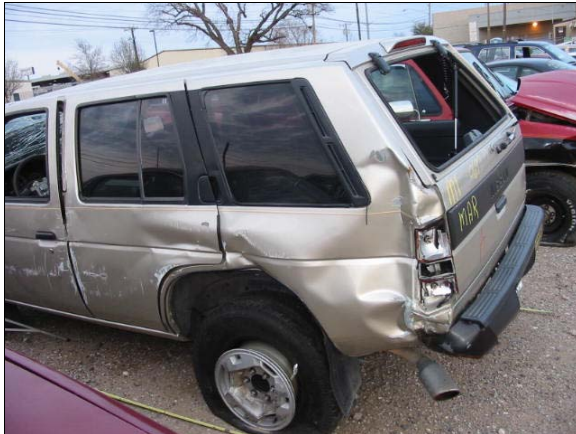
Figure 7: Damage to the left rear corner of Pathfinder from the side-slap impact with the case vehicle, scratches forward of the left rear corner are from the rollover.

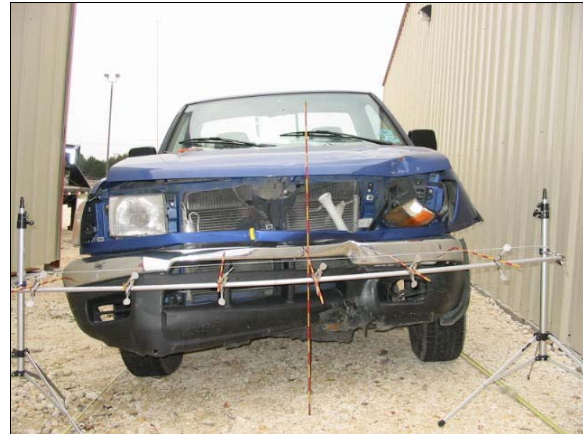
Figure 8: Damage to front of Frontier from impact with front of case vehicle.

Exterior Damage: The Frontier’s impact with the case vehicle involved the front of the vehicle. The front bumper, left fender, left headlamp/turn signal assembly, hood and grille were directly contacted and crushed rearward. The direct damage began at the front left bumper corner and extended 83 centimeters (32.7 inches) to the right along the front of the Frontier. The residual maximum crush was measured as 22 centimeters (8.7 inches) occurring at C₁. The Frontier’s impact with the Cadillac involved the back of the vehicle. The back bumper was directly damaged and crushed forward, and there was minor direct damage to the tailgate. No damage measurements were taken for the rear bumper impact. The table below shows the Frontier’s front crush profile.

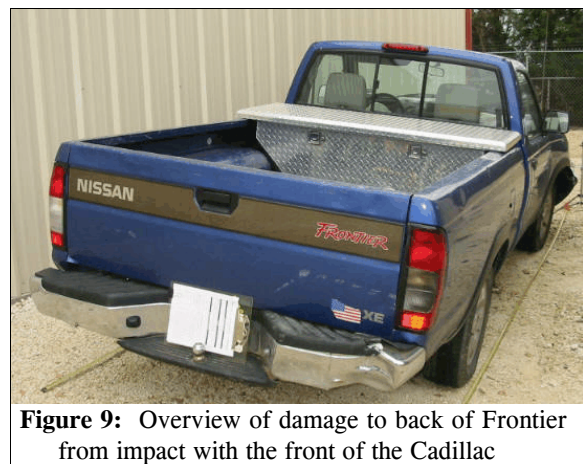
Figure 9: Overview of damage to back of Frontier from impact with the front of the Cadillac

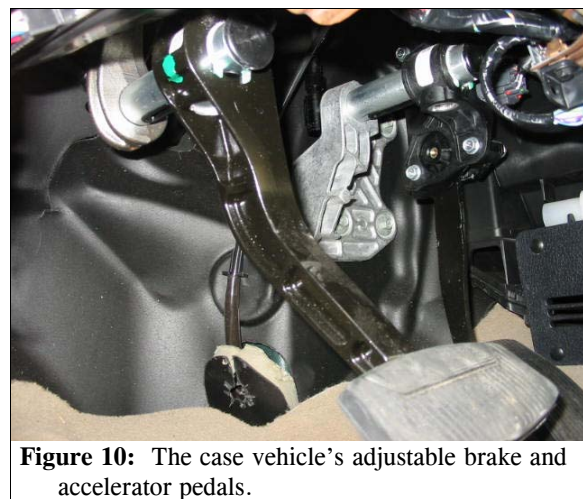
Figure 10: The case vehicle's adjustable brake and accelerator pedals.

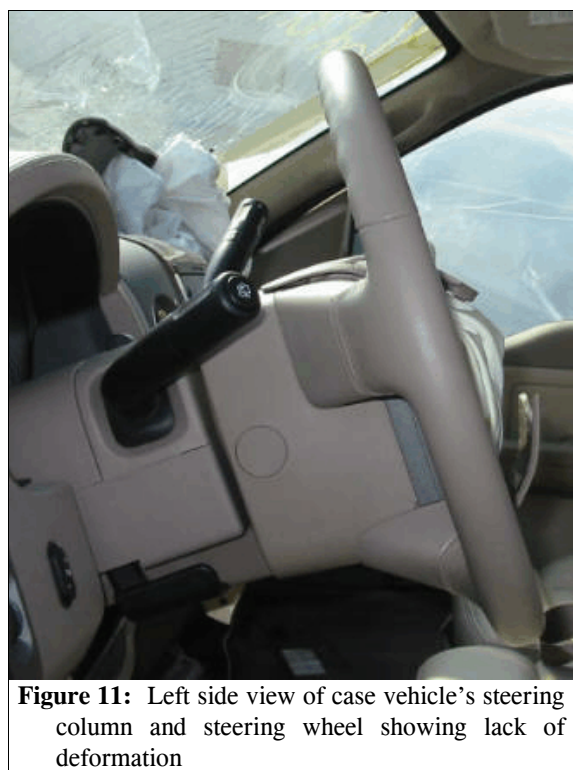
Vehicle Interior: Inspection of the case vehicle's interior revealed a possible occupant contact scuff on the deployed front right air bag. There was no other evidence of occupant contact on any of the interior surfaces or components. Finally, there was no intrusion to the case vehicle's interior, no evidence of compression to the energy absorbing steering column, and no deformation to the steering wheel rim (**Figure 11**).

Figure 11: Left side view of case vehicle's steering column and steering wheel showing lack of deformation

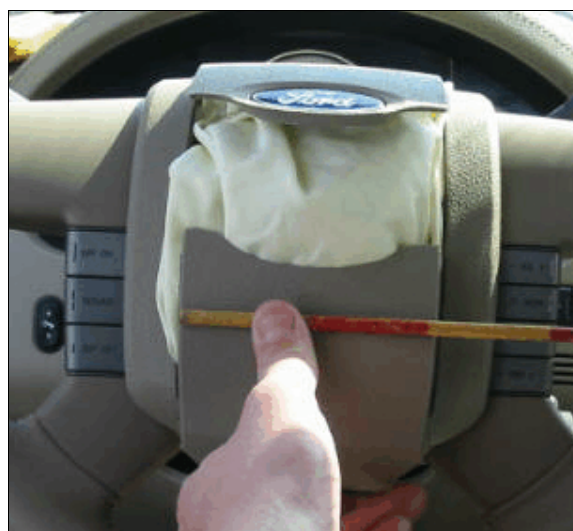
The case vehicle's driver air bag was located in the steering wheel hub. An inspection of the air bag module cover flaps and the air bag fabric revealed that the cover flaps opened at the designated tear points. There was no evidence of damage during the deployment to the air bag fabric or the cover flaps. The cover flaps (**Figure 12**) were approximately rectangular in shape. The upper cover flap had a rounded contour at the tear seam that accommodated the Ford emblem, which mated with a concave contour on the lower cover flap. The upper cover flap was 11 centimeters (4.3 inches) in width and 7 centimeters (2.8 inches) in height. The lower cover flap was 11 centimeters (4.3 inches) in width and 10 centimeters (3.9 inches) in height. The driver's air bag was designed with two tethers, each approximately 14 centimeters (5.5 inches) in width, and had two vent ports (**Figure 13**), each approximately 2.5 centimeters (1.0 inches) in diameter, located at the 10:30 and 1:30 o'clock positions. The deployed driver's air bag (**Figure 14** below) was round with a diameter of approximately 60 centimeters (23.6 inches). An inspection of the driver's air bag fabric revealed no evidence of occupant contact to the air bag. The distance between the mid-center of the driver's seat back, as positioned at the time of the vehicle inspection (i.e., between middle and forward most track position), and the front surface of the air bag fabric at approximate full excursion was 26 centimeters (10.2 inches).

Figure 12: Driver's air bag module cover flaps

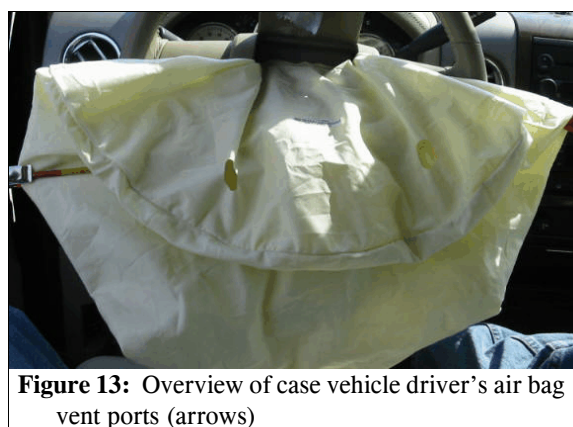
Figure 13: Overview of case vehicle driver's air bag vent ports (arrows)

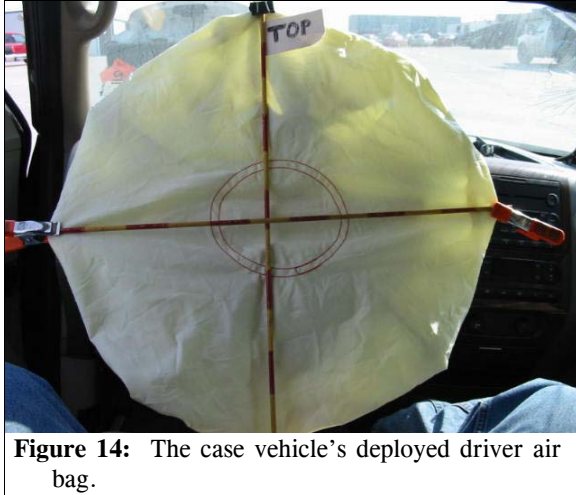
Figure 14: The case vehicle's deployed driver air bag.

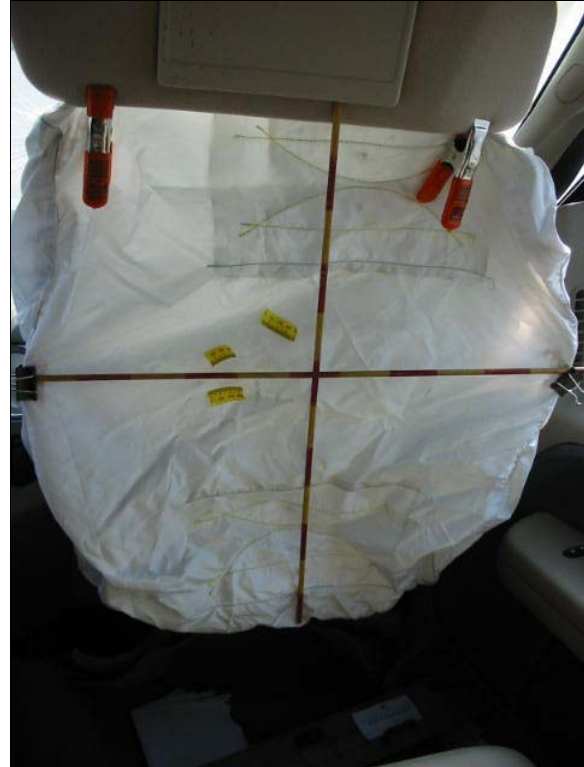
The front right passenger's air bag was located in the top of the instrument panel. It was designed with two tethers, each 20 centimeters (7.9 inches) in width. The two tethers were sewn together at their anchor point and then each tether was sewn separately to the stitching of the face of the air bag. The front right air bag had two vent ports, each approximately 5.5 centimeters (2.2 inches) in diameter, located at the 9:30 and 2:30 o'clock positions. The deployed air bag (**Figure 15**) was rectangular with a height of approximately 62 centimeters (24.4 inches) and a width of approximately 57 centimeters (22.4 inches). The single air bag module cover flap was constructed of metal, covered with vinyl and was rectangular in shape. It was approximately 41.5 centimeters (16.3) in width and about 25 centimeters (9.8 inches) in height. Upon deployment of the air bag, the module cover flap impacted and fractured the windshield in a linear pattern corresponding to the width of the air bag module cover flap (**Figure 16**). Inspection of the front right passenger's air bag fabric revealed some possible deployment scuffs and a possible occupant contact or fluid spill. No other occupant contact evidence was apparent on the air bag fabric. The distance between the mid-center of the front right passenger's seat back, as positioned at the time of the vehicle inspection (i.e., between middle and forward most track position), and the front surface of the air bag fabric at approximate full excursion was 37 centimeters (14.6 inches).

Figure 15: Case vehicle's deployed front right passenger air bag, yellow tape shows area of possible deployment scuffs and possible occupant contact.

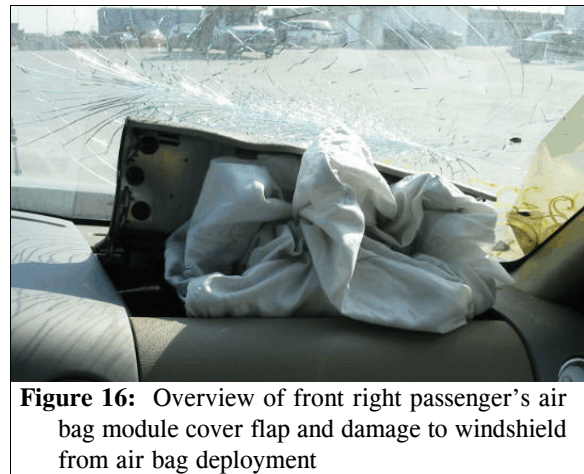
Figure 16: Overview of front right passenger's air bag module cover flap and damage to windshield from air bag deployment

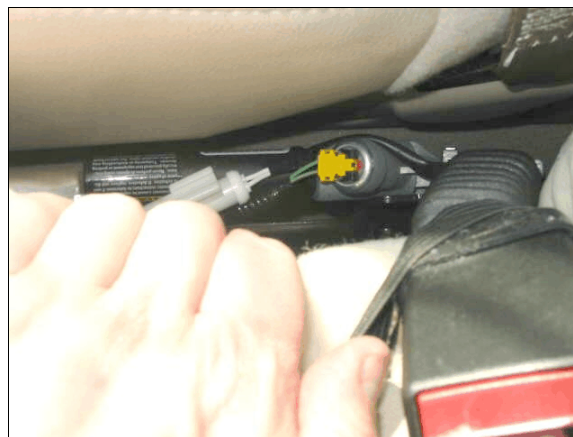
Figure 17: Case vehicle driver's seat belt pretensioner, buckle and buckle stalk.

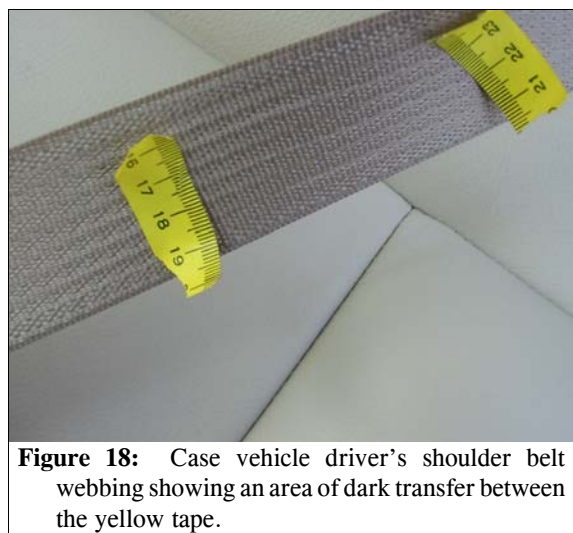
Based on this contractor's vehicle inspection, the case vehicle's driver was restrained by the manual, three-point, lap-and-shoulder safety belt system. The belt system was equipped with a buckle-mounted, pyrotechnic actuated, pretensioner and load-limiting retractor. The inspection of the driver's safety belt buckle assembly showed the pretensioner had activated during the crash as indicated by the compression of the ribbed cover on the stalk of the buckle (**Figure 17**). Inspection of the safety belt webbing revealed a small area of dark transfer that corresponded to the location of the "D"-ring when the safety belt was placed in its approximate in-use configuration (**Figure 18**), and a corresponding small abrasion was found on the "D"-ring.

Figure 18: Case vehicle driver's shoulder belt webbing showing an area of dark transfer between the yellow tape.

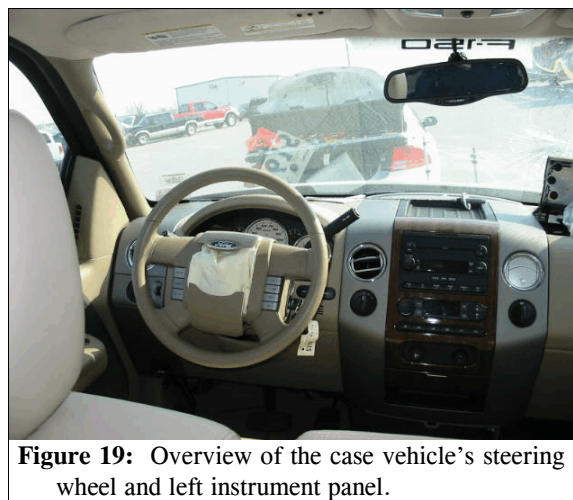
Figure 19: Overview of the case vehicle's steering wheel and left instrument panel.

The driver remained restrained in his seat position as the case vehicle crossed the intersection approaching impact with the Frontier. The case vehicle's front impact with the Frontier caused the driver to move forward along a path opposite the case vehicle's 0 degree direction of principal force as the case vehicle decelerated from the impact, and he again loaded his safety belt. The driver again moved forward and loaded his safety belt as the case vehicle's front left corner impacted the Toyota. The driver remained restrained in his seat as the case vehicle came to final rest against the Toyota and the Frontier. **Figure 19** shows an overview of the driver's seating position, steering wheel and left instrument panel.

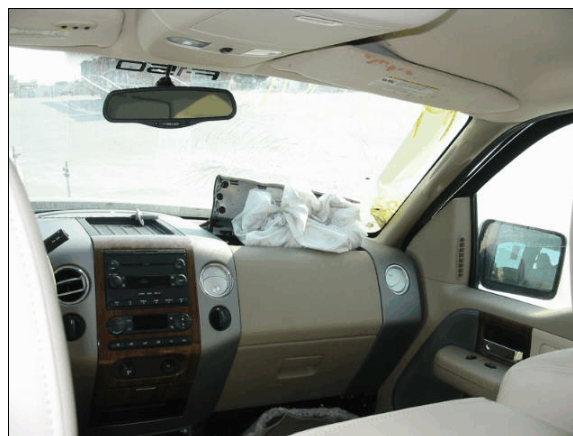
Figure 20: Overview of the case vehicle's front right instrument panel and front right air bag location.

The front right passenger most likely remained in her seat as the case vehicle crossed the intersection approaching impact with the Frontier. The case vehicle's front impact with the Frontier caused the front right passenger to continue forward along a path opposite the case vehicle's 0 degree direction of principal force as the case vehicle decelerated from the impact, and she most likely impacted her now deflated air bag and the underlying instrument panel. The front right passenger again moved forward as the case vehicle's front left corner impacted the Toyota. It is not known if the front right passenger remained in her seat following these two impacts, or how she exited the case vehicle. **Figure 20** shows an overview of the front right seat position and instrument panel.

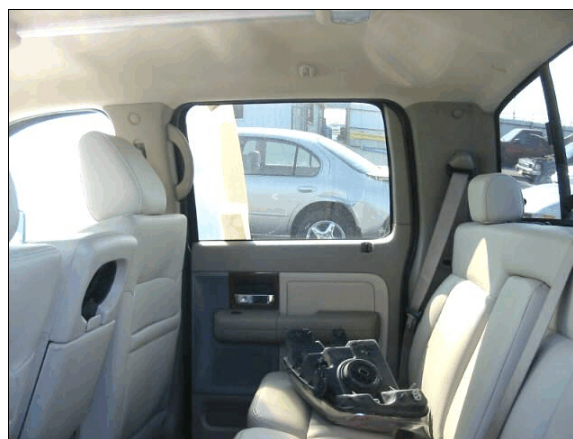
Immediately prior to the crash, the back right passenger [5-year-old, White (Hispanic) female; 104 centimeters and 27 kilograms (41 inches, 60 pounds)] was most likely seated in an upright position, however the positions of her hands, arms, feet, and legs are not known. Her seat track and seat back were not adjustable. **Figure 21** shows the back right seating position.

Figure 21: Overview of the back right seat position.

safety belt. She remained in her seat as the case vehicle came to final rest against the front of the Frontier and left side of the Toyota. **Figure 21** shows an overview of the back right passenger seat position.
