Remote Investigation / Rollover, 15 Passenger Van
Dynamic Science, Inc. / Case Number: DS04011
2003 Ford Econoline E350 van
Washington
December, 2003

1. Report No. DS04011	2. Government Accession No.		3. Recipient Catalog No.	
4. Title and Subtitle Remote Investigation / 15 Passenger Van			5. Report Date July 11, 2006

Dynamic Science, Inc.
Crash Investigation
Case Number: DS04011

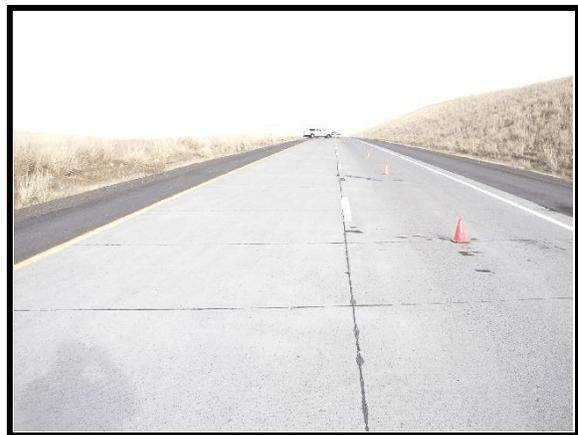
Figure 2. Path of travel, road departure, and final rest. Looking north.

The case vehicle crossed into the shadowed area and struck a patch of ice/frost. The vehicle began to fishtail to the right. The driver overcorrected to the right and the vehicle went into a clockwise yaw. The yaw continued for 56 m (183 ft) until the vehicle had reached approximately a 45 degree angle and the rear tires had entered the left side shoulder. The vehicle tripped at this point with its left side leading. The vehicle overturned three times as it continued on for an additional 46 m (152 ft) before coming to rest on its wheels facing generally east.

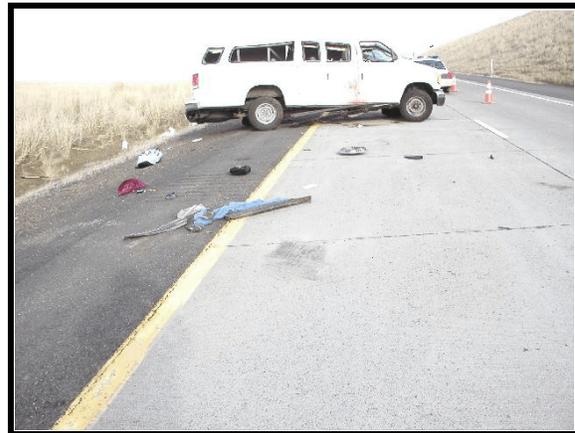
Figure 4. Final rest. Looking north.

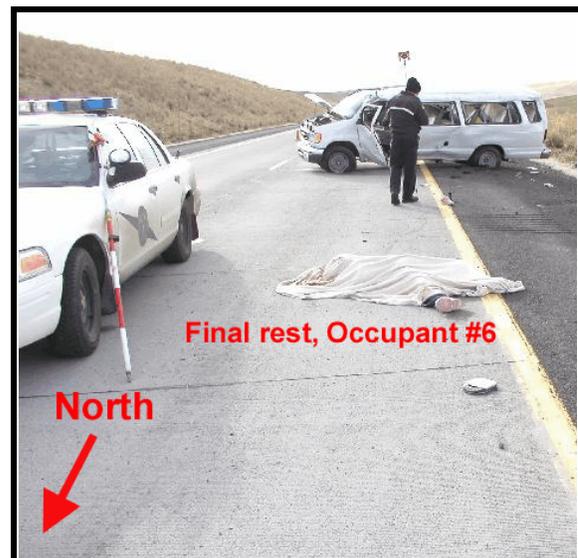
Figure 5. Final rest, Econoline, Occupant 6. Facing south.

The third row left seat occupant (06) was completely ejected and came to rest on the roadway 11 m (35 ft) north of the van's final rest. She had been ejected through the left side window and was fatally injured.. According to the certificate of death, she sustained a blunt head trauma, and neck and thoracic injuries. She had been fully ejected. The interval between the crash and the time of death was listed as instantaneous.

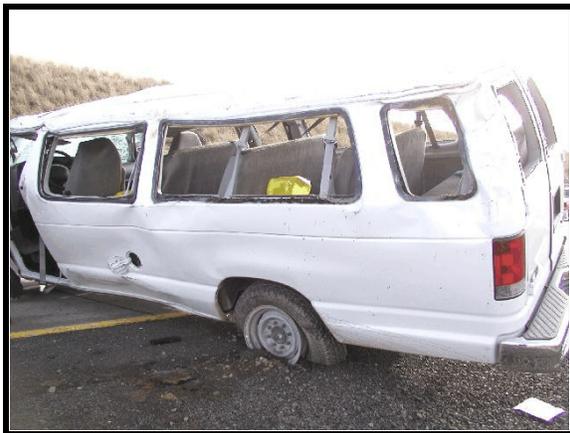
Damage Description: Moderate roof and side damage consistent with a rollover crash. Left side tires were both off the rims.

CDC: 00TDDO3

Figure 6. Left side, Ford Econoline van

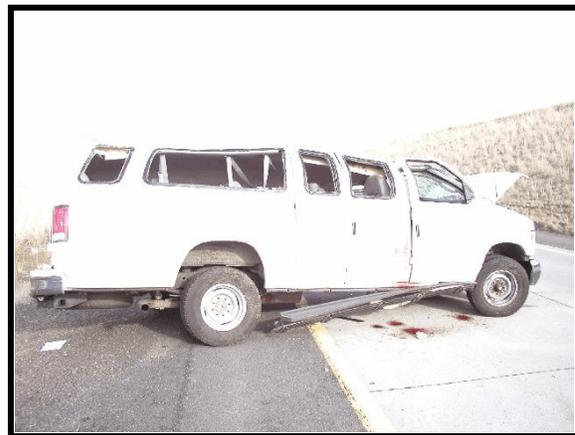
Figure 7. Right side, Ford Econoline van

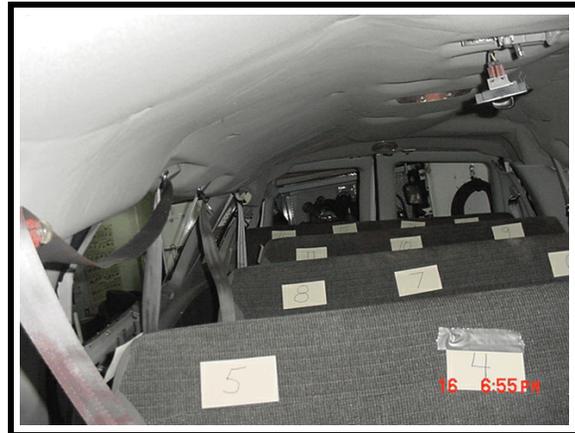
Interior showed large quantities of blood, concentrated primarily on the interior right passenger door. The police indicate that there was hair and blood behind the driver's seat in between the first and second bench seats that most likely came from the occupant who was ejected forward through the left front side window. There was intrusion along both roof rails, particularly on the right. The roof was bowed upwards in the center. All the side glazing and the rear door glazing was disintegrated. The windshield was fractured, holed, and displaced.

Figure 8. Overview of vehicle interior

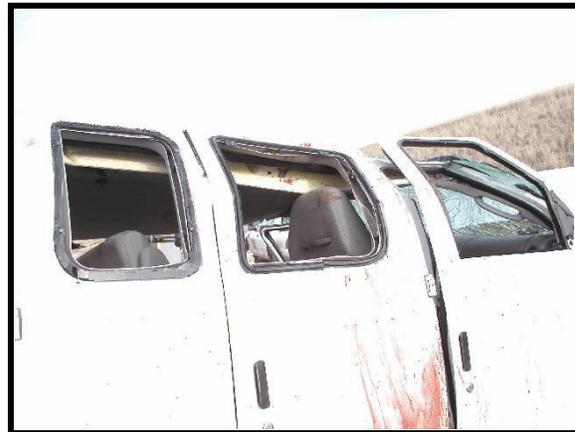
The second row right seat occupant (05) was partially ejected through the right side window and was fatally injured. She remained outside of the window as the vehicle came to rest but was pulled inside by other occupants shortly after the vehicle came to rest. According to the certificate of death, she sustained a blunt head trauma and neck injuries. She had been partially ejected. The interval between the crash and the time of death was listed as instantaneous.

Figure 9. Area of partial ejection of Occupant 5

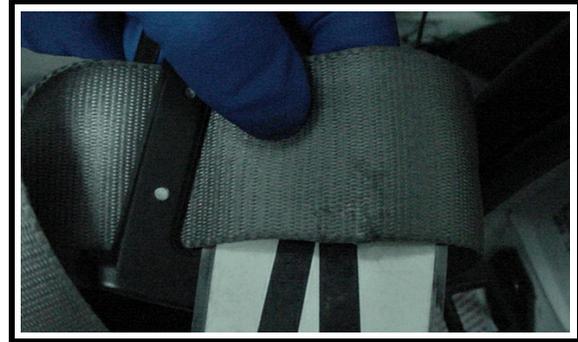
The driver of the E350 was wearing the available lap and shoulder belt. Belt usage was based on the driver's statement and loading evidence found on the belt during the police examination.

Figure 10. Loading to driver's seat belt webbing

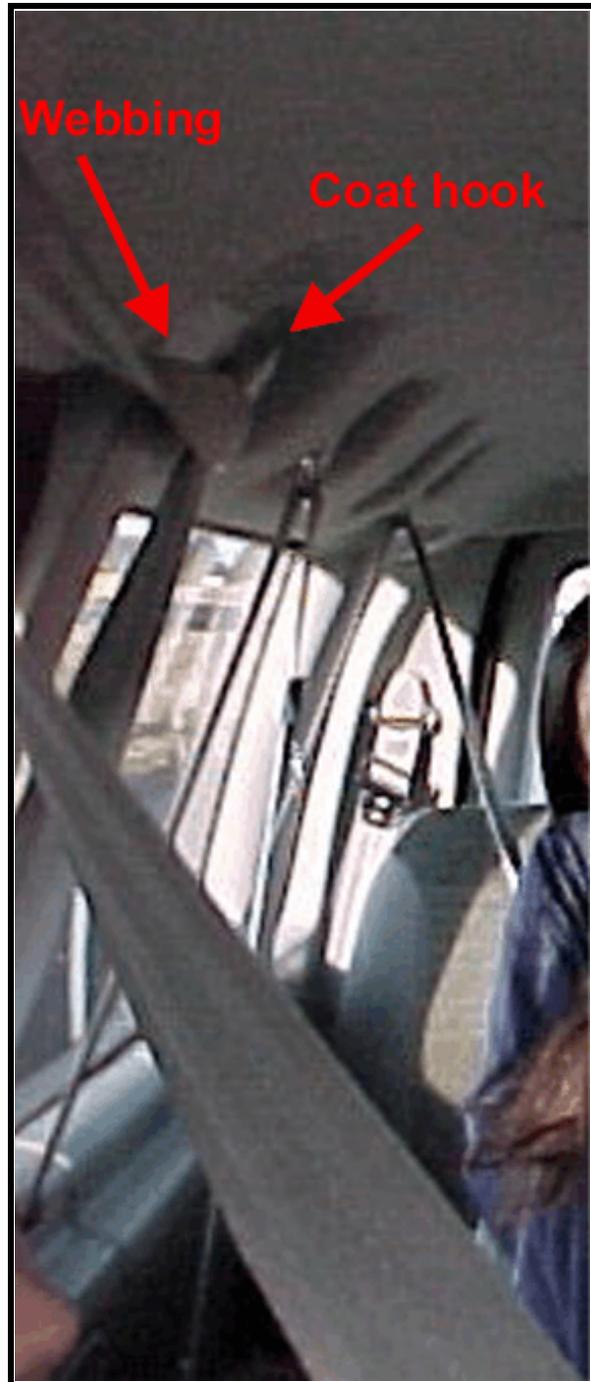
Occupant 5 (seated in position 5) was wearing the lap and shoulder belt in an improper fashion. It appears that the shoulder harness was not being used. The shoulder harness had been wrapped around the right side coat hook. See Figure 13 on the following page.

Figure 12. Seat belt in seat position 5, belt wrapped around coat hook

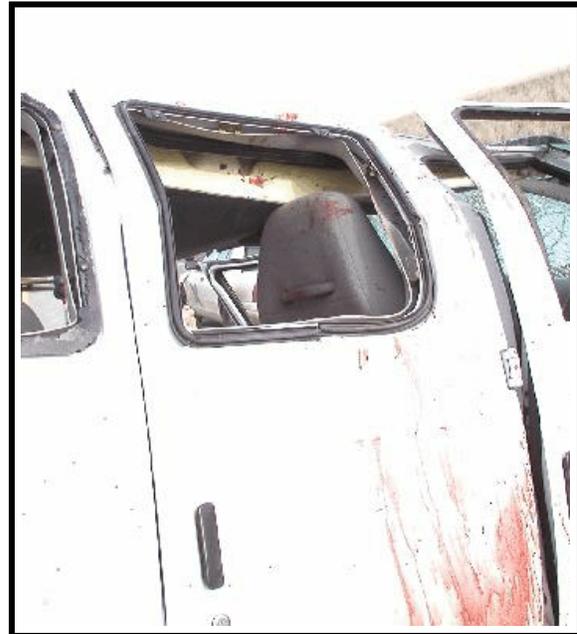
The 16-year-old female second row right occupant was seated in an upright fashion. She was wearing the manual 3-point lap and shoulder belt improperly. It appears that the shoulder harness was not being used. The shoulder harness had been wrapped around the right side coat hook. As the vehicle encountered the frost/ice, the driver began to make sharp steering movements. As he lost control of the vehicle, the vehicle began a clockwise rotation. As the vehicle rotated approximately 90 degrees from its initial path of travel, the vehicle tripped and began to rollover about its longitudinal axis with its left side leading. The vehicle overturned three times. This occupant likely shifted from right to left during the steering maneuver, and then shifted sharply to the right as the vehicle rolled to the left. She was likely pitched out of her seat at various times throughout the rollover sequence. She was partially ejected through the right side window and was fatally injured. She remained outside of the window as the vehicle came to rest but was pulled inside by other occupants shortly after the vehicle came to rest. According to the certificate of death, she sustained a blunt head trauma and neck injuries. She had been partially ejected. The interval between the crash and the time of death was listed as instantaneously.

Figure 17. Second row right seat occupant partial ejection medium

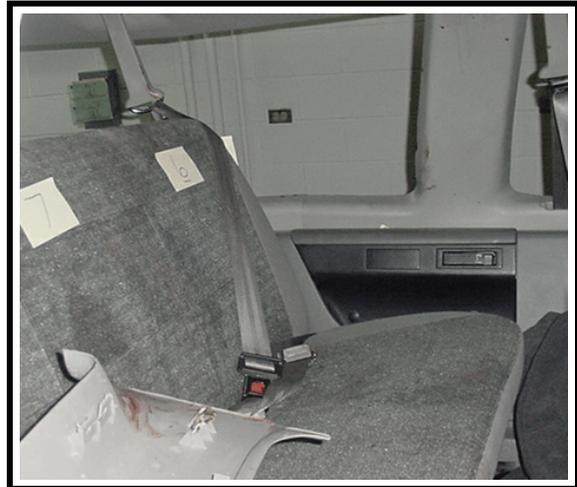
The 17-year-old female third row left occupant was seated in an upright fashion. She was not wearing the manual 3-point lap and shoulder belt. As the vehicle encountered the frost/ice, the driver began to make sharp steering movements. As he lost control of the vehicle, the vehicle began a clockwise rotation. As the vehicle rotated approximately 90 degrees from its initial path of travel, the vehicle tripped and began to rollover about its longitudinal axis with its left side leading. The vehicle overturned three times. This occupant likely shifted from right to left during the steering maneuver, and then shifted sharply to the right as the vehicle rolled to the left. She was likely pitched out of her seat at various times throughout the rollover sequence. She was completely ejected and came to rest on the roadway 11 m (35 ft) north of the van's final rest. She had been ejected through the left side window and was fatally injured. It appears likely that she was partially ejected at some point and contacted the road surface. According to the certificate of death, she sustained a blunt head trauma, and neck and thoracic injuries. The interval between the crash and the time of death was listed as instantaneous.

Figure 18. Third row, left occupant seated position and ejection path

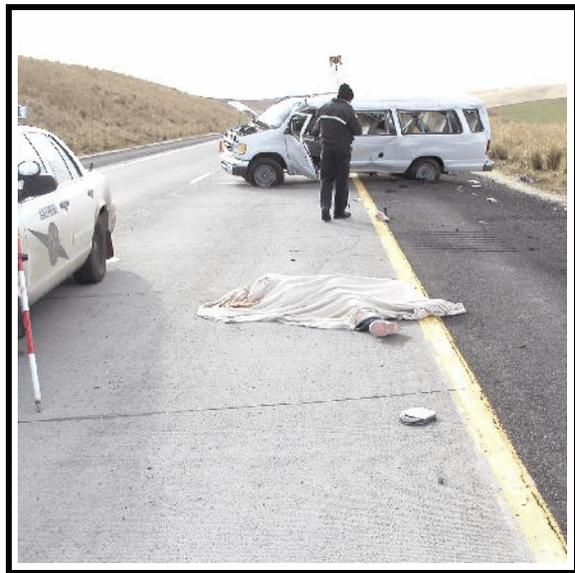
Figure 19. Final rest position, third row left occupant
