# INDIANA UNIVERSITY

## ON-SITE POTENTIAL SAFETY-RELATED DEFECT INVESTIGATION

CASE NUMBER - IN-04-018

VEHICLE - 1998 FORD E350, SUPER EXTENDED CLUB WAGON XLT

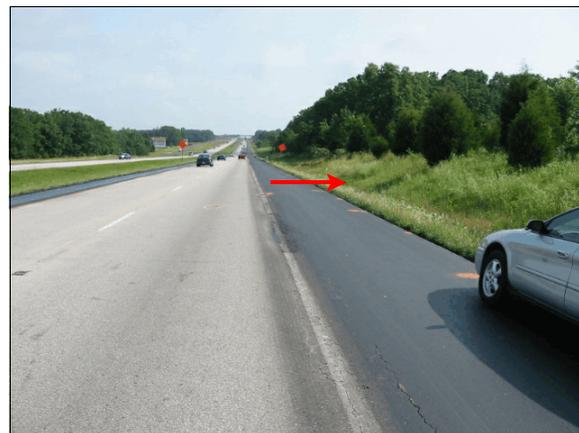
**Figure 1:** Overview of northeastbound lanes; arrow shows area of rollover; shoulders have been oiled since crash (case photo # 01)

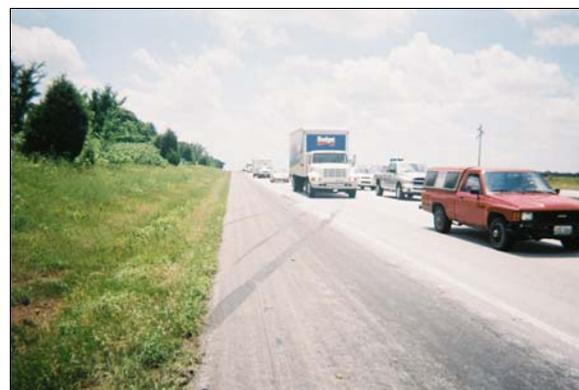
**Figure 2:** On-scene photo showing four tire marks from the case vehicle on shoulder; tire marks are (from bottom to top): left rear, right rear, left front and right front (case photo #150)

The tire mark evidence depicted on the highway patrol crash scene diagram indicates that the case vehicle's left side wheels departed the inside, northeastbound lane and entered the inside shoulder. The case vehicle then began a clockwise yaw and traveled diagonally across both northeastbound travel lanes and the outside shoulder. The tire mark evidence on the outside shoulder (**Figure 2** above) indicates the case vehicle was yawed clockwise about 62 degrees when it departed the shoulder and entered a ditch. It is unknown what avoidance actions the driver took; however, it is likely he applied the brakes at some point prior to the rollover. The crash occurred on the east side of the roadway as the case vehicle departed the shoulder.

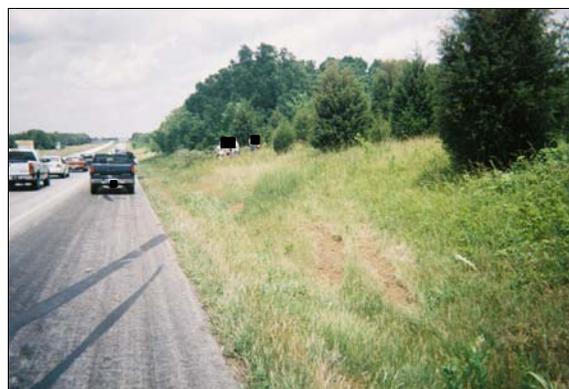
**Figure 3:** On-scene photo showing tire marks on shoulder and ground; marks are (from left to right): left rear, right rear, left rear ground divot, left front ground divot, right front ground divot (case photo #150)

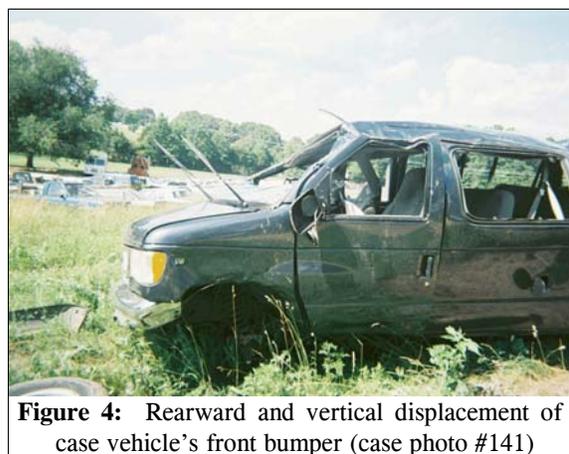
**Figure 4:** Rearward and vertical displacement of case vehicle's front bumper (case photo #141)

to the front of the case vehicle during the rollover. In addition, the left corner of the front bumper (Figure 4 above) above was shifted upward several centimeters and displaced rearward about five centimeters (two inches) indicating the bottom of the bumper and front undercarriage contacted the ground as the case vehicle's left front wheel furrowed into the back slope of the ditch. The case vehicle rolled over two and three quarters rolls (eleven quarter turns). The case vehicle impacted several pine trees near the end of the rollover and three of the ten occupants were ejected from the vehicle. The most severe tree impact occurred to the top of the case vehicle during the ninth quarter roll.

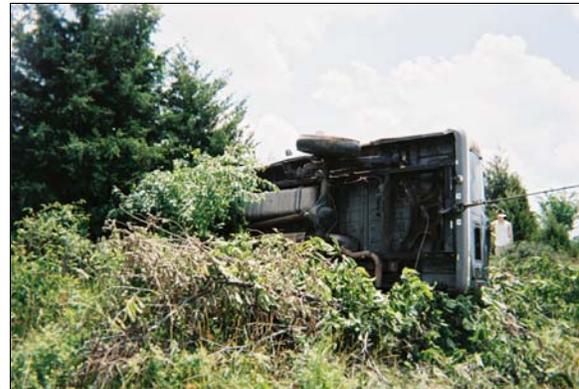
Figure 5: On-scene photo of case vehicle at area of final rest, it is in process of being pulled to tow truck (case photo #156)

**Post-Crash:** The case vehicle came to rest on its right side facing southeast (Figure 5). The highway patrol crash scene diagram indicated that two of the three ejected occupants came to rest a short distance northeast of the case vehicle with the third at rest near the back of the case vehicle.

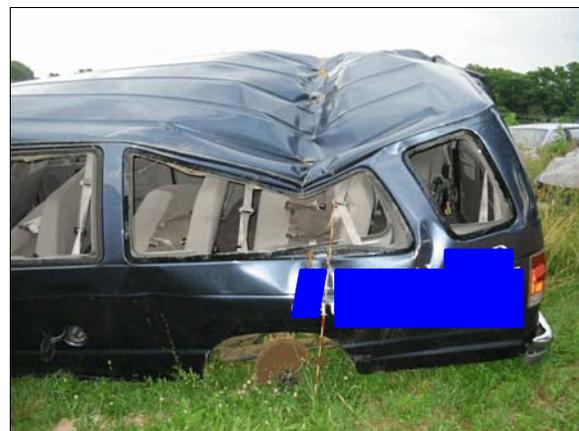
Figure 6: Crush to the roof and left roof side rail over third seat row due to impact with tree during rollover (case photo #38)

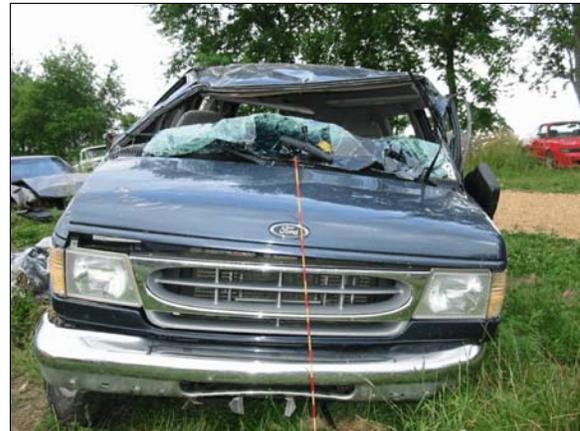
Figure 7: Crush of right A-pillar and roof; each stripe on the rod is five centimeters (two inches), (case photo #34)

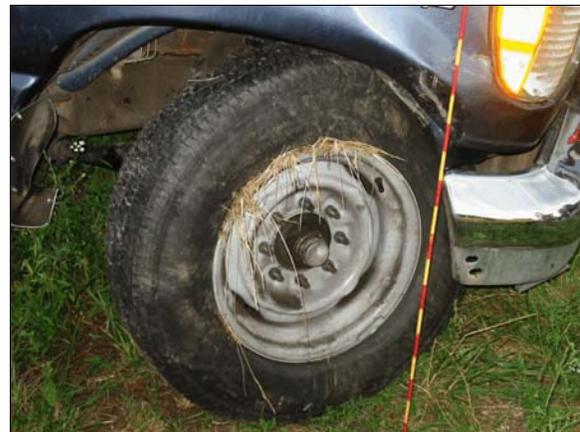
The right front and right rear tires did not blow out because the vehicle inspection showed the right front tire (Figure 8) was restricted by damage and fully inflated and the right rear tire was inflated and undamaged. The left front tire did not blow out because the on-scene photographs show a heavy tire mark on the outside shoulder (Figure 2 above) from this tire (as well as the other three tires), and it does not exhibit characteristics of a flat tire mark. In addition,

Figure 8: Right front wheel inflated and restricted by damage (case photo #50)

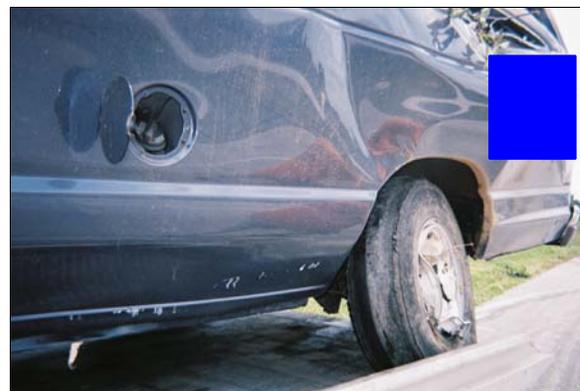
Figure 9: Case vehicle on tow truck at crash scene; left rear tire inflated, tread separated (case photo #148)

the case vehicle was in a severe driver side leading yaw, and a flat tire on the leading side would most likely peel off the rim and the rim would gouge the pavement. No rim gouges were found on the roadway or outside shoulder during this contractor’s scene inspection. The left rear tire did not blow out because an on-scene photograph of the left rear wheel (**Figure 9** above) shows the tire was still inflated.

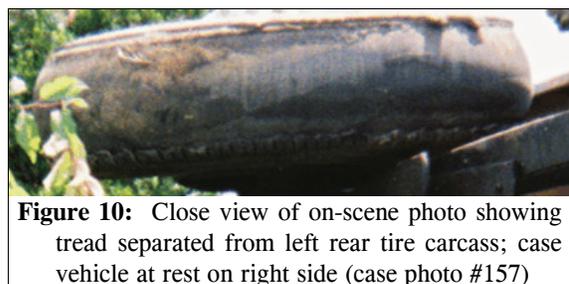
The evidence indicates that the tire tread separated from the left rear tire carcass while the case vehicle was in the inside travel lane as the vehicle was beginning its clockwise yaw. The tow truck operator stated that he found the two pieces of the tread in the left lane near the inside shoulder. His description of the location along the roadway where the two tread pieces were found placed them near the beginning of the case vehicle’s clockwise yaw. The witness’ observations of smoke coming from the left side of the case vehicle prior to the control loss suggest the tire was overheating. The condition of the left rear tire carcass following the crash is shown in **Figure 10**.

**Figure 10:** Close view of on-scene photo showing tread separated from left rear tire carcass; case vehicle at rest on right side (case photo #157)

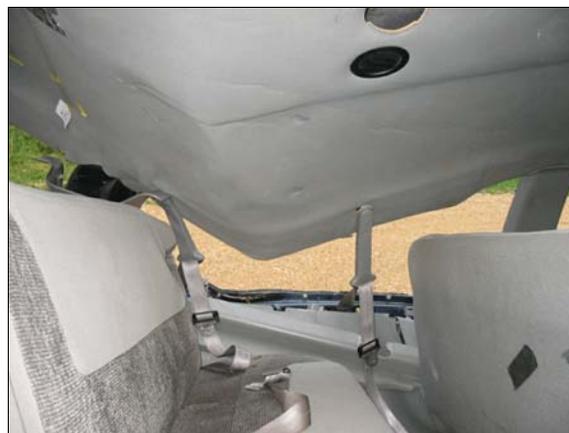
**Figure 11:** Roof and roof side rail intrusion into the third back seat row (case photo #129)

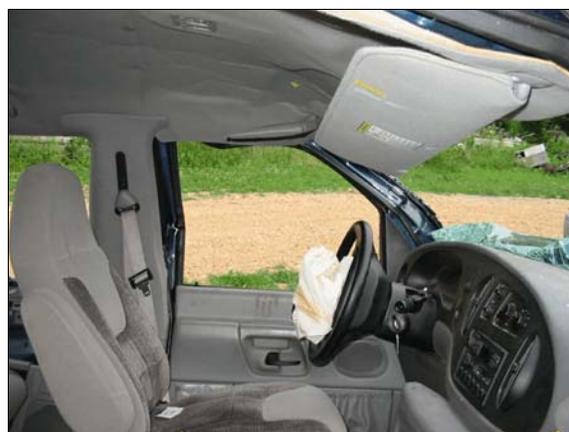
**Interior Damage:** Inspection of the case vehicle's interior revealed occupant contacts to the roof in the driver's seat position and front right seat position, as well as the left outboard and center seat positions in the first back seat row, and the roof in the left outboard third back seat row. There was also evidence of occupant contact to the left C-pillar. In addition, there were multiple occupant compartment intrusions. The most severe intrusion involved the roof and roof side rail intruding vertically about 28 centimeters (11 inches) into the left outboard seat position of the third back seat row (**Figure 11**). Other primary intrusions involved the right A-pillar intruding laterally into the front right seat position and the roof intruding vertically into the driver's seat position (**Figure 7** above). Lastly, there was no evidence of compression of the energy absorbing steering column, and no deformation of the steering wheel rim was observed (**Figure 12** below).

**Figure 12:** Overview of driver's seat, steering wheel and steering column (case photo #77)

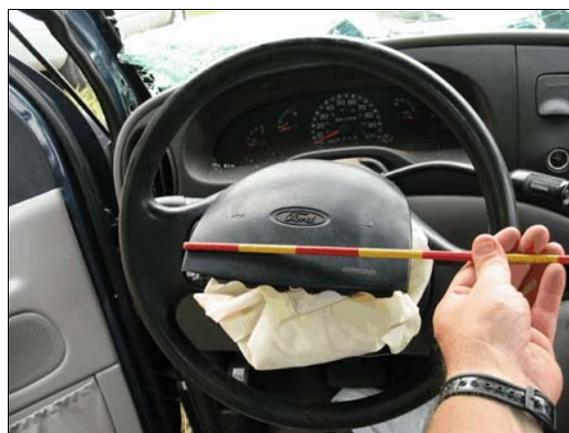
**Figure 13:** Driver's top air bag module cover flap (case photo #75)

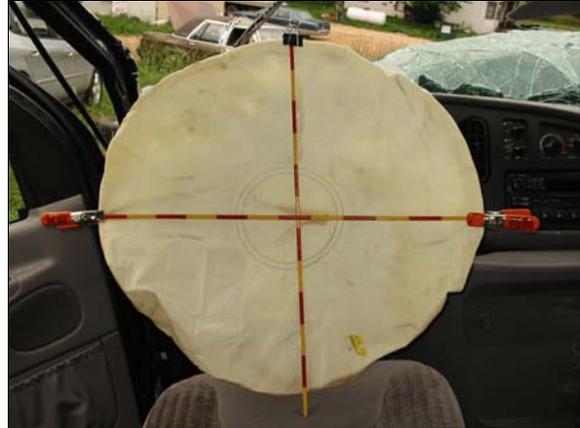
**Figure 14:** Driver's air bag; each stripe on rod is five centimeters (two inches), (case photo #71)

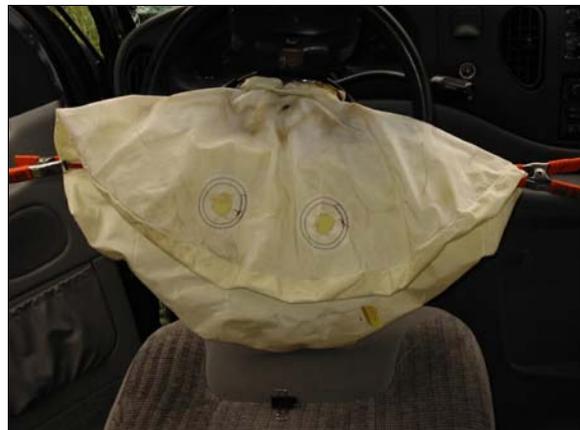
**Figure 15:** Driver air bag, vent ports (case photo #73)

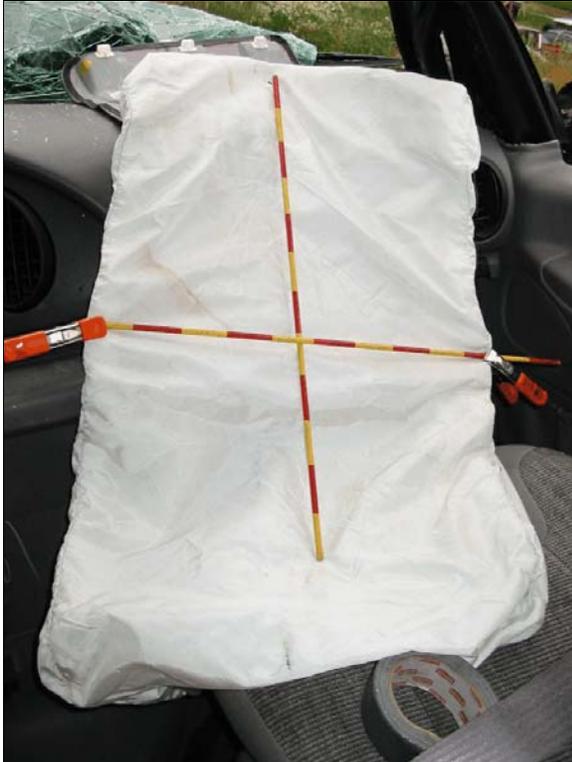
The front right passenger's air bag (**Figure 16** below) was located in the middle of the instrument panel (**Figure 17** below). There was a single, essentially rectangular, air bag module cover flap (**Figure 18** below). The cover flap was made of thin vinyl over a sheet metal frame/liner which acted as the hinge point for the deploying flaps. The flap's dimensions were 37.5 centimeters (14.8 inches) in width at the lower horizontal seam and 28.5 centimeters (11.2 inches) in height along both vertical seams. The profile of the case vehicle's instrument panel was flush with the leading edge of the cover flap. An inspection of the single air bag module cover flap and the air bag fabric revealed that the cover flap opened at the designated tear points. There was no evidence of damage during the deployment to the air bag; however, the air bag module cover flap was bent. The bend to the cover flap did not appear to be due to occupant contact. The deployed front right air bag was rectangular with a height of 75 centimeters (29.5 inches) and a width of 49 centimeters (19.3 inches) and was designed without any tethers. It had two vent ports located at the 9:00 and 3:00 o'clock positions. The vent ports were six centimeters (2.4 inches) in diameter. Although some occupant contact with the air bag was likely, an inspection of the air bag fabric revealed no evidence of occupant contact.

**Figure 16:** Overview of front right passenger's air bag; each stripe on the rod is five centimeters (two inches), (case photo #92)

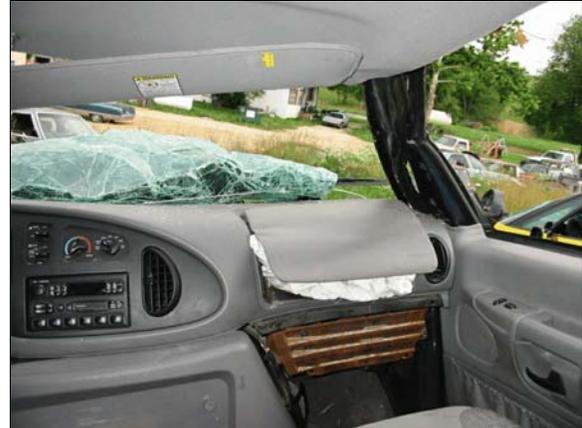
**Figure 17:** Overview of front right instrument panel and air bag location (case photo #81)

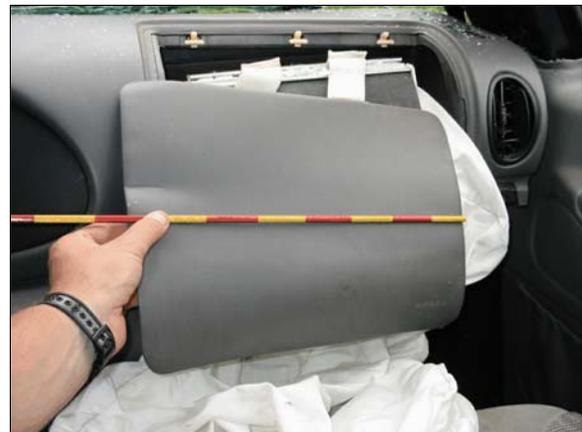
**Figure 18:** Front right passenger's air bag module cover (case photo #95)

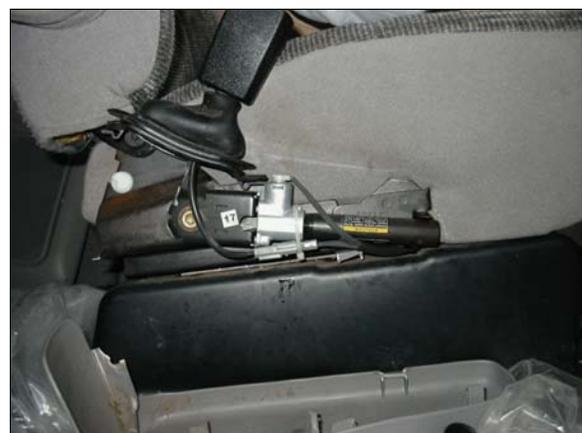
The evidence indicates the driver was not using his available, active, three-point, lap-and-shoulder, safety belt system. The safety belt system was equipped with a belt pretensioner, which did not activate (**Figure 19**), and inspection of the safety belt assembly revealed no load markings on the safety belt webbing, latch plate or "D"-ring.

**Figure 19:** Driver's safety belt pretensioner did not activate; the buckle stalk is not shortened and the stalk cover is not compressed (case photo #67)

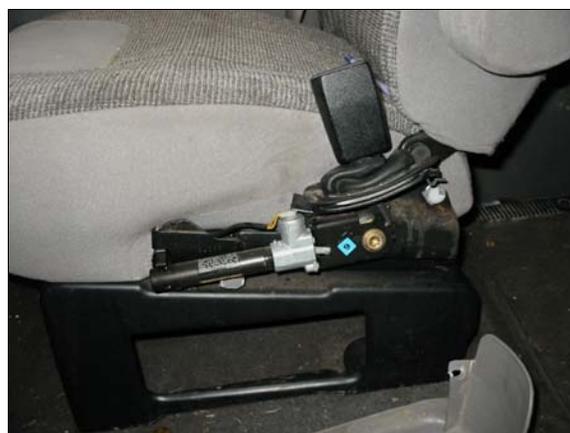
**Figure 20:** Front right passenger’s safety belt pretensioner activated; the buckle stalk is shortened and the stalk cover compressed (case photo #90)

The evidence indicated that the front right passenger was restrained by her available, active, three-point, lap-and-shoulder, safety belt system. The safety belt system was equipped with a belt pretensioner. The safety belt buckle stalk was shortened and the stalk cover compressed indicating the pretensioner activated during the crash (**Figure 20**).
