**CALSPAN ON-SITE CERTIFIED ADVANCED 208-COMPLIANT
VEHICLE CRASH INVESTIGATION**

CASE NO: CA04-020

VEHICLE: 2004 DODGE DURANGO

CRASH DATE: MARCH 2004

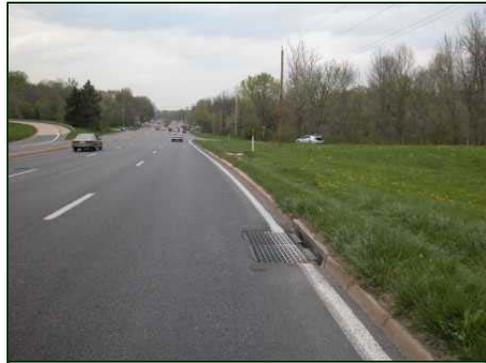
Figure 2. Overall view of the crash site.

The crash occurred off-road of a five-lane divided arterial roadway during dark, but lighted conditions. The roadway consisted of three northbound lanes and two southbound lanes that were divided by a curbed median. All travel lanes were delineated

by broken white lane lines with solid edge lines. Both road edges were bordered by 15 cm (6") barrier curbs. The roadway curved to the left for northbound travel with a slight downgrade of less than two percent. A grassy area was located adjacent to the east road edge. A single wooden utility pole was located within the grassy area and was positioned 8.2 m (27') east of the curb line. This pole was struck and fractured by the crash. At the time of the SCI inspection, the utility pole was replaced. Located south of the crash site were an overpass for an Interstate roadway and an off-ramp for Interstate travel. The driver of the Durango exited the Interstate onto the ramp that transitioned into the northbound travel lanes. The posted speed limit was 48 km/h (30 mph). **Figure 2** is an overall view of the crash site. The Crash Schematic is included as **Figure 15** of this narrative report.

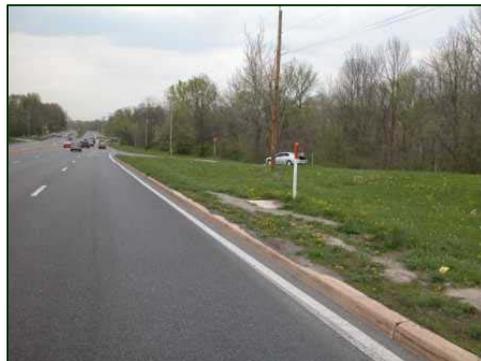
Figure 3. Point of road departure and location of struck pole.

The driver of the 2004 Dodge Durango was traveling in a westerly direction on an interstate roadway and exited onto a divided five-lane road to travel in a northerly direction. He directed the vehicle onto the outboard travel lane and traveled under an overpass while negotiating a left curve. As he continued northbound, the driver experienced a medical episode (seizure) due to a previous health issue and became unconscious at the wheel. The driver slumped to his right which resulted in an inadvertent right steering input to the vehicle. The Durango departed the right road edge in a presumed tracking attitude (**Figure 3**).

The outer bead area of the left front wheel engaged the barrier curb as the vehicle departed the travel lane. The curb impact abraded the wheel and dented the steel wheel to a depth of 1 cm (0.5"). This impact resulted in an air out of the left front tire. Gouge marks were present of the top surface of the curb at the location of road departure.

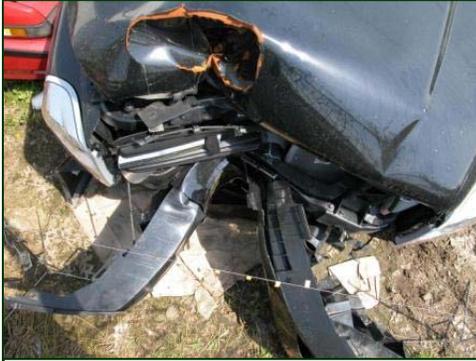
Figure 4. Frontal damage to the Dodge Durango.

The center front area of the Dodge Durango impacted a wooded utility pole that was located 8.2 m (27') outboard of the curb line. The 12 o'clock direction of force impact fractured the pole. (The pole was replaced prior to notification of this SCI investigation).

The center frontal area of the Dodge Durango impacted the utility pole deforming the front bumper system to a U-shape. The bumper system consisted of the fascia that was formed to fit over the bumper beam. The bumper beam was supported by mounts at the front frame rails and extended 12 cm (4.75") outboard of the frame rails. The corners of the fascia extended beyond the beam; however, there was no structure at the corners of the fascia. The direct contact damage on the bumper fascia began 8 cm (3") left of center and extended 20 cm (8") to the right. The impact fractured and separated the fascia on both sides of the license plate assembly. The narrow impact was located between the frame rails and crushed the bumper beam to a maximum depth of 49 cm (19.4"), located 10 cm (4") right of the vehicle's centerline (**Figure 4**). The lateral width of the deformed bumper beam was 53 cm (21"). This value represented the Field L, a combination of direct and induced damage. The frontal crush profile was documented at six equidistant points along the bumper beam (**Figure 5**). These values were as follows: C1 = 0 cm, C2 = 9 cm (3.5"), C3 = 34 cm (13.25"), C4 = 49 cm (19.4"), C5 = 31 cm (12.4"), C6 = 2 cm (0.75"). The Collision Deformation Classification (CDC) for this impact was 12-FCEN-3.

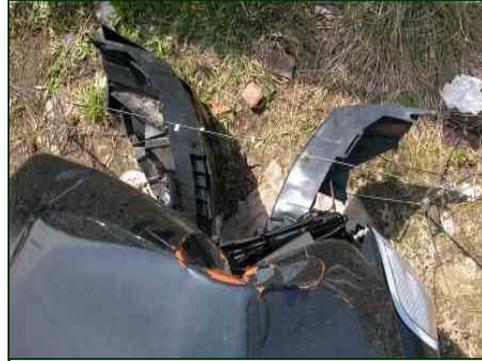
Figure 5. Overhead view documenting the extent of frontal crush.

The impact crushed the front bumper system to a measured depth of 49 cm (19.4"). The barrier routine algorithm of the WINSMASH program was utilized to compute a total velocity change of 30 km/h (18.6 mph) for the Durango. The vehicle's single point sensing system detected a sufficient longitudinal deceleration to deploy the CAC frontal air bag system and the front retractor pretensioners. Due to the lack of a downloadable Event Data Recorder (EDR), the deployment stage of the frontal air bags was unknown. There was no evidence at the crash site to support final rest location of the vehicle.

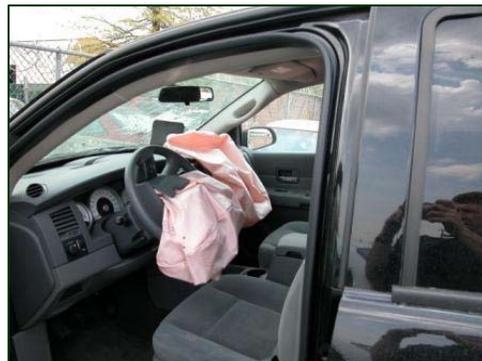
Figure 6. Deployed CAC Frontal air bags.

The 2004 Dodge Durango was equipped with Certified Advanced 208-Complaint frontal air bag system for the driver and front right passenger positions. This system consisted of dual stage frontal air bags, seat track positioning sensors, a front right occupant presence sensor, and retractor pretensioners. The system deployed (**Figure 6**) as a result of the frontal impact with utility pole. The manufacturer of this vehicle has certified that

this 2004 Dodge Durango meets the advanced air bag requirements for FMVSS 208. This system utilized a single point crash sensing and diagnostic module that was mounted on the center tunnel within the passenger compartment. This air bag control module was not supported by the Vetronix Crash Data Retrieval tool; therefore it was not downloaded for this investigation.

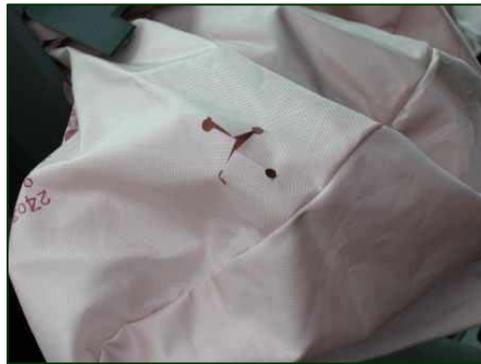
Figure 7. X-cut vent port.

The driver air bag membrane measured 63 cm (25") in diameter in its deflated state. The air bag was tethered by two internal straps that were 6 cm (2.25") in width located at the 12 and 6 o'clock positions. The maximum excursion of the bag at the tether locations measured 23 cm (9"). The air bag was vented by two X-cut ports that formed four triangles (**Figure 7**). The air bag was stamped with the following nomenclature at the 12 o'clock position of the forward panel:

There was no contact evidence or damage to the driver's air bag.

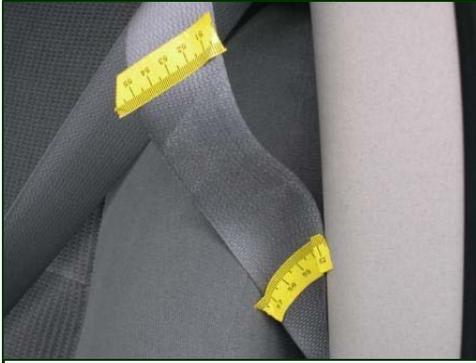
Figure 8. D-ring transfer.

The driver’s D-ring was adjusted to the full-up position. He loaded the belt system which resulted in frictional abrasions on the outboard aspect of the latch plate from the shoulder belt webbing. A D-ring transfer was present full width across the webbing and measured 9 cm (3.5”) in length (**Figure 8**). The transfer began 2 cm (0.75”) below the D-ring and extended toward the retractor due to the firing of the pretensioner which locked the belt in its worn position (**Figure 9**).

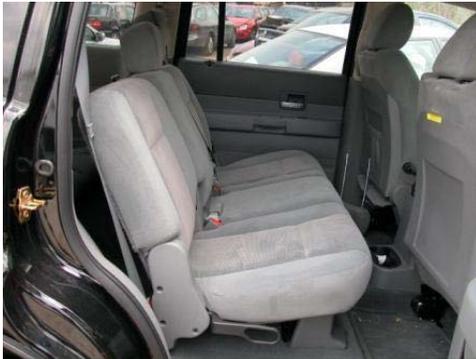
Figure 10. Second row seat and safety belt systems.

The second row left safety belt was utilized to restrain a forward facing CSS that was occupied by a 9-month old male. This belt system contained subtle wear marks on the latch plate; however, there was no loading evidence on the webbing or hardware. The second row, center rear position was occupied by a 7-year old female. She was restrained by the manual safety belt system and was not injured. There was no crash related loading evidence on this belt system. The right rear position of this seat was occupied by a 12-year old female. She was restrained by the 3-point safety belt system. Loading evidence was limited to a frictional abrasion on the plastic locking mechanism of the light-weight locking latch plate. **Figure 10** is an overall view of the second row seat and the safety belt systems.

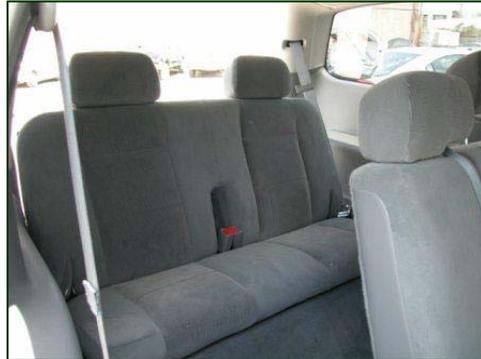
Figure 11. Third row seat and safety belt systems.

The third row, left side belt system was utilized to restrain a forward facing CSS that was occupied by a 3-year old female. An 11-year old female occupied the right position of the third row. There was no loading evidence to these safety belt systems. **Figure 11** is an overall view of the third row seat and the safety belt systems.

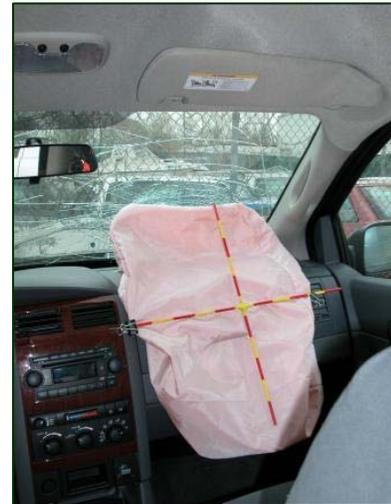
Figure 12. Front right passenger’s trajectory and deployed air bag.

Immediately prior to impact, the front right passenger extended her right arm in an attempt to brace against the upper right instrument panel. At impact, the CAC frontal air bag system deployed. The expanding front right air bag contacted the front right passenger’s right forearm which abraded and contused the arm. The gases that exhausted from the lateral vent port of the front right air bag discharged onto her right wrist and sleeve area. She reported that the sleeve of her coat was singed. The hospital medical records listed the passenger as sustaining a 2nd degree burn of the right anterior forearm.

She initiated a forward trajectory and loaded the deployed front right air bag which prevented her from contact with frontal components (**Figure 12**) and protected the passenger from potential injury. She rebounded into the front right seat back where she came to rest.
