ON-SITE AIR BAG RELATED CHILD FATALITY INVESTIGATION
CALSPAN CASE NO: CA04-027

VEHICLE – 1997 CADILLAC CATERA
LOCATION – FLORIDA
CRASH DATE – JUNE 2004

**ON-SITE AIR BAG RELATED CHILD PASSENGER FATALITY INVESTIGATION
CALSPAN CASE NO: CA04-027**

**VEHICLE: 1997 CADILLAC CATERA
LOCATION: FLORIDA
CRASH DATE: JUNE, 2004**

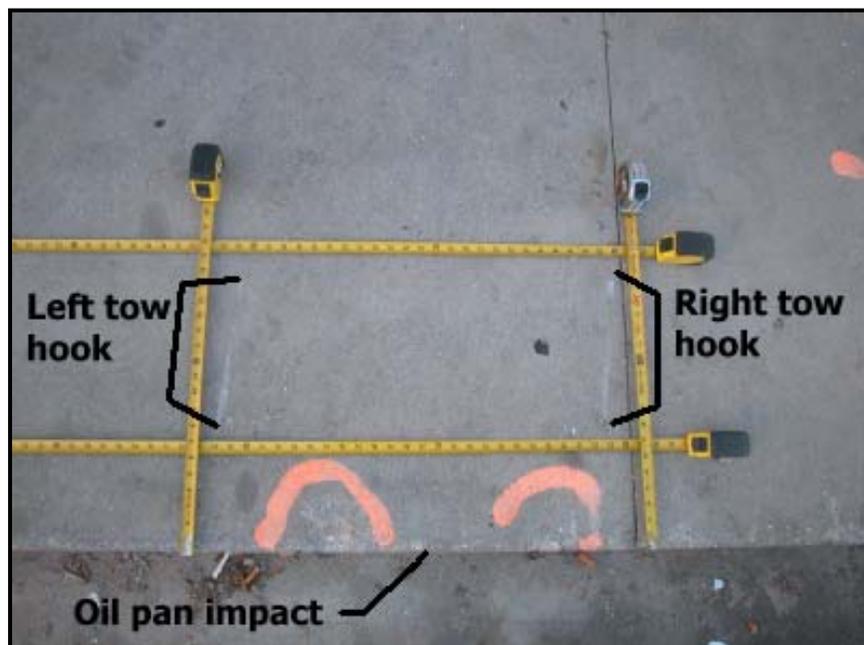
Figure 4: Contact evidence identified at the point of impact.

The front of the Cadillac pitched downward and the two tow hooks located 41 cm (16.0 in) aft of the front of the vehicle overrode the curb and contacted the sidewalk. This contact was evidenced by two scratch marks identified during the scene inspection. Refer to **Figure 4**. The left scratch mark began 20 cm (7.75 in) from the edge of the curb and measured 24 cm (9.4 in) in length. The right mark began 21 cm (8.25 in) from the curb edge and measured 23 cm (9.2 in) in length. The width between the marks measured 62 cm (24.5 in).

The Cadillac's oil pan impacted the curb edge across its entire 43 cm (16.75 in) width. The edge of the concrete was chipped and fractured as a result of the impact and was identified by the evidence paint of the police investigation (**Figure 4**). This impact arrested the forward momentum of the vehicle and it came to rest. The vehicle's engine probably stalled at this time. The crash pulse (deceleration) generated during this impact was sufficient to cause the deployment of the vehicle's frontal air bags. The delta V of the impact was less than 16 km/h (10 mph).

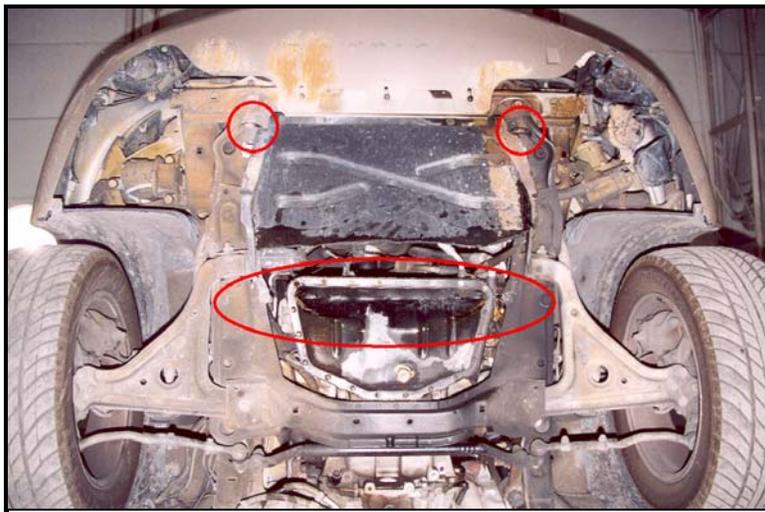
Figure 6: View of the Cadillac's forward undercarriage and the identified contacts.

Figure 6 is a view of the Cadillac’s forward undercarriage. The vehicle was raised by a hydraulic hoist to facilitate its inspection. Three areas of contact to the sidewalk and curb were identified and are depicted in the figure. The bottom of the tow hooks were abraded by direct contact with the surface of the sidewalk; and the oil pan was deformed across its entire 43 cm (16.75 in) width from a direct impact with the edge of the 15 cm (5.75 in) tall curb. It should be noted that the underside of the bumper fascia was abraded in several areas forward of the tow hooks. It was probable that these abraded regions occurred at the time of the crash. No structural damage or deformation to the undercarriage, other than the tow hook/oil pan damage was identified. The Collision Deformation Classification of the damage was 12-UFDW-1.

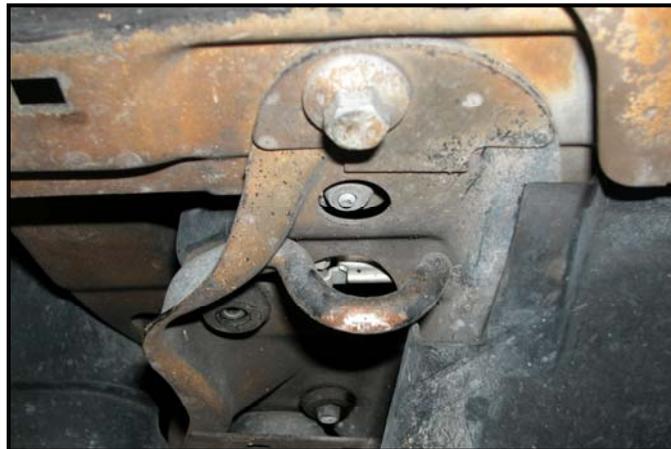
Figure 7: Close-up of the right tow hook.

Figures 7 and 8 are close-up views of the right and left tow hooks, respectively. The tow hooks were manufactured from 11 mm (7/16 in) diameter steel round stock formed into a “U” shape. The uprights of the “U” were centered 5 cm (2.0 in) apart. The height of the hook measured 4 cm (1.375 in). The hooks were located symmetrically, 41 cm (16.0 in) rearward of the furthest protrusion of the front bumper (measured on the vehicle’s centerline). The lateral separation of the hooks measured 62 cm (24.375 in) (consistent with the physical evidence identified at the crash scene). The elevation of the bottom of the right hook measured 18 cm (7.0 in) above the ground. The elevation of the left hook measured 18 cm (7.25 in). All of the elevation (vertical) measurements were taken prior to lifting the vehicle. Inspection of the tow hooks determined that the bottom surface of each hook was abraded. The width of the each abrasion measured approximately 2 cm (0.6 in). The abrasion on the right tow hook appeared to have concrete dust embedded in the region. The abrasion on the left hook did not appear to be quite as distinct as compared to the right hook.

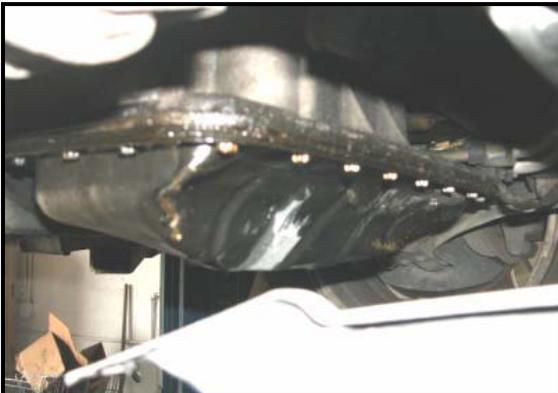
Figure 9: Right view of the deformed oil pan.

Figures 9 and 10 are close-up views of the damaged oil pan viewed from the right and left, respectively. The front face of the oil pan was deformed across its entire width. The width of the deformation measured 43 cm (16.75 in). The height of the deformed face measured 8 cm (3.0 in). The estimated longitudinal crush of the oil pan was 4 cm (1.5 in). The elevation of the deformed oil pan above the floor measured 16 cm (6.25 in). This measurement was taken on the centerline of the Cadillac at deformed front face of the oil pan.

For reference, the bolt pattern located at the leading edge of the oil pan was located 75 cm (29.625 in) rearward of the front of the vehicle. At this plane, the bolt pattern falls rearward of the forward edge of the front tires. In other words, the oil pan would normally be protected from a curb strike by the tires. The plumb bob in **Figure 11** represents the location of this plane. In this crash however, due to the dynamics of the impact, the front tires and suspension compressed and exposed the face of the oil pan to the curb.

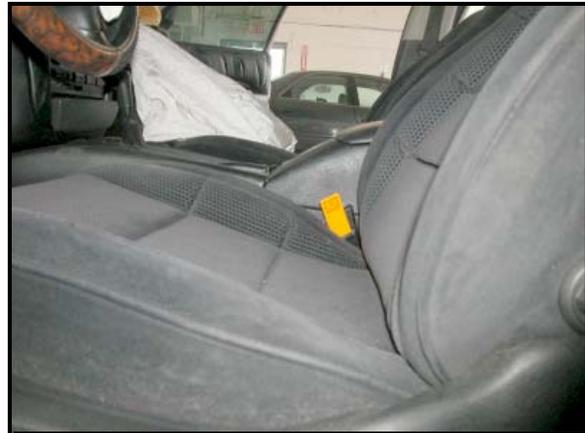
Figure 12: View of the driver's safety belt buckle.

The driver's restraint was stowed within the retractor at the time of the inspection and the retractor was operational. The D-ring was adjusted to the lowest position. Examination of the latch plate revealed historical use indicators consistent with the vehicle's age. There was no crash related evidence identified on any of the friction surfaces of the restraint system. The D-ring and hardware surfaces of the latch plate were free of abrasion. Extension and examination of the webbing was unremarkable. However, given the relative low severity of the impact, crash related loading evidence on the restraint webbing was not expected. The driver's buckle pretensioner had fired evidenced by the (now) visible warning label, **Figure 12**. Inspection of the fired pretensioner indicated that it had fully stroked. The fully stroked pretensioner was an indication that the driver was unrestrained at the time of the crash. Based on the evidence gathered at the time of the inspection, it has been determined the driver was unrestrained at the time of the impact.

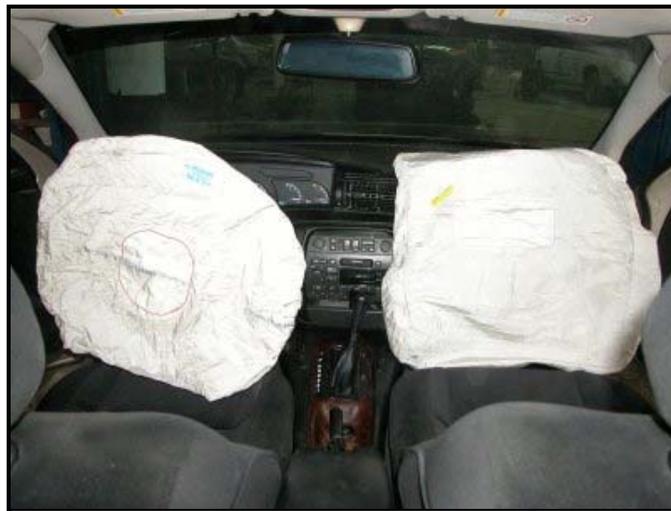
Figure 13: View of the deployed frontal air bags.

The Supplemental Inflatable Restraint (SRS) in the Cadillac Catera consisted of driver and front right passenger air bags that deployed as a result of the undercarriage impact, **Figure 13**. The vehicle was also equipped with seat back mounted side impact air bags. The SIR was monitored and controlled by a Sensing and Diagnostic control Module (SDM) that was mounted within the center console on the vehicle's centerline. The sensor measuring the severity of the crash was located within the SDM. There were no other external satellite sensors incorporated into the design of the SIR. This SDM was not compatible with the Vetronix Crash Data Retrieval Tool; therefore any crash related data that may have been recorded by the module could not be directly accessed.

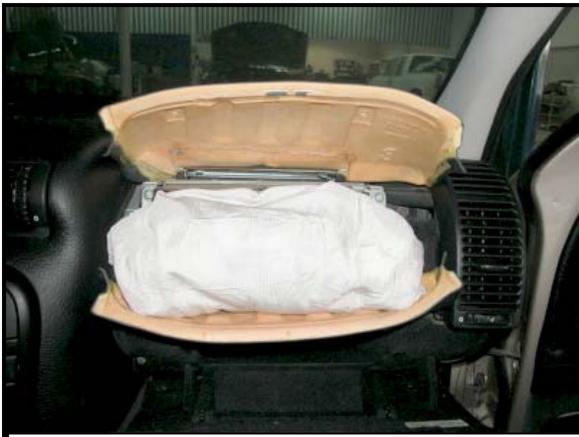
Figure 14: View of the deployed front right air bag cover flap.

The front right passenger air bag module was a mid-mount design located in the right aspect of the instrument panel. The module was a “clam-shell” H-configuration design, **Figure 14**. During the deployment sequence, the cover flaps opened at the designed tear seams. There was no evidence of occupant contact to the surfaces of the flaps. The width of the center seam measured 35 cm (14.0 in). The height of the upper and lower flaps measured 15 cm (5.9 in) and 8 cm (3.0 in), respectively.

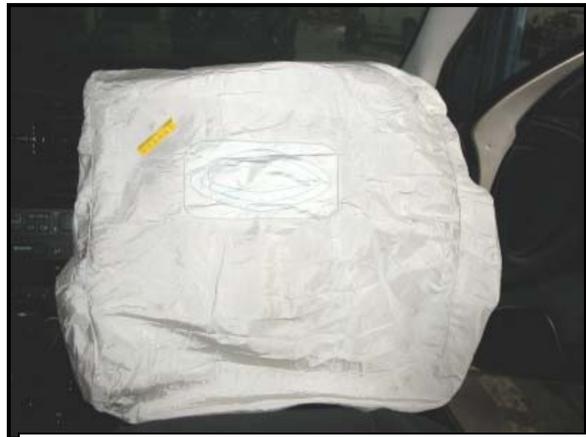
Figure 15: View of the deployed PAB.

The face of the deployed front right passenger air bag, **Figure 15**, measured 57 cm x 64 cm (22.5 in x 25.0 in), width by height. The rearward excursion of the bag’s face measured 51 cm (20.0 in) from the module. The face of the air bag was tethered by two 20 cm (8.0 in) wide straps. The perimeter dimensions of the tether stitching located on the face of the bag measured 22 cm x 11 cm (8.5 in x 4.4 in). The air bag was vented by two 3 cm (1.25 in) diameter ports located on the side panels. The face of the air bag exhibited minor evidence of contact in the upper left quadrant. The contact measured 14 mm (0.6 in) in diameter and was located 9 cm (3.4 in) right of the inboard side panel and 13 cm (5.1 in) below the top of the membrane. The contact was gray/black in color and was probably related to direct contact with the 2 year old child. There were no other contacts identified on the air bag.

Inspection of the front right interior space surrounding the deployed air bag did not reveal any evidence of an altered deployment. There was no evidence of air bag scuffing to the windshield, instrument panel or interior trim panels typical of the altered deployment. The altered air bag deployment typically occurs when the unrestrained occupant (moving forward in response to a pre-crash braking maneuver) impedes and deflects the deploying air bag forward into the interior structures of the vehicle. The expansion of the deflected air bag causes frictional contact between the bag’s fabric and the interior and results in frictional transfers. In this crash, the absence of contact between the air bag and the interior, in conjunction with the minimal contact evidence on the air bag membrane, indicated the air bag deployed normally rearward and struck the child occupant prior to significant occupant motion.

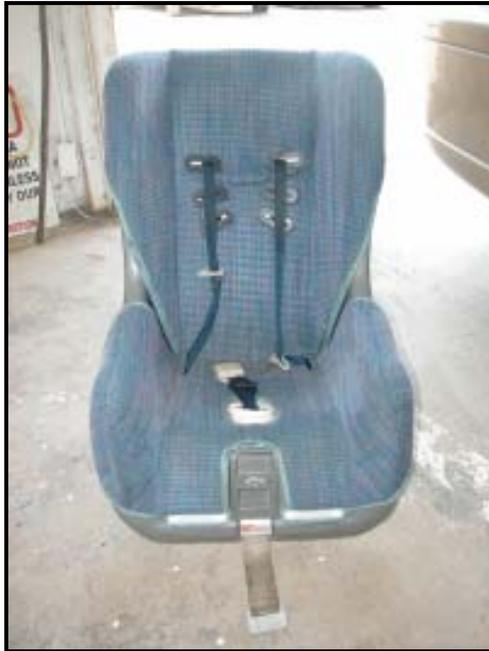
Figure 16: Century convertible CSS.

Figure 16 is a front view of the Century convertible child safety seat positioned in the right rear of the Cadillac. The seat was not restrained by the vehicle’s safety belt system at the time of the inspection. Inspection of the seat revealed that all of the manufacturer’s labeling had been removed. The child restraint was consistent with Century’s 1500 STE series. The seat was equipped with a 5 point harness that was adjusted to the top slots. The shoulder straps were roped and appeared worn. The chest clip was missing. The absence of the chest clip would allow for greater lateral movement of the shoulder straps.
