**OFFICE OF DEFECTS INVESTIGATION  
2003 FORD CROWN VICTORIA POLICE INTERCEPTOR  
REAR IMPACT CRASH AND FIRE INVESTIGATION**

**CALSPAN CASE NO: CA04-035**

**LOCATION: TEXAS  
CRASH DATE: AUGUST, 2004**

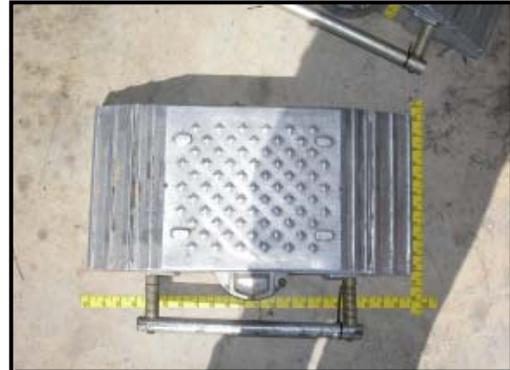
**Figure 3: GEC Inc. MD400 truck scale.**

During the crash sequence, the scales were driven forward through the forward trunk wall by the force of the impact resulting in an 8 cm x 13 cm (3 in x 5 in) angular tear of the back side of the fuel tank. The width of the tear was irregular and measured 1.0 cm (0.4 in) along its center aspect. The tear was the source of the fuel leak that fueled the ensuing fire.

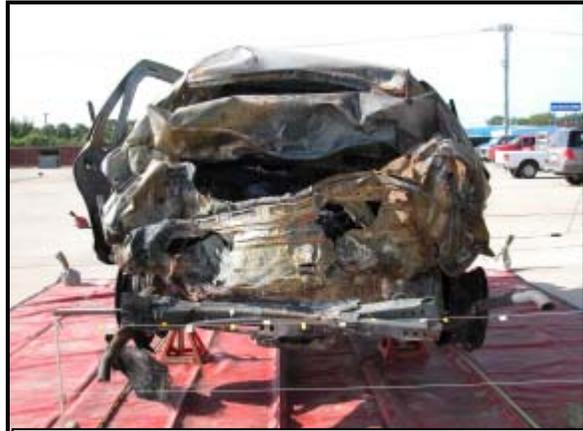
**Figure 6** is the rear view of the damaged CVPI. **Figures 7 and 8** are the left and right views of the rear damage and **Figure 9** is an overhead view of the damaged rear plane. The back plane of the Ford CVPI sustained severe direct and induced damage as a result of the impact. The direct contact began at the left rear bumper corner and extended 152 cm (62 in) to the right rear bumper corner. The dynamics and force of the impact compressed the volume of the trunk space around the commercial vehicle scales and displaced the scales forward through the trunk wall. The scales are visible in Figure 9 below.

The rear residual deformation profile of the CVPI was documented along the rear bumper reinforcement bar and along the aft edge of the trunk. The average rear crush profile resultant to those measurements was as follows: C1 = 63.0 cm (24.8 in), C2 = 72.0 cm (28.3 in), C3 = 63.0 cm (24.8 in), C4 = 58.0 cm (22.8 in), C5 = 47.0 cm (18.5 in), C6 = 54.0 cm (21.3 in). The maximum crush measured 79.0 cm (31.1 in) and was located along the aft edge of the trunk at C2. The residual crush measured at the end of the left and right frame rails was 58.1 cm (22.9 in) and 34.0 cm (13.4 in), respectively. The trunk latch released during the impact and the lid was displaced forward through the backlight and into contact with the roof. The rear aspect of the roof buckled. The longitudinal deformation of the upper left and upper right corners of the roof measured 13.3 cm (5.3 in) and 3.5 cm (1.4 in), respectively. The deformation and compression of the body caused by the rear impact jammed the doors of the vehicle shut. The fuel neck disengaged from the crushed left rear quarterpanel during the crash sequence. The filler neck remained in tact and relatively undeformed. There was no fuel leakage along the neck. The left wheelbase was reduced 30.4 cm (12.0 in). The left axle tube separated from the differential housing and the left axle shaft fractured inside the differential. The right wheelbase reduced 13.3 cm (5.3 in).

**Figure 6: View of the damaged back plane.**

The Collision Deformation Classification (CDC) of the Ford was 06-BDAW-6. The total Delta V of the CVPI calculated by the Damage Algorithm of the WINSMASH model was 36.2 km/h (22.5 mph). The longitudinal and lateral components were +36.2 km/h (+22.5 mph) and 0 km/h, respectively. This calculation utilized the model's default stiffness coefficients; therefore the calculation underestimated the severity of the crash. The presence of the scales in the trunk increased the rear stiffness of the Ford, altered the vehicle deformation and affected the crash dynamics due to the pocketing of the front plane Nissan around the scales.

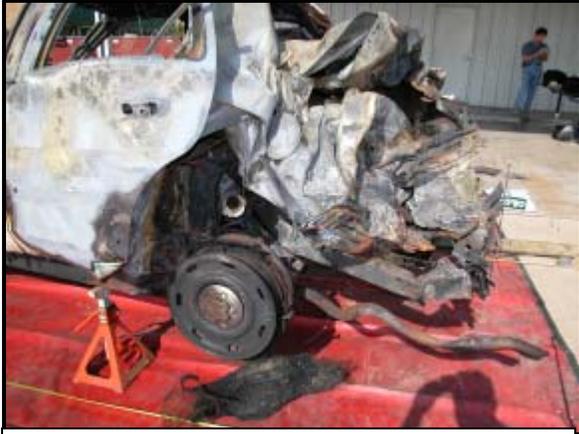
**Figure 7: Left view of the rear CVPI damage.**

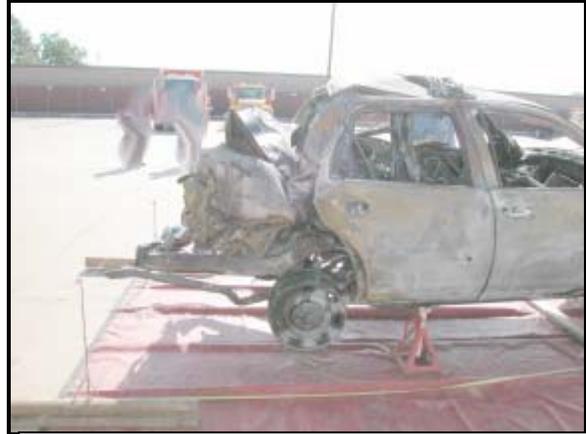
**Figure 8: Right view of the CVPI rear damage.**

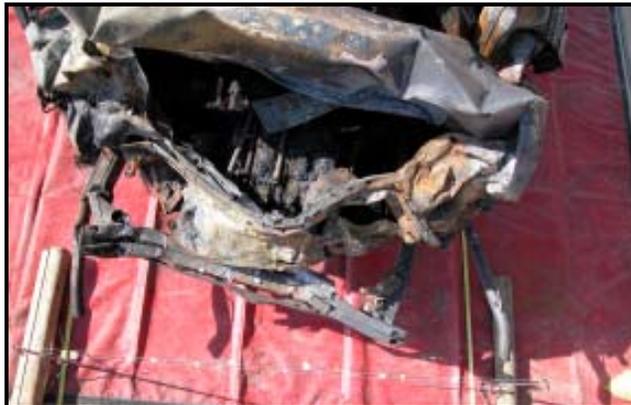
**Figure 9: Over head view at the damaged back plane.**

Note: the rear baseline in Figures 6-9 was set 31.5 cm (12.4 in) shorter than the original length of the vehicle. The crush measurements were adjusted for this offset.

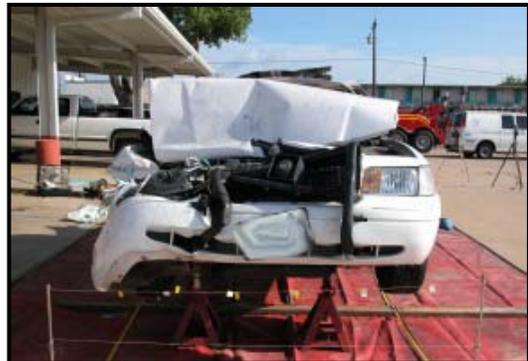
The force of the rear impact displaced the CVPI forward into contact with the Acura. The center and right aspects of the CVPI's frontal plane, **Figure 10**, impacted and underrode the back plane of the Acura. The frontal plane's direct contact damage began 15.5 cm (6.1 in) right of center and extended 61 cm (24 in) to the right front corner. This direct contact pattern wrapped around the right front corner as a result of the Ford's counterclockwise rotation and extended 18 cm (7 in) along the right side. The combined width of the direct and induced damage extended across the vehicle's entire 152 cm (60 in) frontal end width. The

**Figure 10: Front view of the CVPI.**

residual crush was documented along both the bumper reinforcement bar and upper radiator support elevations due to the underride impact configuration. The resulting average frontal crush profile was as follows: C1 = 1.0 cm (0.4 in), C2 = 0, C3 = 9.0 cm (3.5 in), C4 = 13.0 cm (5.1 in), C5 = 18.0 cm (7.1 in), C6 = 32.0 cm (12.6 in). The maximum crush measured 54.0 cm (21.3 in) and was located at on the upper radiator support at C6. The hood buckled and v'ed at the fold point. The right front fender shifted rearward and deformed. There was no structural damage to either front suspension and there was no front axle displacement. The CDC of the frontal damage was 12-FZEW-2.

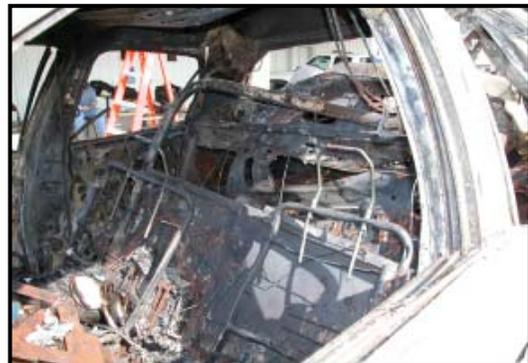
**Figure 11** is an interior view of the Ford through the left front window. The interior of the vehicle was completely burned. The front seats were in an estimated rear track position. The angle of the driver seat back frame measured 40 degrees. The front and rear interior compartments were separated by a safety cage. The residual longitudinal intrusion of the rear seat was measured along the forward edge of the package shelf and is listed in the table below:

The crush and deformation of the body panels at the left lower C-pillar location created a 51 cm x 15 cm (20 in x 6 in), height by width, opening into the interior compartment from the undercarriage. The separation of the right lower C-pillar measured 33 cm x 8 cm (13 in x 3 in). The sheet metal surrounding the spot welds in the areas of these separations failed by overload. The left rear door buckled and deformed outboard creating a 28 cm x 10 cm (11 in x 4 in), length by width, opening at the sill. These separations/openings created direct paths for the fire to enter the occupant compartment.

**Figure 11: Left interior view of the Ford.**

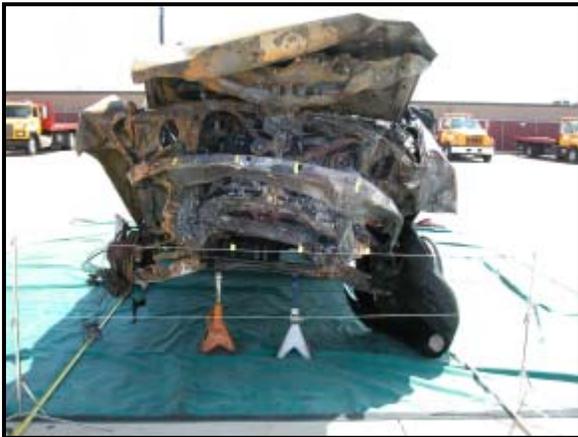
**Figures 12 and 13** are the front and overhead views of the Nissan. The vehicle's front plane sustained 147 cm (58 in) of direct contact damage that spanned the entire end width of the vehicle. The nature of the direct damage was indicative of an in-line front-to-rear impact configuration. The forward frame's lower cross member was deformed into a U-shape that conformed to the shape of the scales located in the CVPI trunk. The width of the U measured 51 cm (20 in) and had a maximum depth on centerline of 31.8 cm (12.5 in). Refer to **Figure 14**. The residual crush of the Nissan was documented along the bumper reinforcement bar and was as follows: C1 = 31.0 cm (12.2 in), C2 = 19.0 cm (7.5 in), C3 = 27.0 cm (10.6 in), C4 = 33.0 cm (13.0 in), C5 = 35.0 cm (13.8 in), C6 = 43.0 cm (16.9 in). The left wheelbase was reduced 4.8 cm (1.9 in) and the right wheelbase was reduced 7.1 cm (2.8 in). All the doors remained closed during the impact. At the time of the inspection, the doors were inoperative as a result of the fire. The plastic (combustible) fasteners attaching the mechanical linkage inside the door panel had burned allowing the linkage to fall to the bottom, of the door. The front doors probably were operational prior to the fire. At the scene, reportedly, both occupants exited the vehicle through the front left door.

The CDC of the vehicle was 12-FDEW-3. The total delta of the Nissan calculated by the Damage Algorithm of the WINSMASH model was 39.1 km/h 24.3 mph. The longitudinal and lateral components were -39.1 km/h (-24.3 mph) and 0, respectively. This calculation underestimated the crash severity due to the altered stiffness and damage profile related to the CVPI previously discussed. The frontal air bags of the Nissan probably deployed as a result of the impact based on SCI experience. Air bag deployment could not be determined due to the consequences of the fire.

**Figure 12: Nissan front view.**

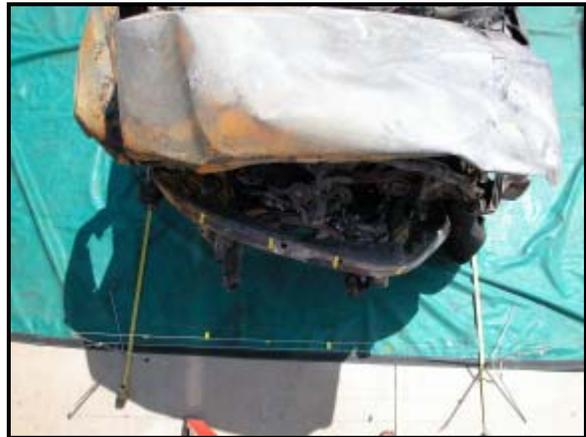
**Figure 13: Overhead view of the frontal damage.**

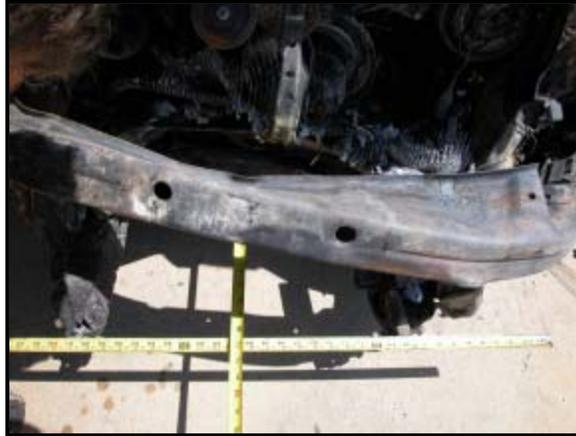
**Figure 14: Deformed lower frame caused by the scales in the CVPI trunk.**

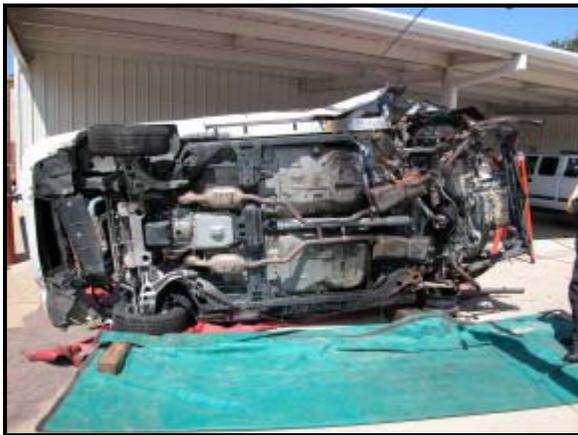
After the exterior inspection of the CVPI by all the involved parties, a procedure to inspect the undercarriage of the vehicle and to remove the fuel tank was discussed and developed. To facilitate this process, the CVPI was rolled onto its right side. In this manner the vehicle could be safely inspected and sequentially disassembled to access the fuel tank. **Figure 15** is an overall view of the Ford's undercarriage. **Figure 16** is a view of the aft section of the CVPI depicting the damaged fuel tank and rear axle.

**Figure 15: Overall undercarriage view.**

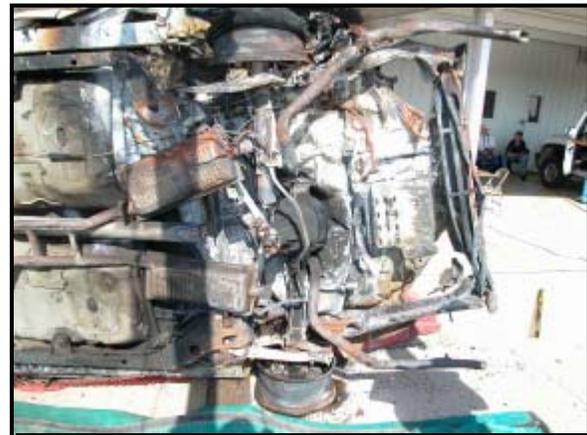
**Figure 16: Aft undercarriage view.**

During the impact sequence, the aft section of the CVPI crushed and deformed longitudinally forward. The fuel tank mounted on the forward wall of the trunk was in-turn displaced forward and into contact with the differential. Referring to Figure 16 above, examination of the tank revealed that its lower central aspect was crushed to near full thickness. With the lower aspect of the tank captured by the differential, the top aspect of the tank and trunk wall rotated over the top

of the axle during maximum engagement. The straps attaching the tank to the trunk wall separated during the rotation. The sway bar engaged the lower forward side of the tank across its width. Areas of substantial contact between the sway bar bracket shields and tank were noted. The shields protecting the sway bar brackets appeared structurally sound, although partially burned by the fire. The forward left side of the tank heavily engaged the left axle housing. There were no punctures of the forward side of the fuel tank from engagement with the undercarriage, differential, or suspension components. The drive axle fractured in an irregular manner forward of the differential yoke. Heavy deposits of asphalt were noted to be embedded in the yoke from the post-crash travel of the vehicle to rest.

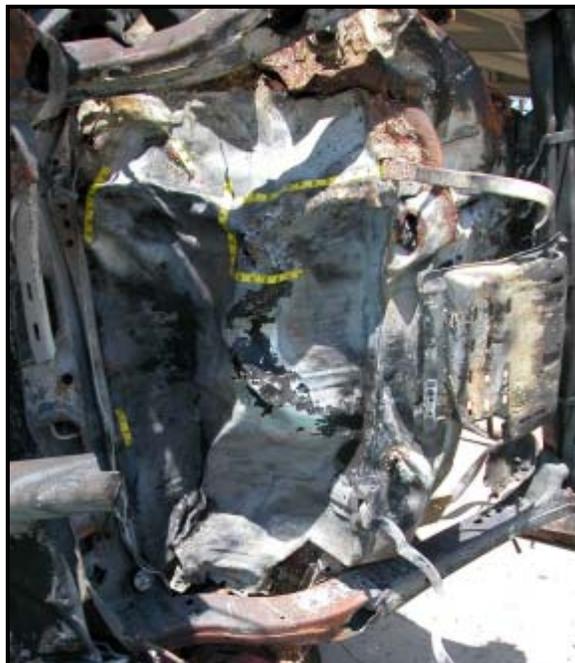
After the undercarriage examination, the rear axle, exhaust pipes, suspensions links and sway bar were removed. The fuel tank was engaged with the forward trunk wall and retained by the deformation. With the tank removed, the forward trunk exhibited deformation directly related to the dimensions of the scales. **Figure 17** is a view of the forward trunk wall with the tank removed. The wall was deformed over a 46 cm (18 in) width and protruded approximately 13 cm (5 in). The sheet metal in the area highlighted by the yellow tape was torn from contact by the lower forward corner of the wooden box containing the scales. The sheet metal tear was irregular due to the deformation and was approximately 20 cm (8 in) in length.

**Figure 17: View of the deformed trunk wall.**

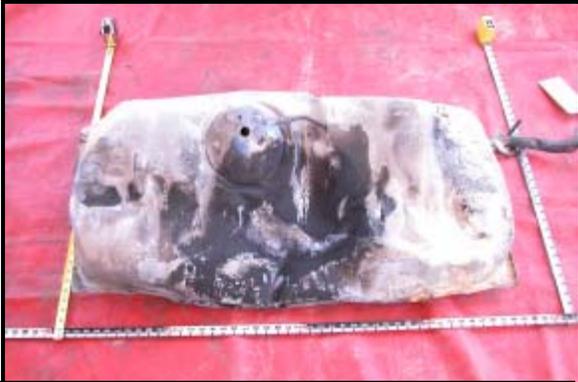
**Figures 18 and 19** are views of the forward and back side of the tank, respectively. The lower central aspect of the forward side of the tank was compressed to near full thickness. This area of deformation measured 25 cm x 38 cm (10 in x 15 in), width by height, and was caused by direct interaction with the rear differential. The sending unit was intact and undamaged. There was no leakage at the port. Based on inspection, the volume of the tank was reduced approximately 20 percent. As previous stated, there were no punctures or perforations of the forward side of the tank. The fuel neck was intact upon disassembly and there was no leakage at its junction with the tank. The rear side of the tank exhibited deformation related to its contact from the trunk wall and scales. The deformation was rectangular conforming to the shape of the scales and measured approximately 36.8 cm x 23 cm (14.5 in x 9 in), width by height. The deformation began 20 cm (8 in) inboard of the left side. The tank was punctured and the sheet metal was torn within the left upper corner of the deformation. The tear is highlighted by yellow tape in **Figure 19**. **Figure 20** is a close-up view of the tear. The tear was irregular in shape and measured 8 cm x 13 cm (3 in x 5 in). The orientation and location of the tank puncture related to the upper left corner of the truck scales housed within the trunk in its homemade wooden box. This tear was the source of the leak that fueled the post-crash fire. There were no other noted punctures or perforations to the fuel tank.

**Figure 18: View of the forward side of the tank.**

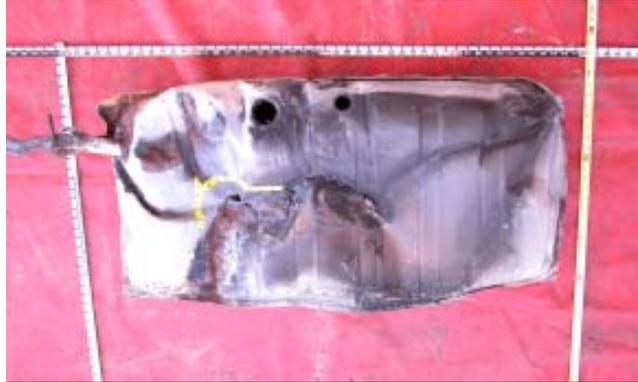
**Figure 19: View of the back side of the tank.**

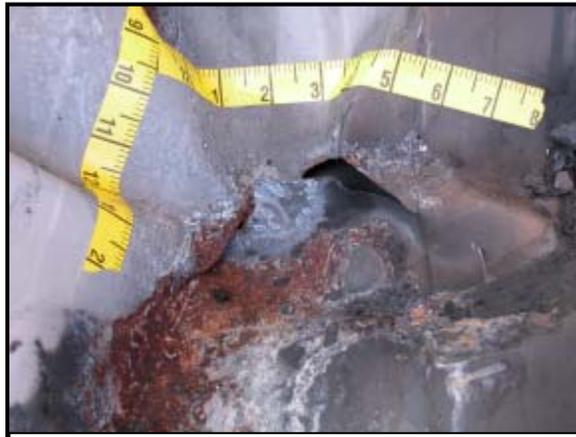
**Figure 20: Close-up view of the tank perforation.**
